# Sun River Assessment

# Sun River Assessment Final Report

Sun River Watershed Group  
and  
Cascade Conservation District

March 2014

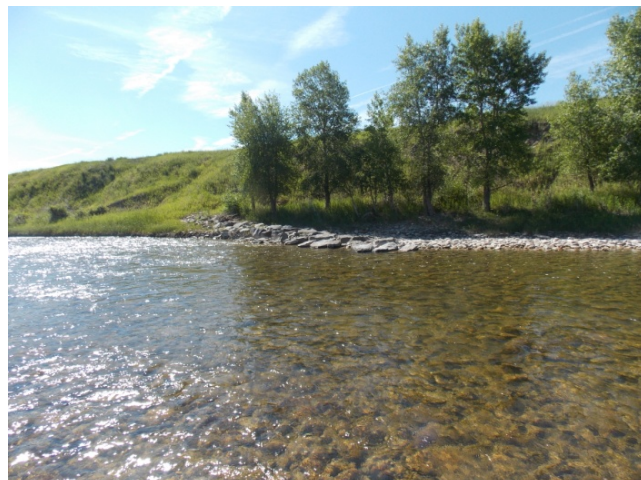
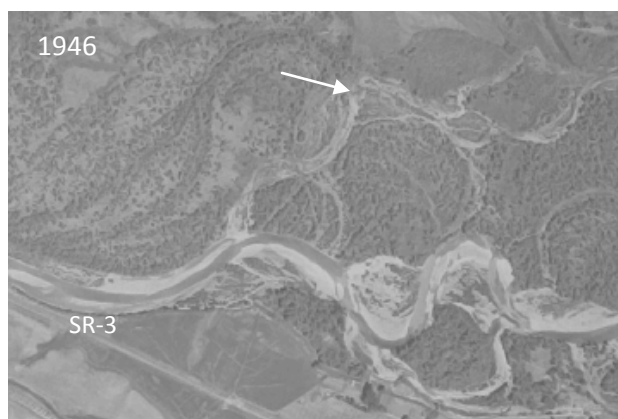
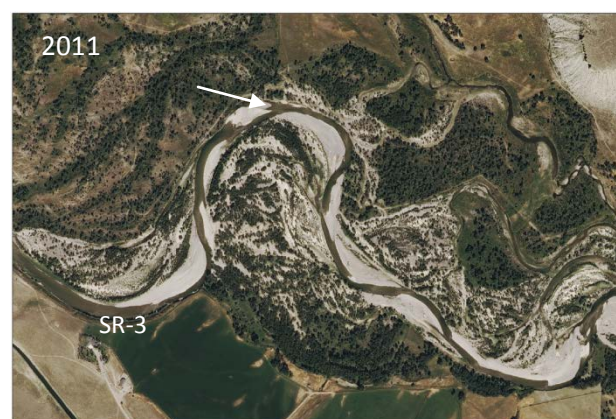
Rock flow deflector on the upper end of the terrace that is still intact and functional.

Downstream from Site SR-3. White arrow (point of reference) on the 1946 and 2011 aerial photography shows the rapid channel migration over the last 65 years.

- 1) Salvage the rock from the failed flow deflectors and use it to reinforce the third deflector. Leave the buried rock in the gravel bar on the north side of the river in-place.

- 3) After each out-of-bank flood event, walk the floodplain/old channels and check for active headcuts. If active headcutting is found, armor the upper end of the headcuts to prevent further migration across the meander.

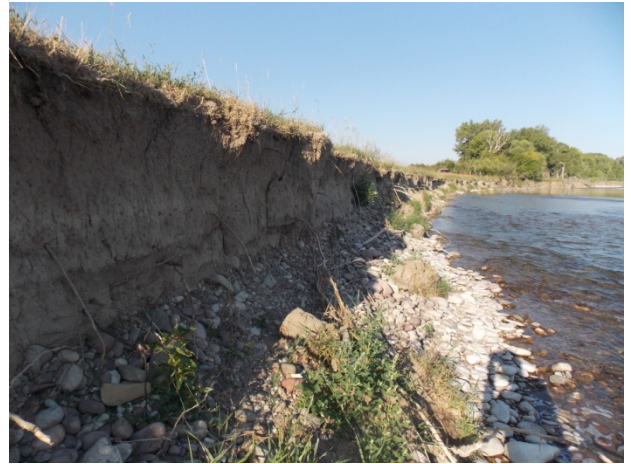
Site SR-4: Active bank erosion along a pasture. The river migrated south approximately 80 feet during the 2011 flood.

- 1) The eroding bank at Site SR-4 would be expensive to armor with traditional rock rip-rap. A less expensive option is a bank stabilization project using bioengineering techniques. This approach would still be expensive and come with a relatively high risk of failure.
- 2) Monitor old channel traces and irrigation laterals for active headcutting on the south floodplain downstream from Site SR-4. If active headcutting is found, armor the headcuts to prevent further migration across the floodplain.
- 3) Conduct aggressive noxious weed control targeting spotted knapweed.

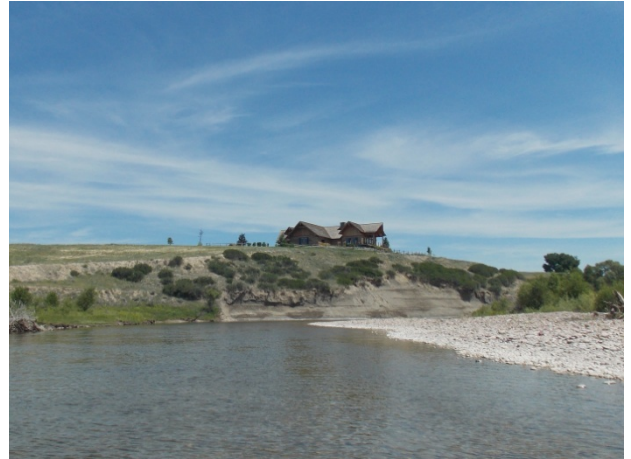
Natural precipitation, irrigation water, and septic seep can quickly percolate through the surface alluvial materials (unconsolidated clay/silt/gravel) and eventually reach the laminated glacial lake sediment interface. The terrace's steep slope and water saturation of the interface are creating unstable conditions. Small seeps along the terrace face confirm the presence of water along this interface. Terrace stability may be further compromised by scouring of the terrace toe during high flow events. Seismic activity could exacerbate the situation although this site is not located in a high hazard seismic zone.

Site SR-5: House built on a high terrace.  
The terrace face is actively sloughing.

- 1) Minimize the use of landscaping water. Divert all surface run-off away from the sloughing terrace.
- 2) Planting deep-rooted shrubs across the upper terrace slope will help utilize excess water and bind the soil.
- 3) Look for signs of increased slope instability which may include: 1) increased terrace sloughing; 2) new tension cracks parallel to the slope contour or; 3) bulges, cracks, and water seepage where there were none before. If slope instability begins to threaten the house, a professional contractor experienced in hillside slope stability should be consulted. They will likely suggest geotechnical approaches commonly used to treat unstable slopes (i.e. shotcrete, hill pins, geogrids, etc.). Such treatments are often expensive and require contractor expertise from outside of Montana.
- 4) Conduct aggressive noxious weed control targeting spotted knapweed.

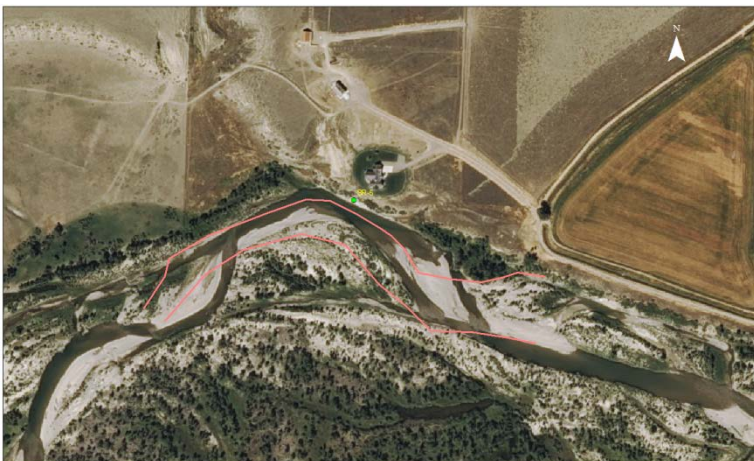
Red lines show the 1995 channel bank superimposed on 2011 imagery. The terrace toe has slowly scoured over this 18 year period.

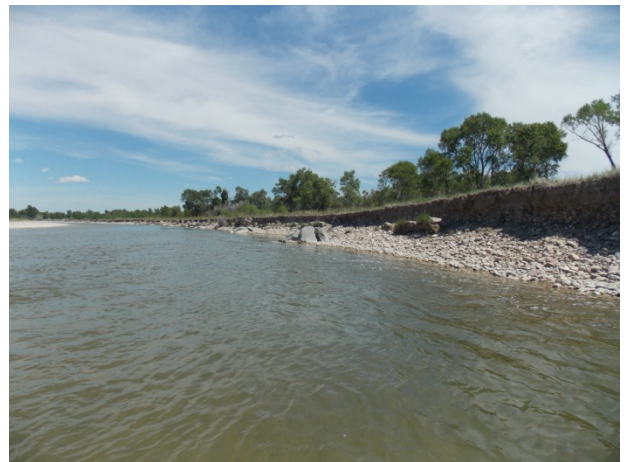
Eroding bank where root wads were used as bank protection to prevent the river from reoccupy an old channel.

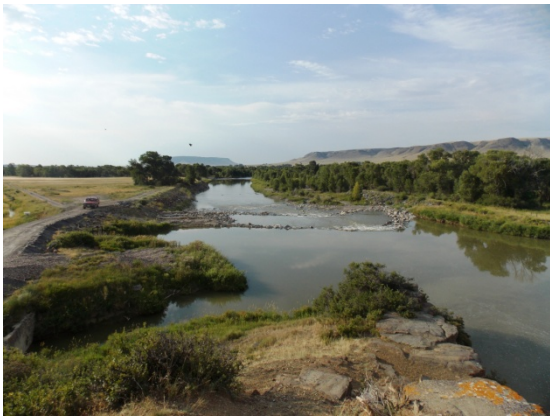
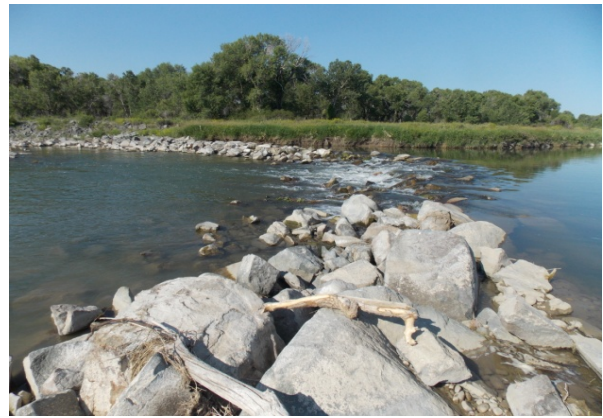
cross-sectional flow area and reducing water velocity in the upstream backwater. A large gravel bar (1.6 acres) has formed along the south bank due to bedload deposition behind the diversion. This gravel bar build-up is further exacerbated by the eddy effect caused by the protruding “reef” on the north bank.

Approximately 700 feet of rock rip-rap and dike have been placed on the south bank above the diversion along the large gravel bar. The toe of the rip-rap is beginning to scour. Below the diversion, a 4 foot high dike faced with rock rip-rap lines the north bank and extends over 1,000 feet downstream.

Site photos of the Rocky Reef Diversion taken during the summer of 2013. The diversion backwater creates a wide cross-sectional area and low velocities. A large amount of gravel and silt have deposited upstream from the diversion.

Feasibility and costs associated with Option 1 would require a detailed analysis by a qualified and experienced river hydrologist or engineer. For the water users, this option would require additional operational steps (placing and removing portable blocks) during each irrigation season to keep the system functional. But, it would significantly reduce recurring maintenance costs and mitigate the impacts caused by a permanent weir.

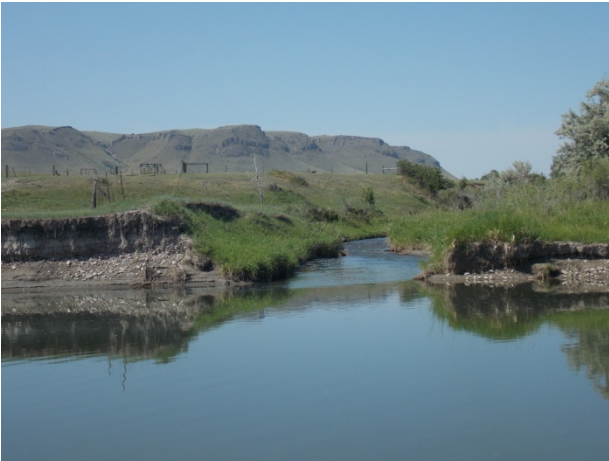
The mouth of the return flow channel is 90 feet further south than it was in 1995. Immediately downstream from the return flow channel, the river has eroded into a small pasture. Over the last 18 years, ½ acre of the pasture has been lost. Concern was expressed in the late 1990s about an eroding bank downstream close to where buildings are located on a high terrace. This bank has eroded very little in the last two decades and is relatively stable as shown by the 1995 bank line (dashed red line on 2011 aerial photo below).

Site SR-12: The mouth of the irrigation return flow channel on the south bank of the Sun River.

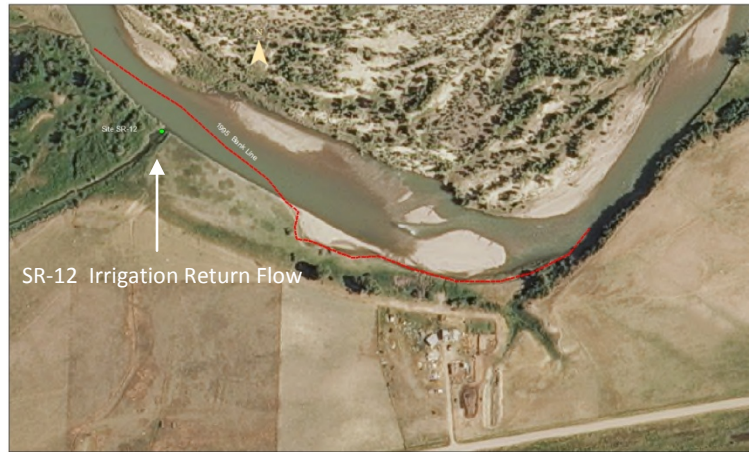
The red dashed line depicts the 1995 bank overlain on a 2011 aerial photo. Over the last 18 years, ½ acre of pasture on the south bank has been lost.

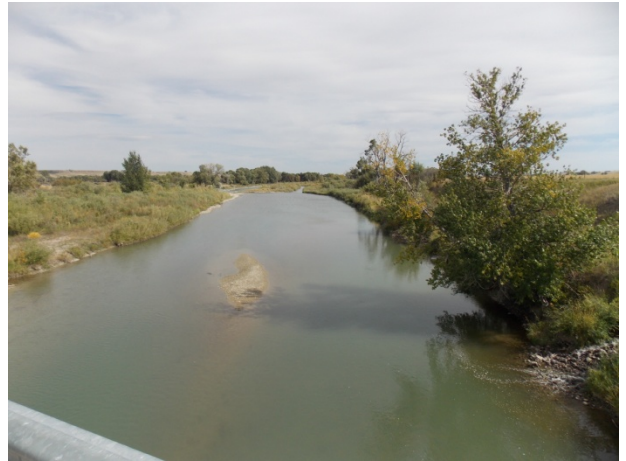
Looking downstream from the Fort Shaw Bridge. Old car bodies and metal trash are scattered along the right bank.

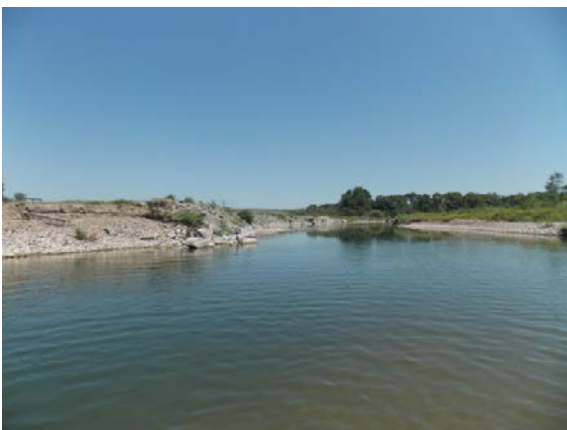
The upper end of Site SR-15. The river has eroded over 50 feet behind the jetty. Most of the erosion occurred during the 2011 flood.

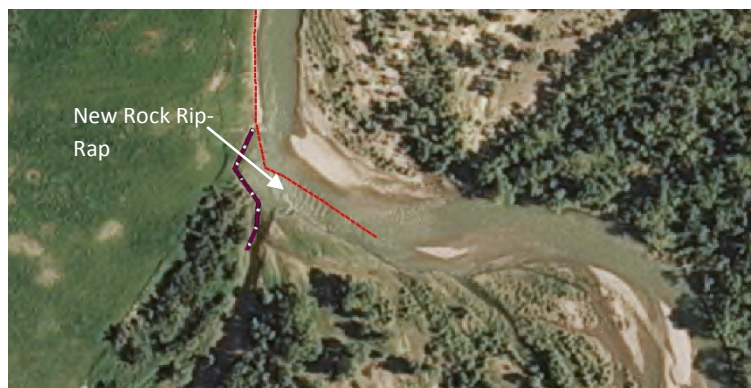
The red line depicts the 1995 bank overlain on a 2011 aerial photo. The purple line is where rock rip-rap could be placed to prevent further bank erosion and potential flanking of downstream rip-rap.

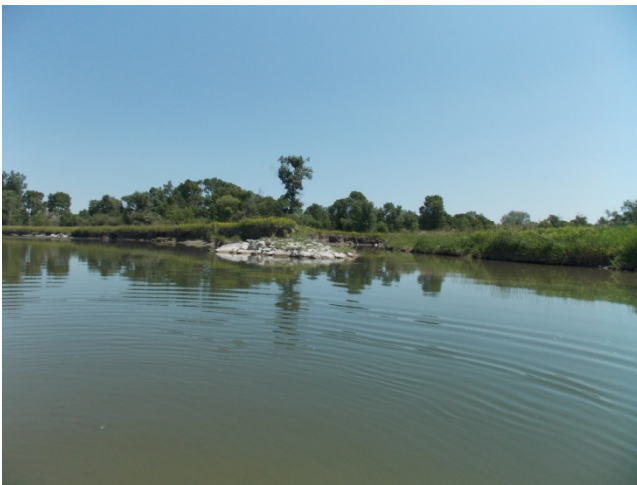
Point #1: The side channel was the Sun River’s main channel in 1946. Sometime between 1946 and 1975, the river shifted to the west making it a secondary side channel. The side channel is used as a conveyance to deliver water to an irrigation pump (adjacent hay field with gated pipe). A rock hard point was constructed over 10 years ago to maintain flow in the side channel and keep the Sun River in its present location. The hard point is close to being flanked. A narrow “isthmus” (10 feet wide) behind the rock point is actively eroding on both sides. If it erodes through, the hard point will become an isolated pile of rocks in mid-channel. It is uncertain how this would affect flows into the side channel, but it is conceivable that the side channel would again become the main river channel.

Point #1: Looking downstream at the hard point that separates the Sun River mainstem (left) from the side channel (right). Rock was placed to create this hard point over 10 years ago. It was repaired in late 2013.

Point #1: Reinforce the rock hard point with additional rock extending down both sides of the “isthmus”, 70 feet on the river side and 170 feet on the side channel. Incorporate a short bendway weir flow deflector into the reinforced rock point. See the conceptual diagram below. Some repair work was completed on the hard point in late 2013.

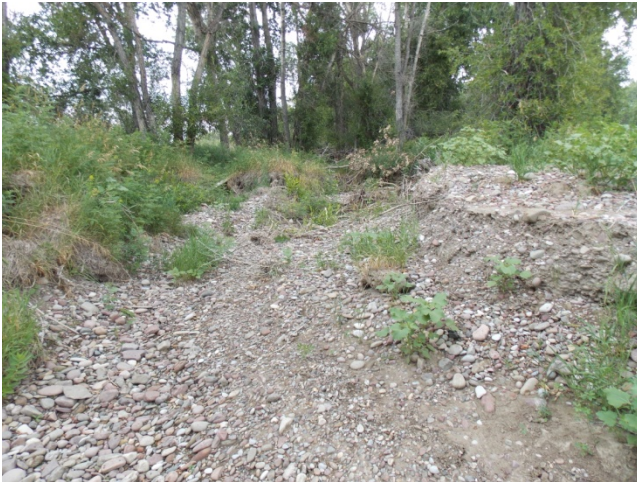
Point #2: On the Sun River mainstem, approximately 500 feet downstream from the mouth of the side channel, the river is close to breaching into the channel. Since 1995, the river migrated 130 feet towards the side channel. A 120 foot wide “neck” currently separates the main channel from the side channel. Over-bank flows have created several active headcuts across this “neck”. The headcuts are migrating towards the main channel and if they are allowed to continue, the river will likely breach into the side channel.

Point #2: Active headcut traveling across a narrow riparian “neck” separating the river from the side channel.

- 1) Rip-rap 300 feet of the east river bank at the “neck” separating the river from the side channel.
- 2) Place a rock sill across the head end of the active headcuts to prevent further movement. The sill needs to be extended far enough across the top of the headcut to prevent flanking by over-bank flows.

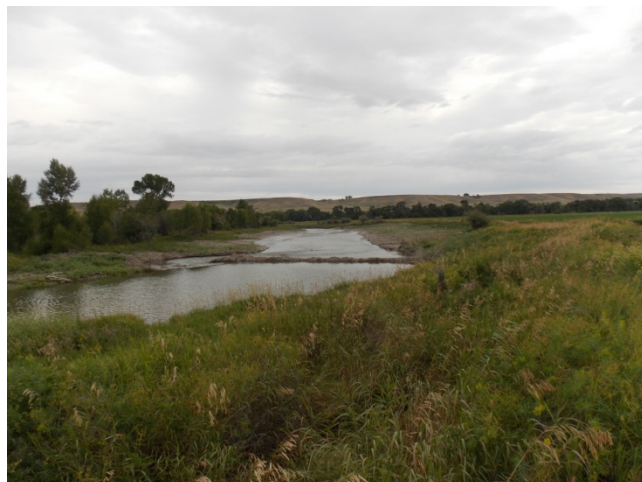
Looking downstream on the side channel below the irrigation pump. The photo shows a berm in the side channel intended to elevate the water level for an upstream irrigation pump.

Side Channel: Below the irrigation pump, 700 feet of side channel was shaped in 2013. Gravel was pushed up against the east channel bank. It is recommended that no further channel work be done. The channel will eventually narrow and deepen, creating meanders and point bars within the shaped channel. Install a permanent rock check structure for the irrigation pump instead of continuing to push-up a gravel berm each summer. See diagram below.

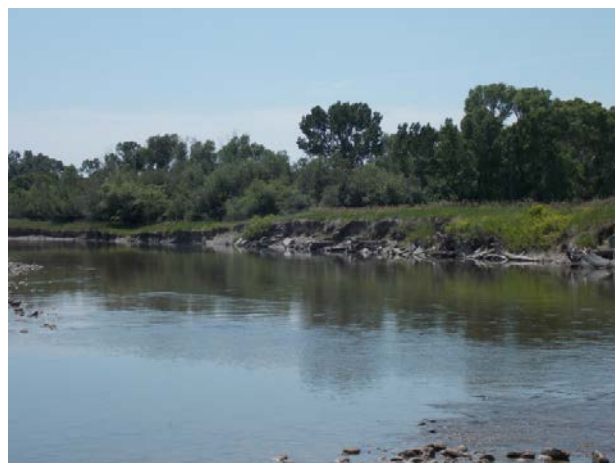
Bank stabilization project eroding out on the upstream end of Site SR-17.

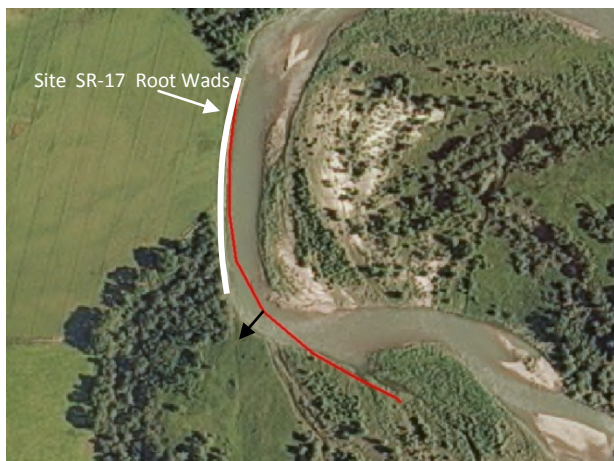
The red line shows the 1995 west bank. The black arrow shows the primary direction that the channel is migrating. Over 60 feet of bank has eroded over the last 18 years at the apex of the bend.

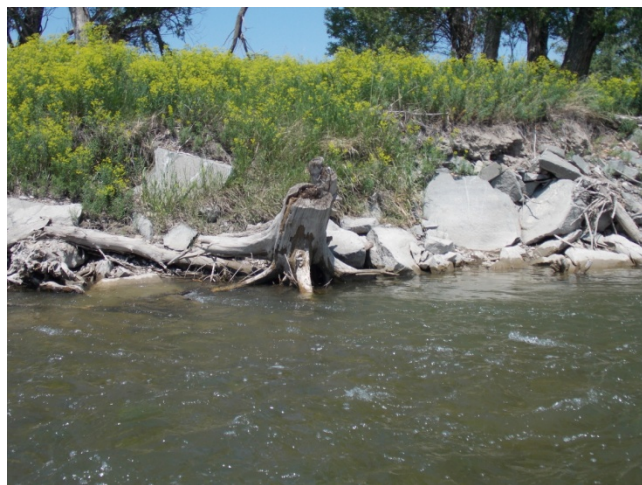
Rock rip-rap sloughing down the bank.  
Leafy spurge dominates the upper bank.

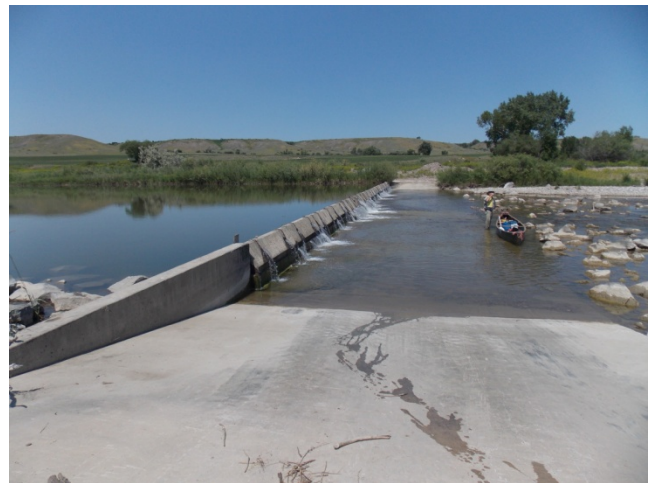
Sun River Valley Irrigation Diversion using portable concrete blocks to raise the water level in late summer.

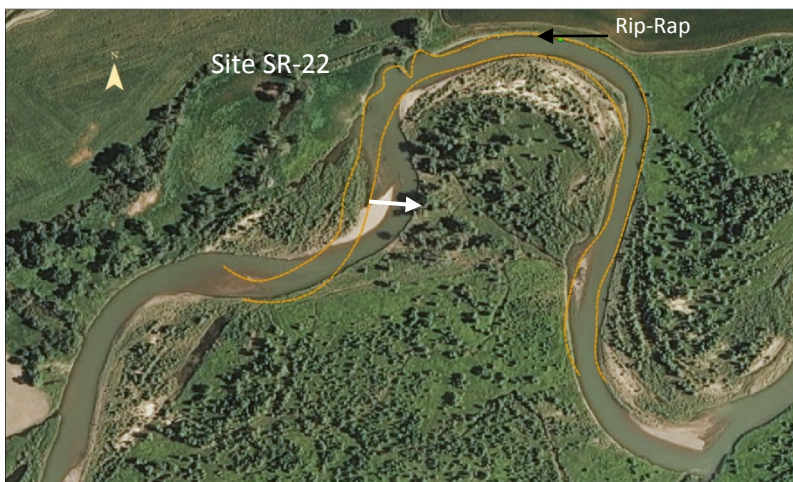
1995 bank lines overlain on 2011 aerial photography. South of Site SR-22, the river has migrated 165 feet east over an 18 year period.

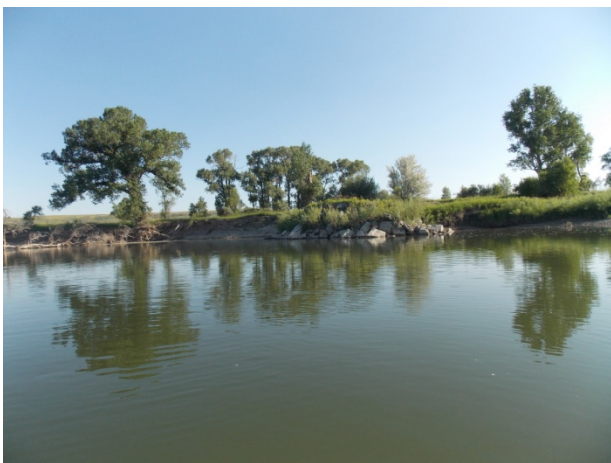
Large rock jetty that has created an upstream eddy. The eddy is eroding the bank on the upstream side of the jetty.

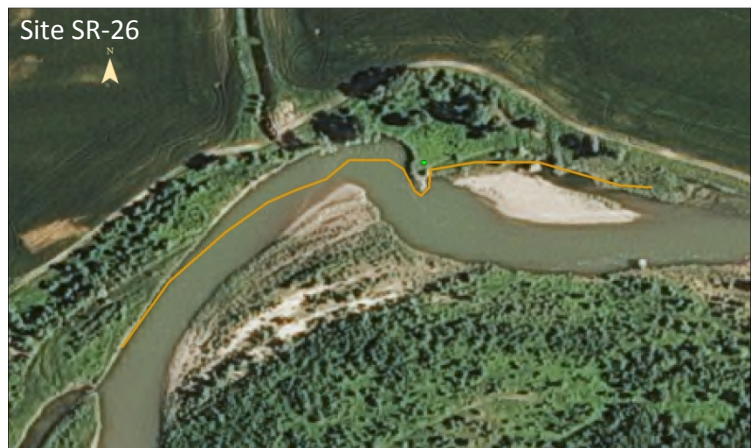
The orange line depicts the 1995 bank. Over the last 18 years, the river has eroded 50 feet into the bank.

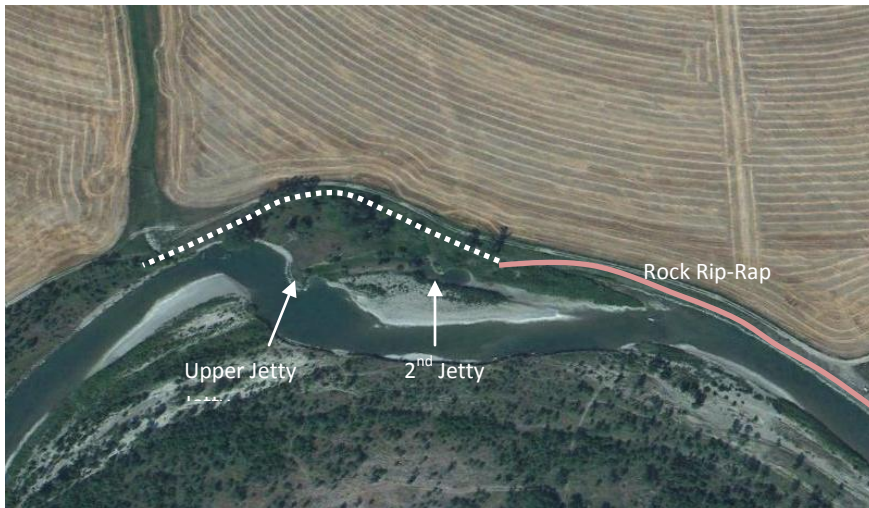
Conceptual view of recommended approach. The white dashed line is the proposed location of future bank stabilization along the field border if needed.

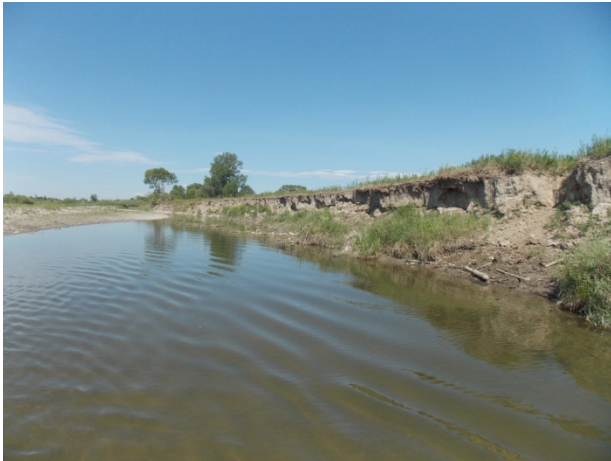
Eroding bank on the north side of the river.

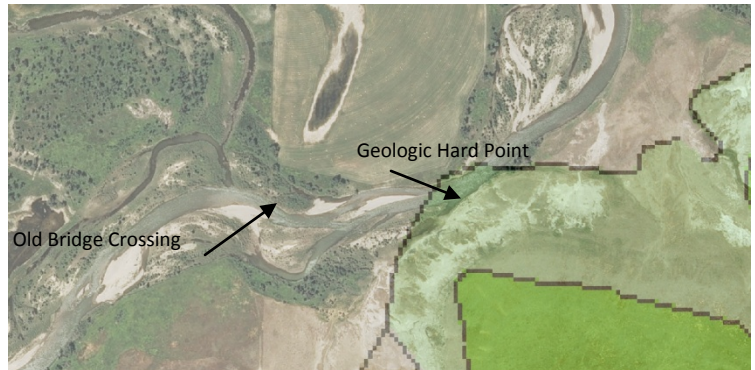
The light green geologic formation creates a “hard point” in the river.

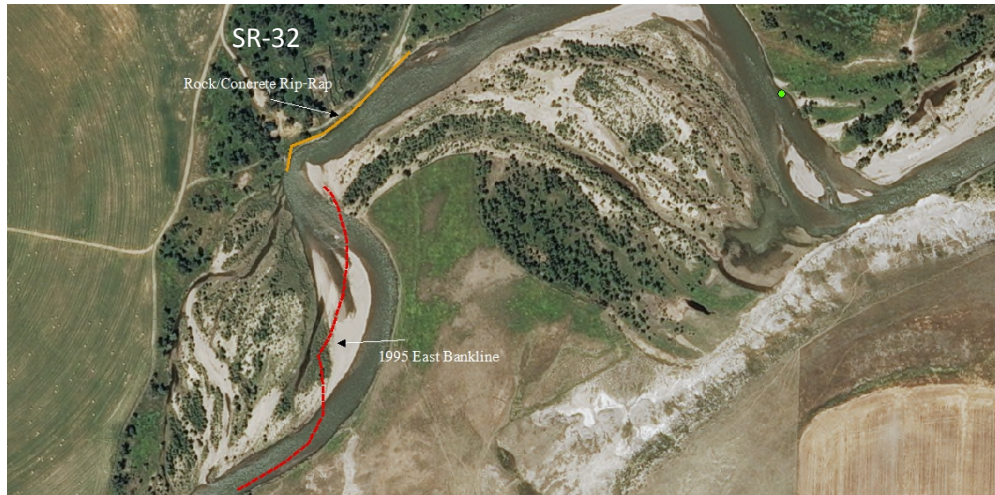
The red dashed line depicts the 1995 east river bank. The river has migrated east nearly 250 feet over the last 18 years. The easterly migration has realigned the river towards Site SR-32 directing the main current into the north bank above the existing rip-rap.

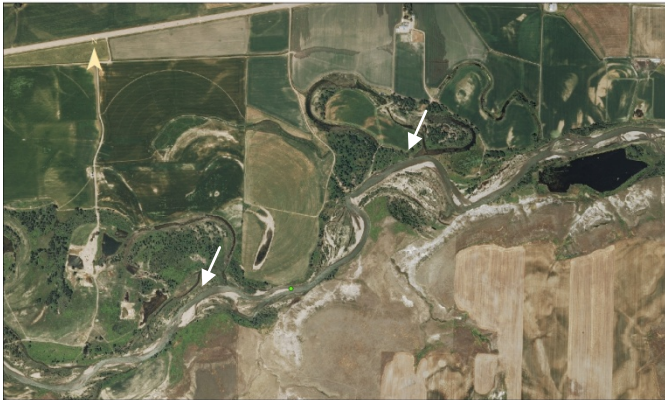
2011 – White arrows show the location of two meander avulsions. Two miles of channel were lost since the 1940s.

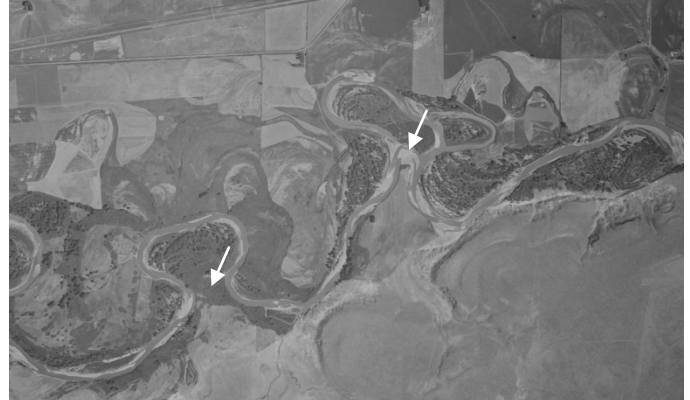
1946 – White arrows show the location of two meander avulsions. The upper right meander avulsed in 1946. The lower left meander avulsed a few years later.

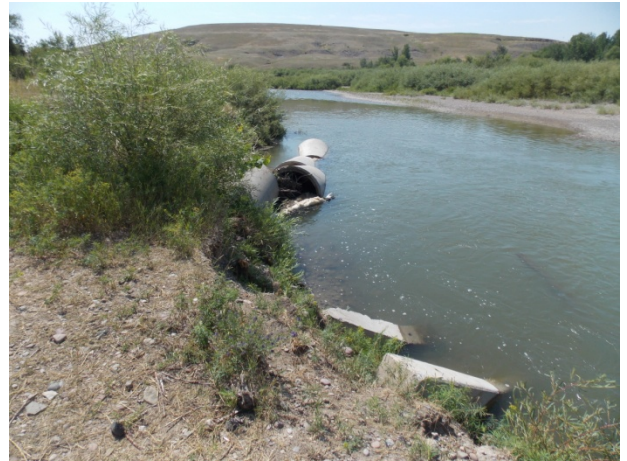
Concrete pipe and rubble scattered along the river bank. Rather than providing bank protection, they are contributing to the bank erosion and creating a public safety hazard.

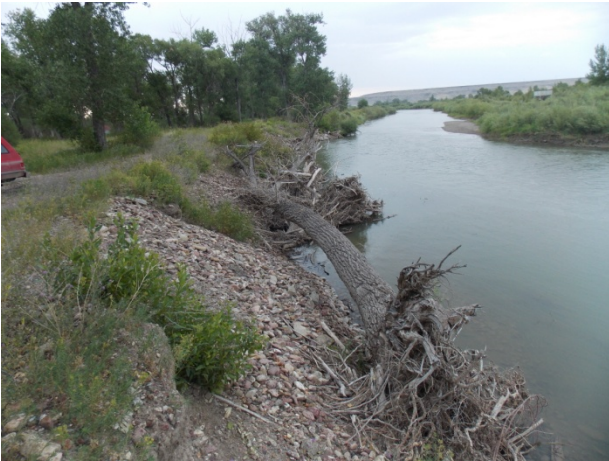
Site SR-38: Cobbles dumped over the bank serving as bank stabilization.

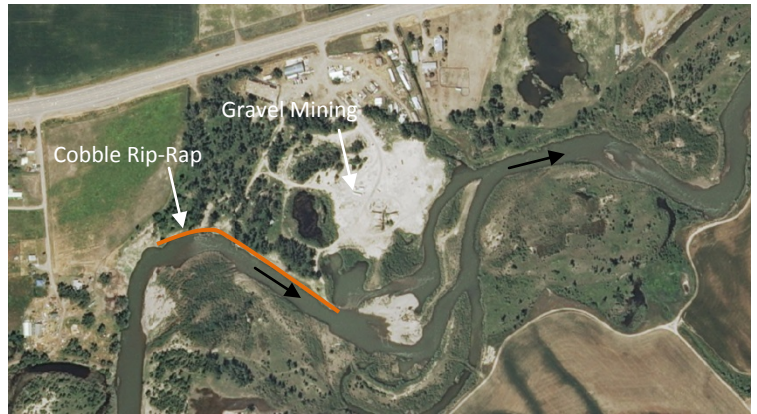
Recent gravel mining on the north floodplain.

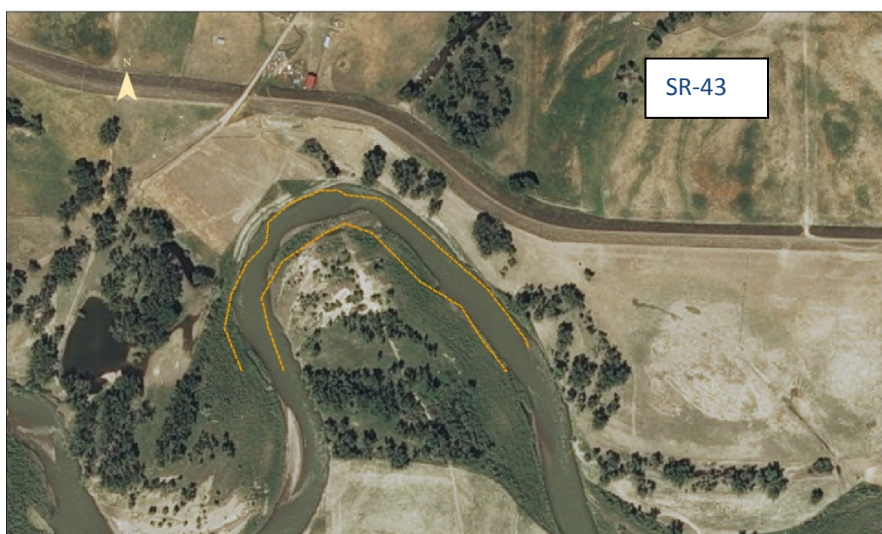
Rock rip-rap has partially failed on a river bend near the Vaughn Levee. The orange lines depict the 1995 bank lines.

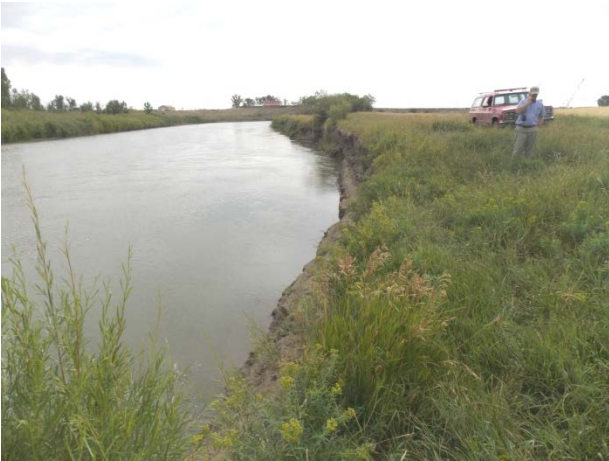
Bank erosion along the Sun River across from the Muddy Creek confluence.

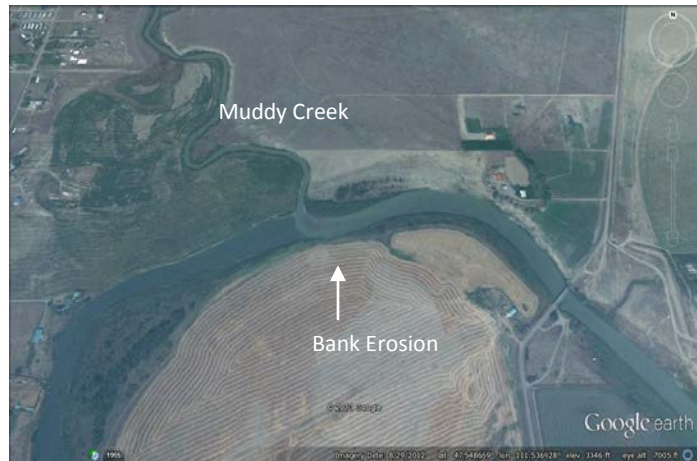
2012 aerial photo showing the Muddy Creek current directly impacting the south bank of the Sun River.
