August 24, 2021

# Channel Migration Mapping Sun River (Phase 1) Elk Creek (Phase 2)

### **Executive Summary**

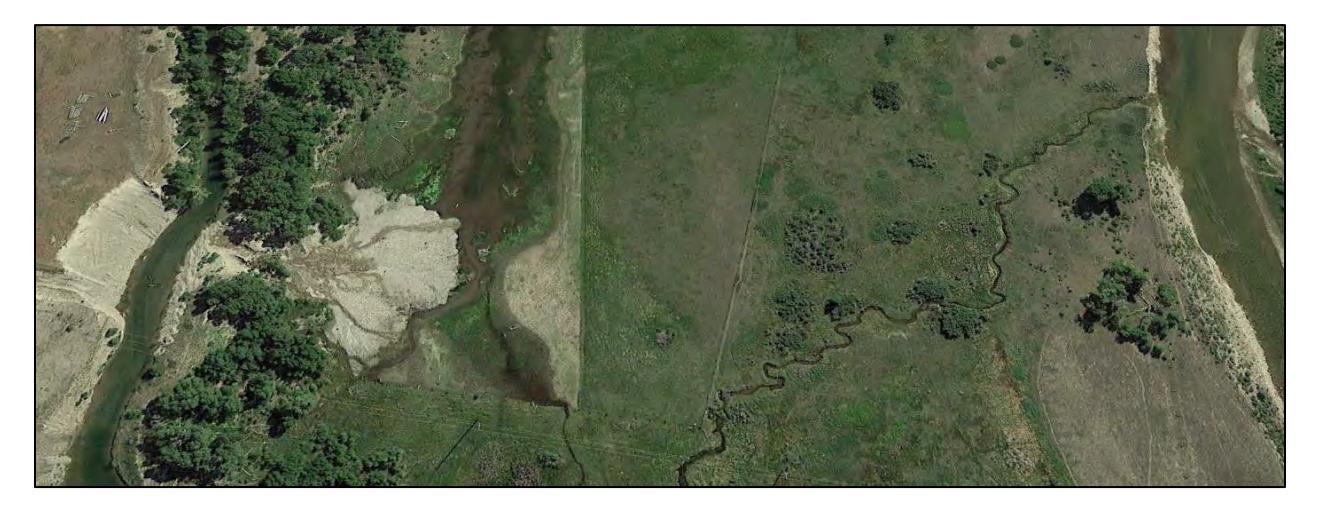
Figure 10. Google Earth photo showing Floweree Canal hillslope failure causing canal breach (left); Sun River is to right.

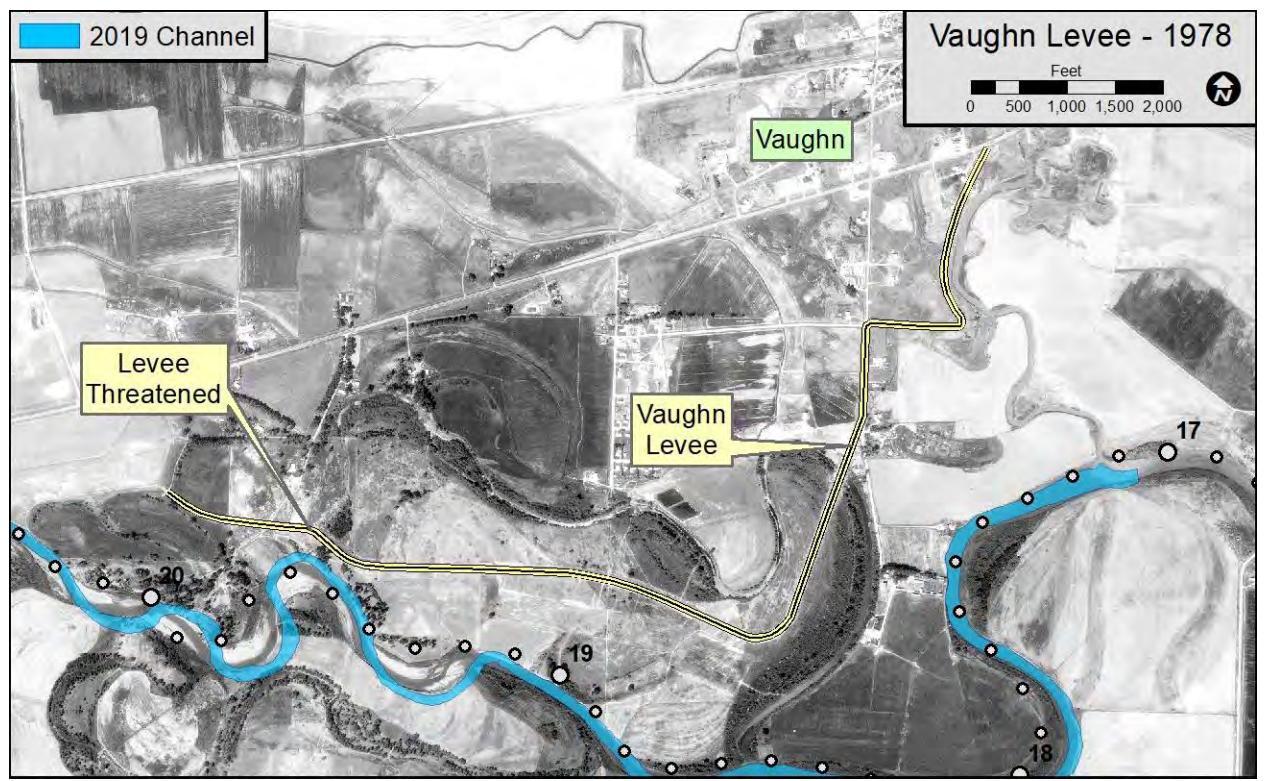
Figure 27. Vaughn Levee showing conditions a decade after it was built (1978 air photo); blue shows 2019 Sun River course and highlights large meander approaching and threatening levee.

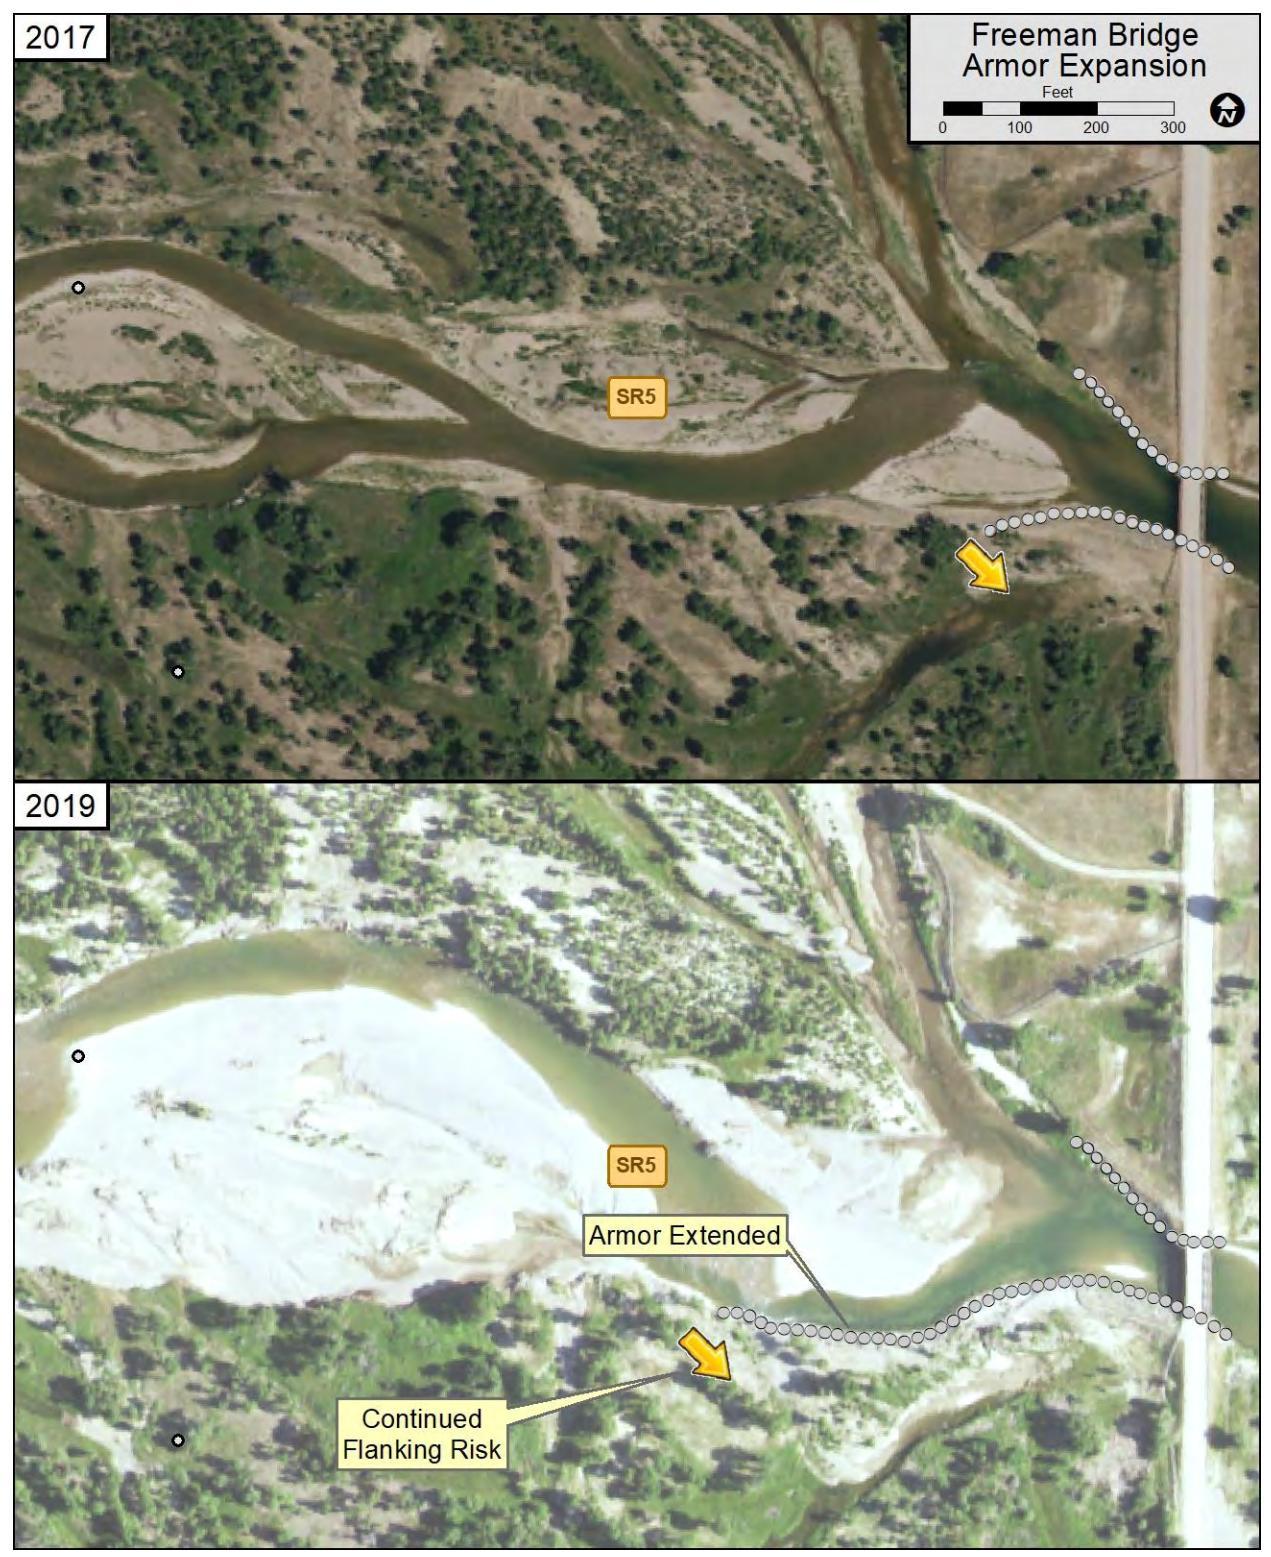
Figure 59. Bank armor expansion above Freeman Bridge between 2017 (top) and 2019 (bottom) showing continued flanking risk south of armor.

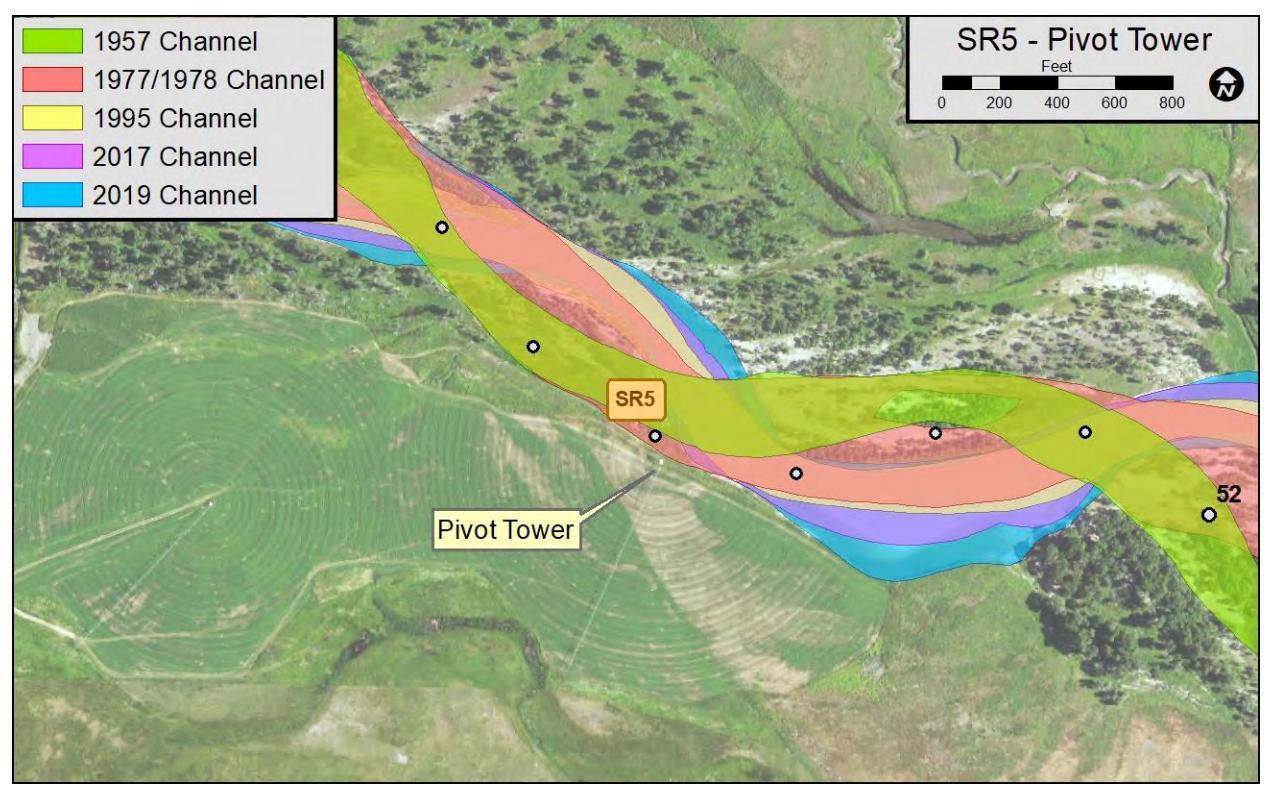
Figure 60. Pivot tower at RM 52.4R at high risk of damage due to channel migration.

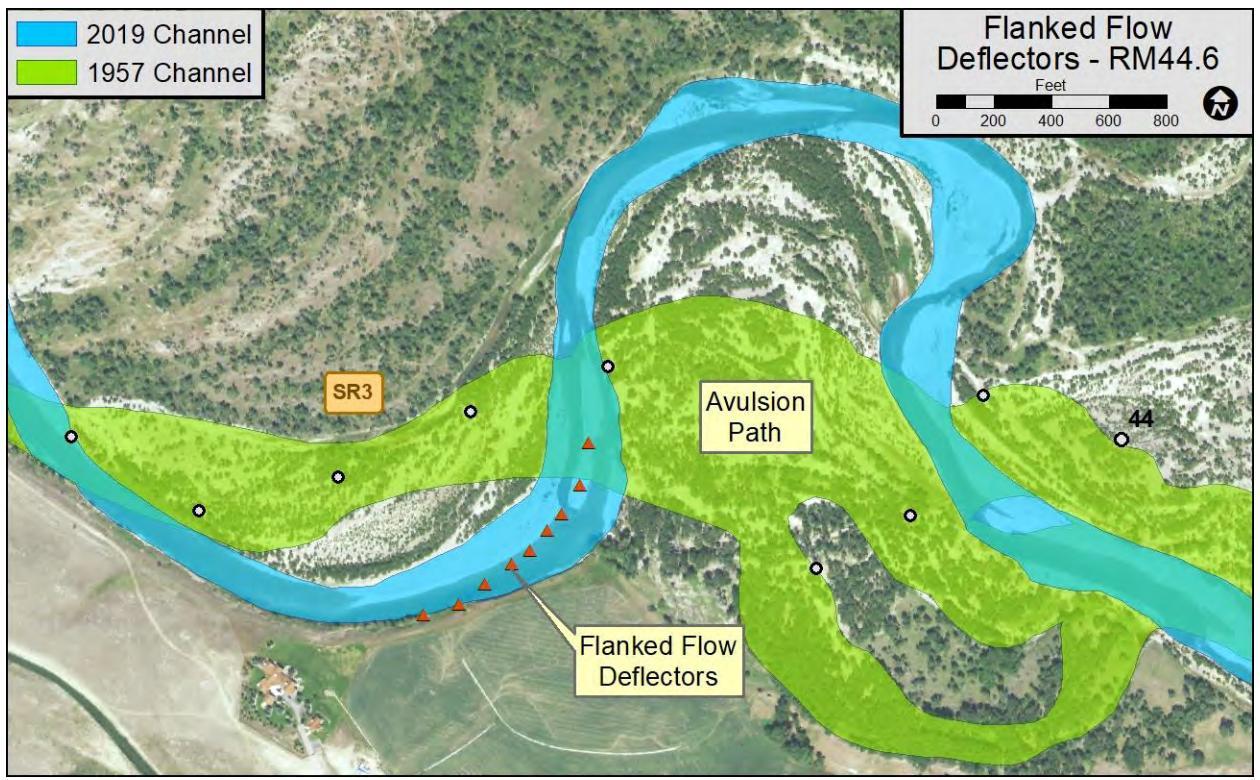
Figure 66. Channel migration at RM 44.7, site of Kellogg (2014) Site SR-3; at least five barbs have been flanked on the right bank; note avulsion path following 1957 channel route just downstream.

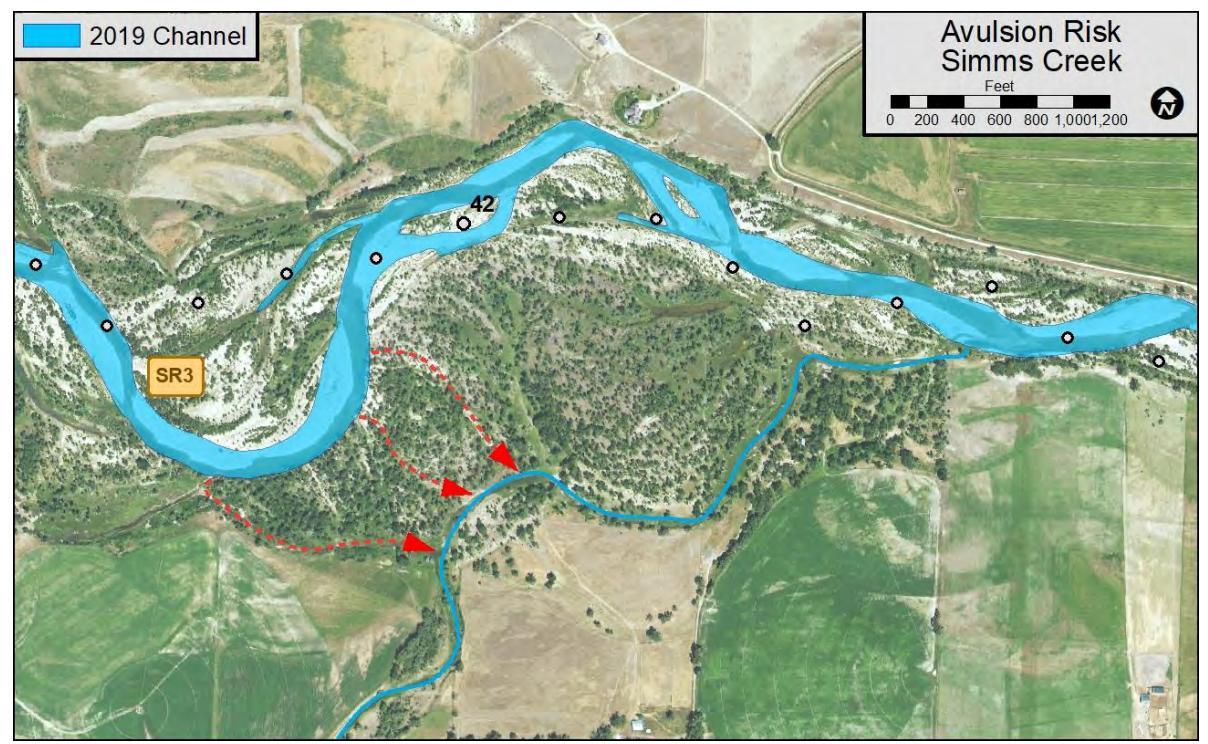
Figure 67. Multiple avulsion paths have developed from an outside bend towards Simms Creek, creating a high avulsion risk in this area.

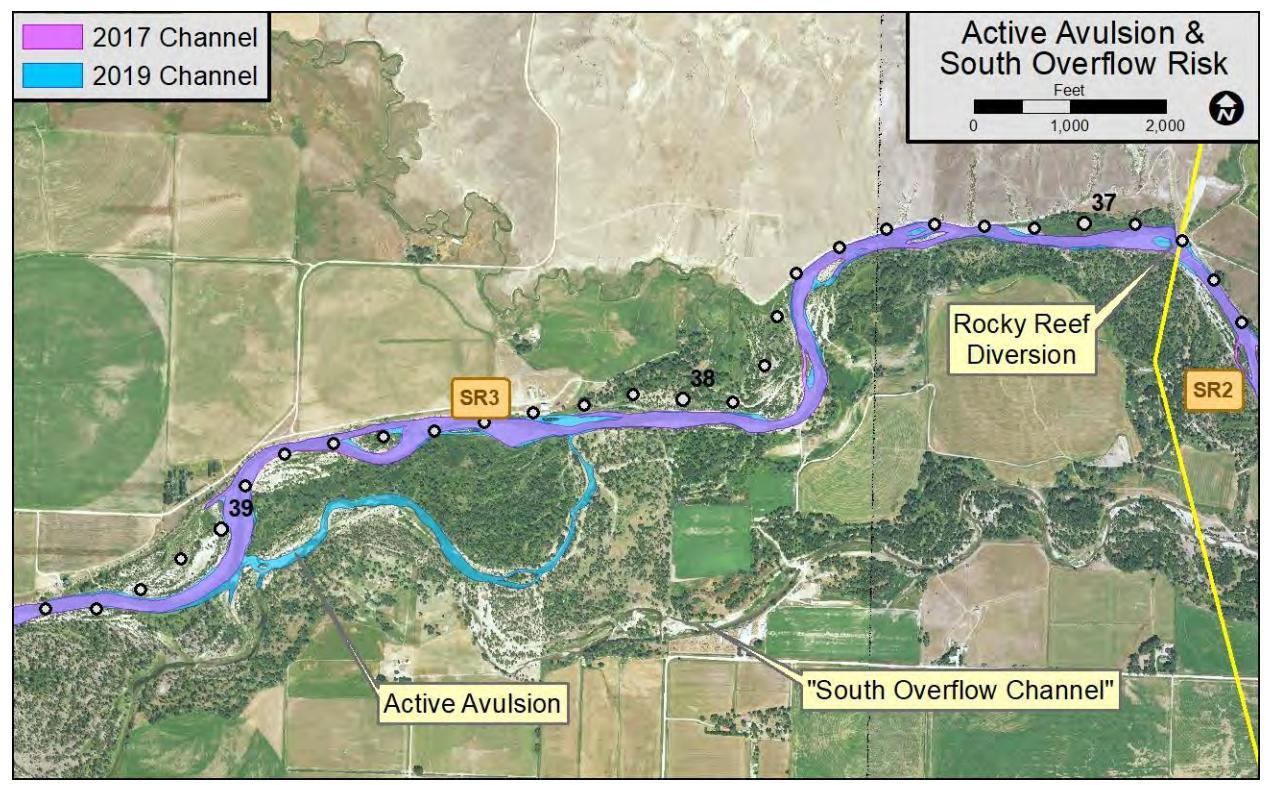
Figure 70. Active avulsion (blue 2019 path) at RM 38.5 showing potential for reactivation of South Overflow Channel that would bypass Rocky Reef Diversion.

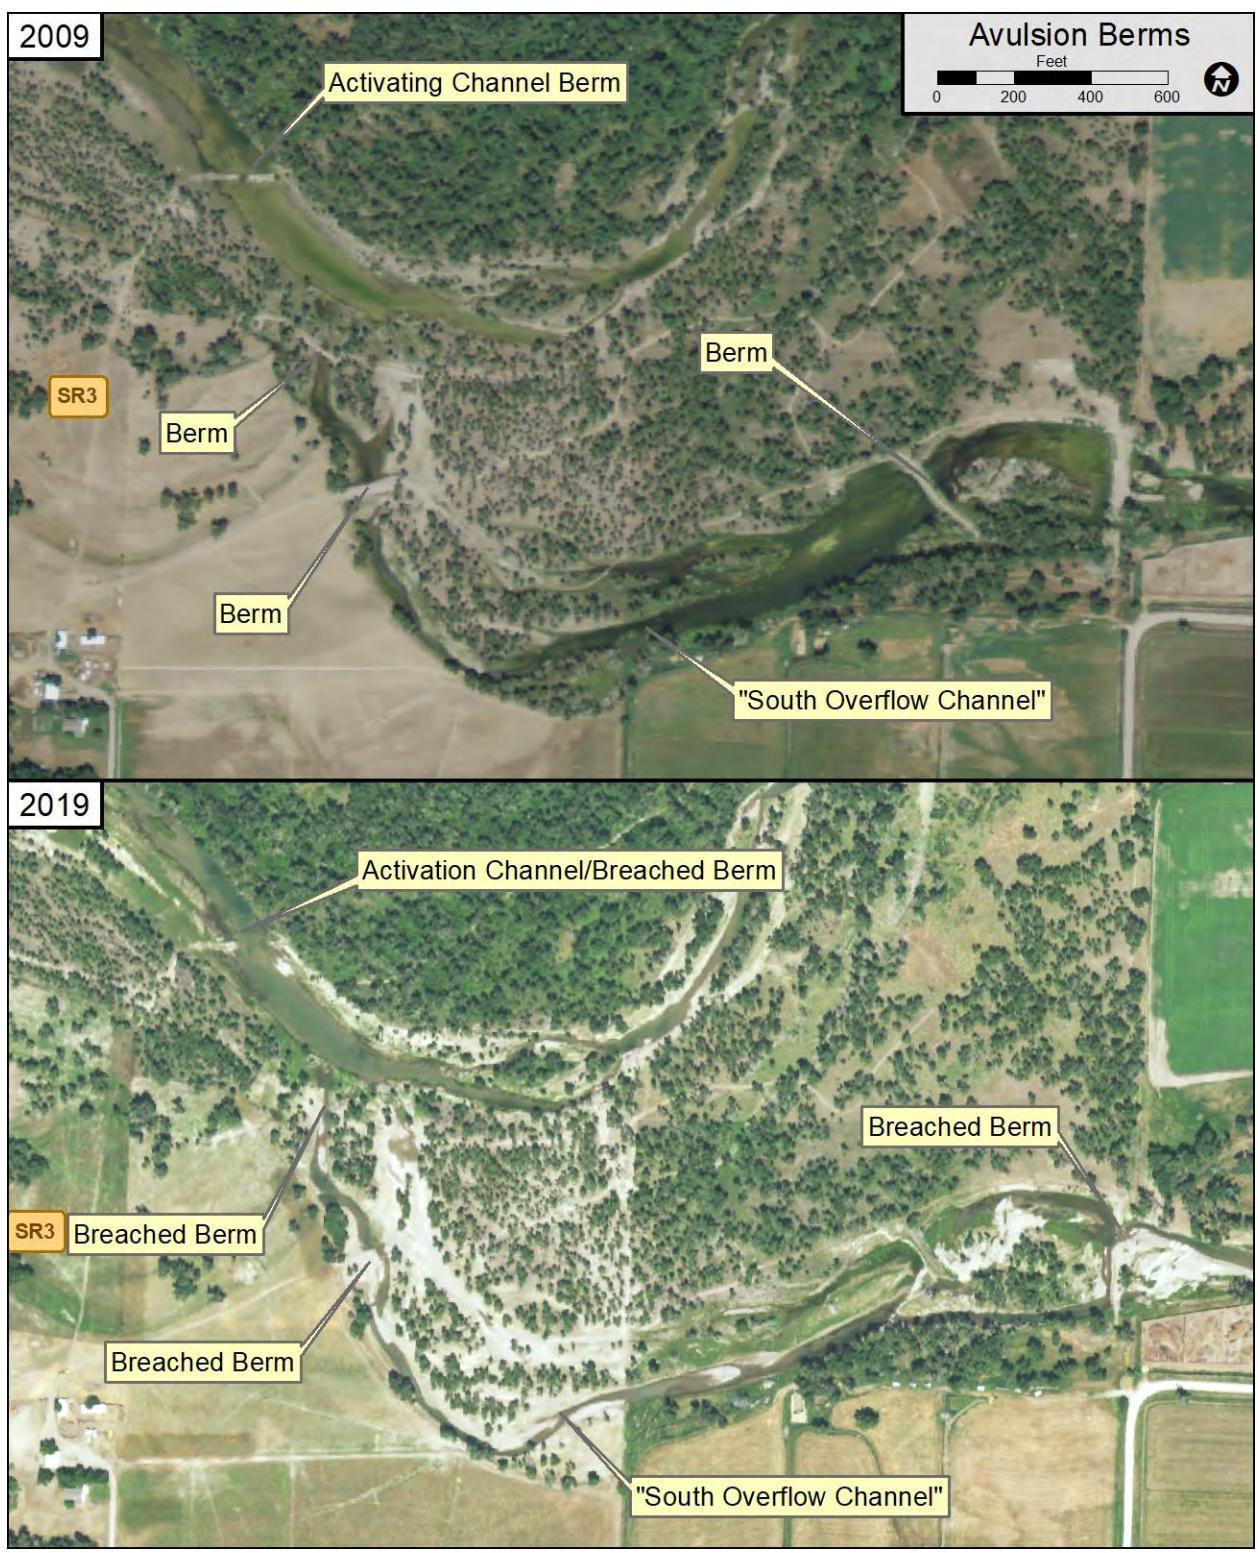
Figure 71. Activating channels on south floodplain about 1.5 miles upstream of Rocky Reef Diversion showing breaching of crosschannel berms between 2009 and 2019.

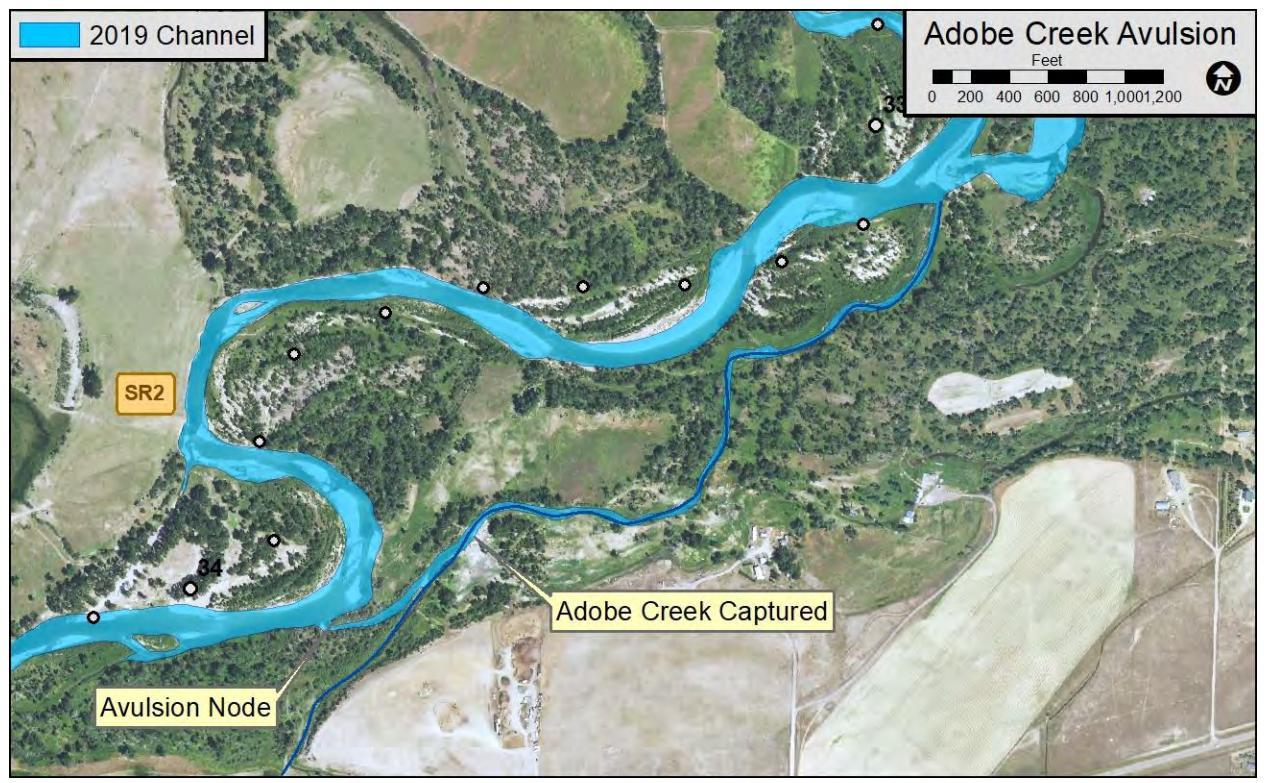
Figure 74. 2019 image showing active avulsion into lower Adobe Creek; avulsion path is about 2,000 feet shorter than the main river.

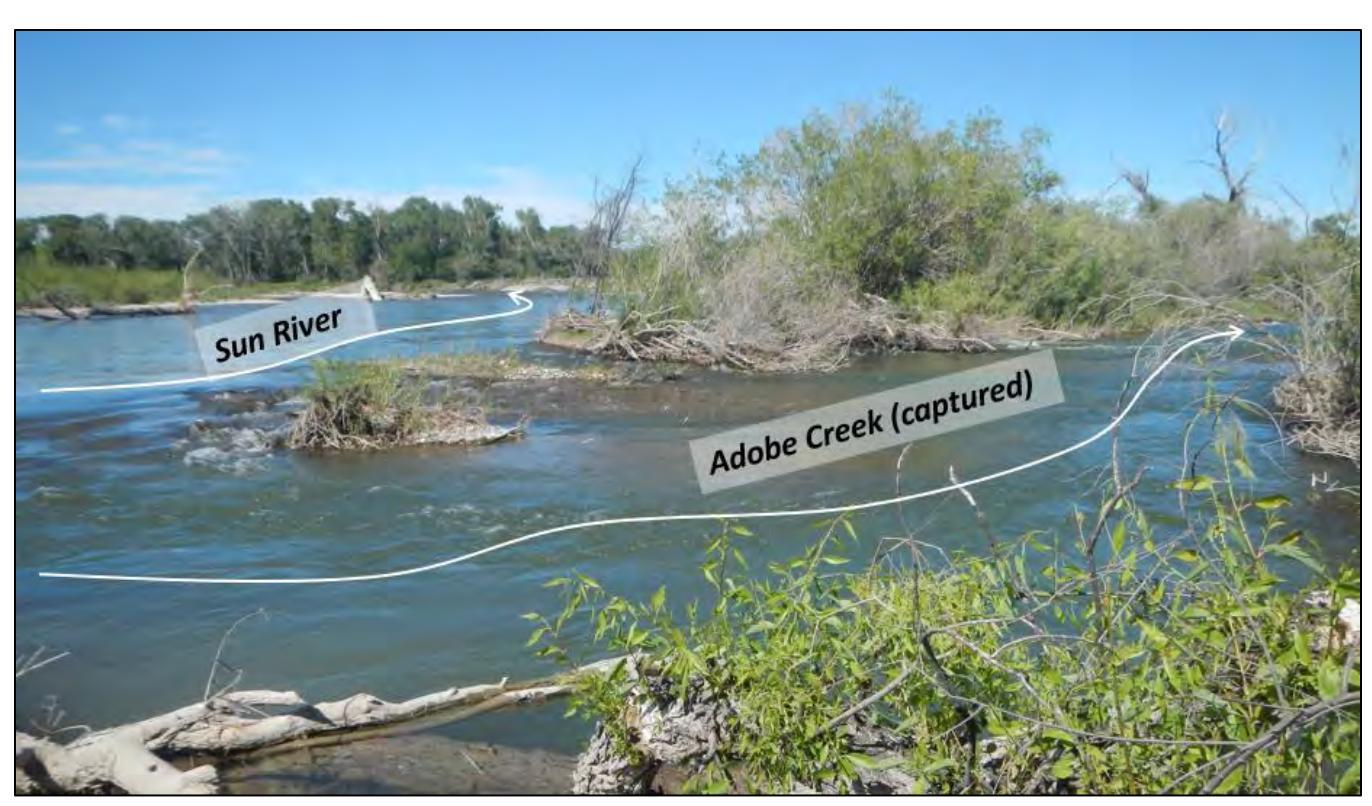
Figure 77. View downstream from avulsion node showing breach in right bank that captured swale feeding Adobe Creek (June, 2020).

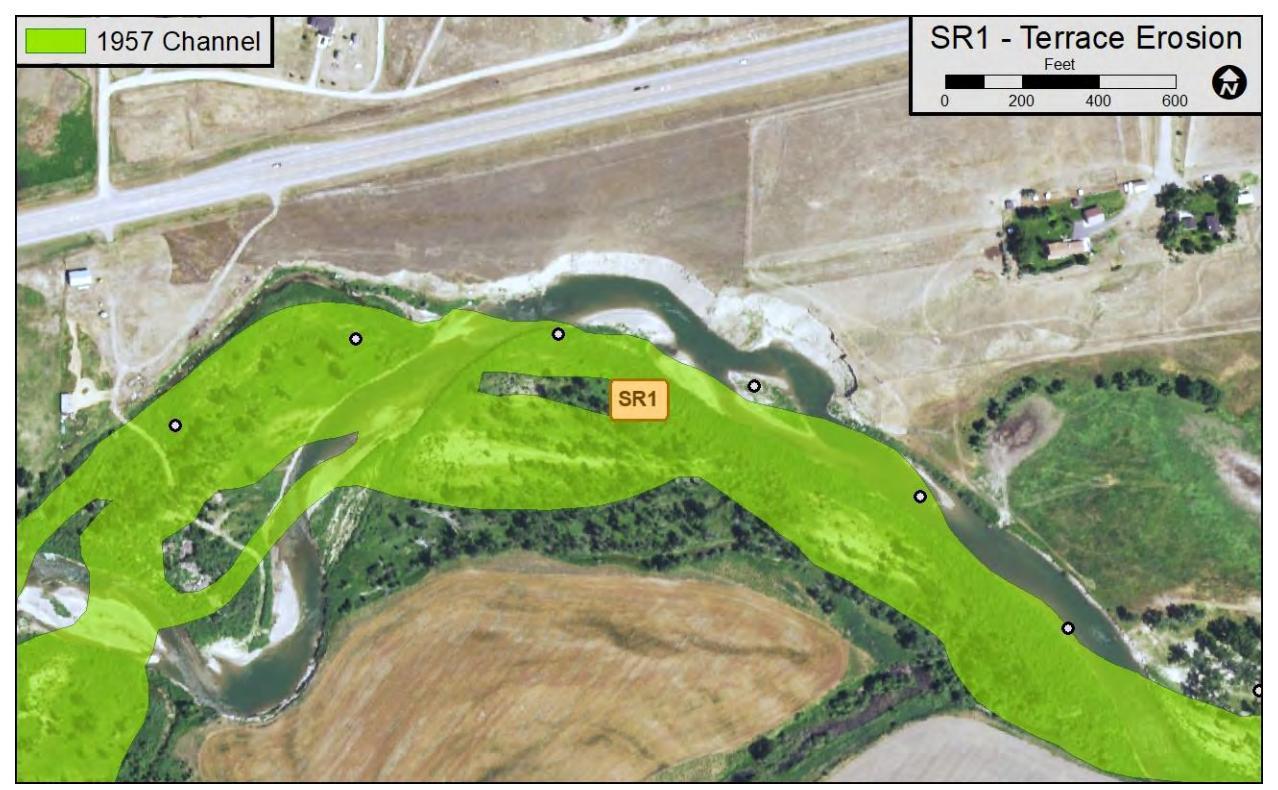
Figure 81. Terrace erosion at RM 20.5; green polygon shows channel location in 1957.

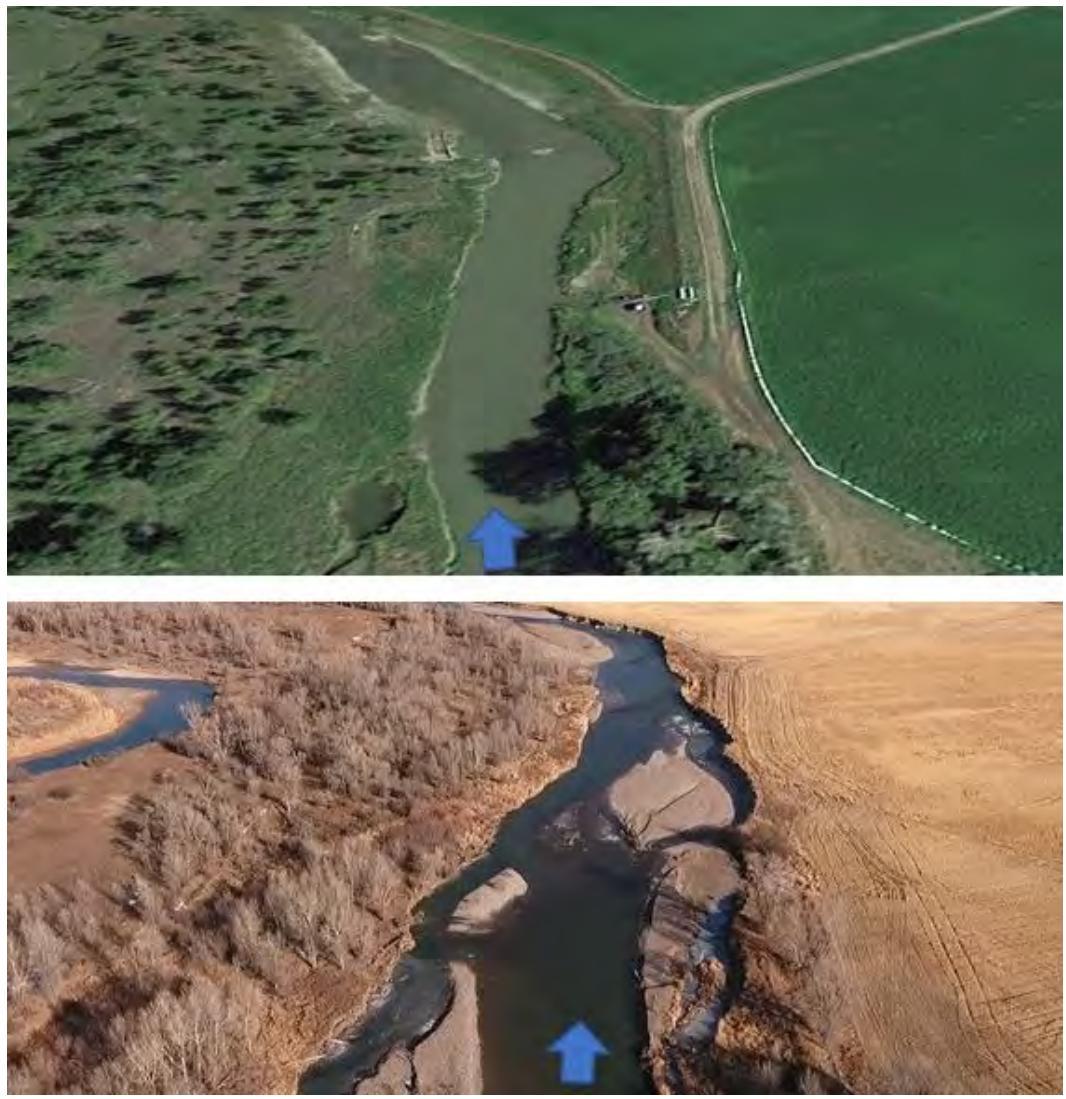
Figure 90. Pre- and post- flood photos showing enlargement of channel against fields and loss of pump site (lower photo was taken in December 2020).

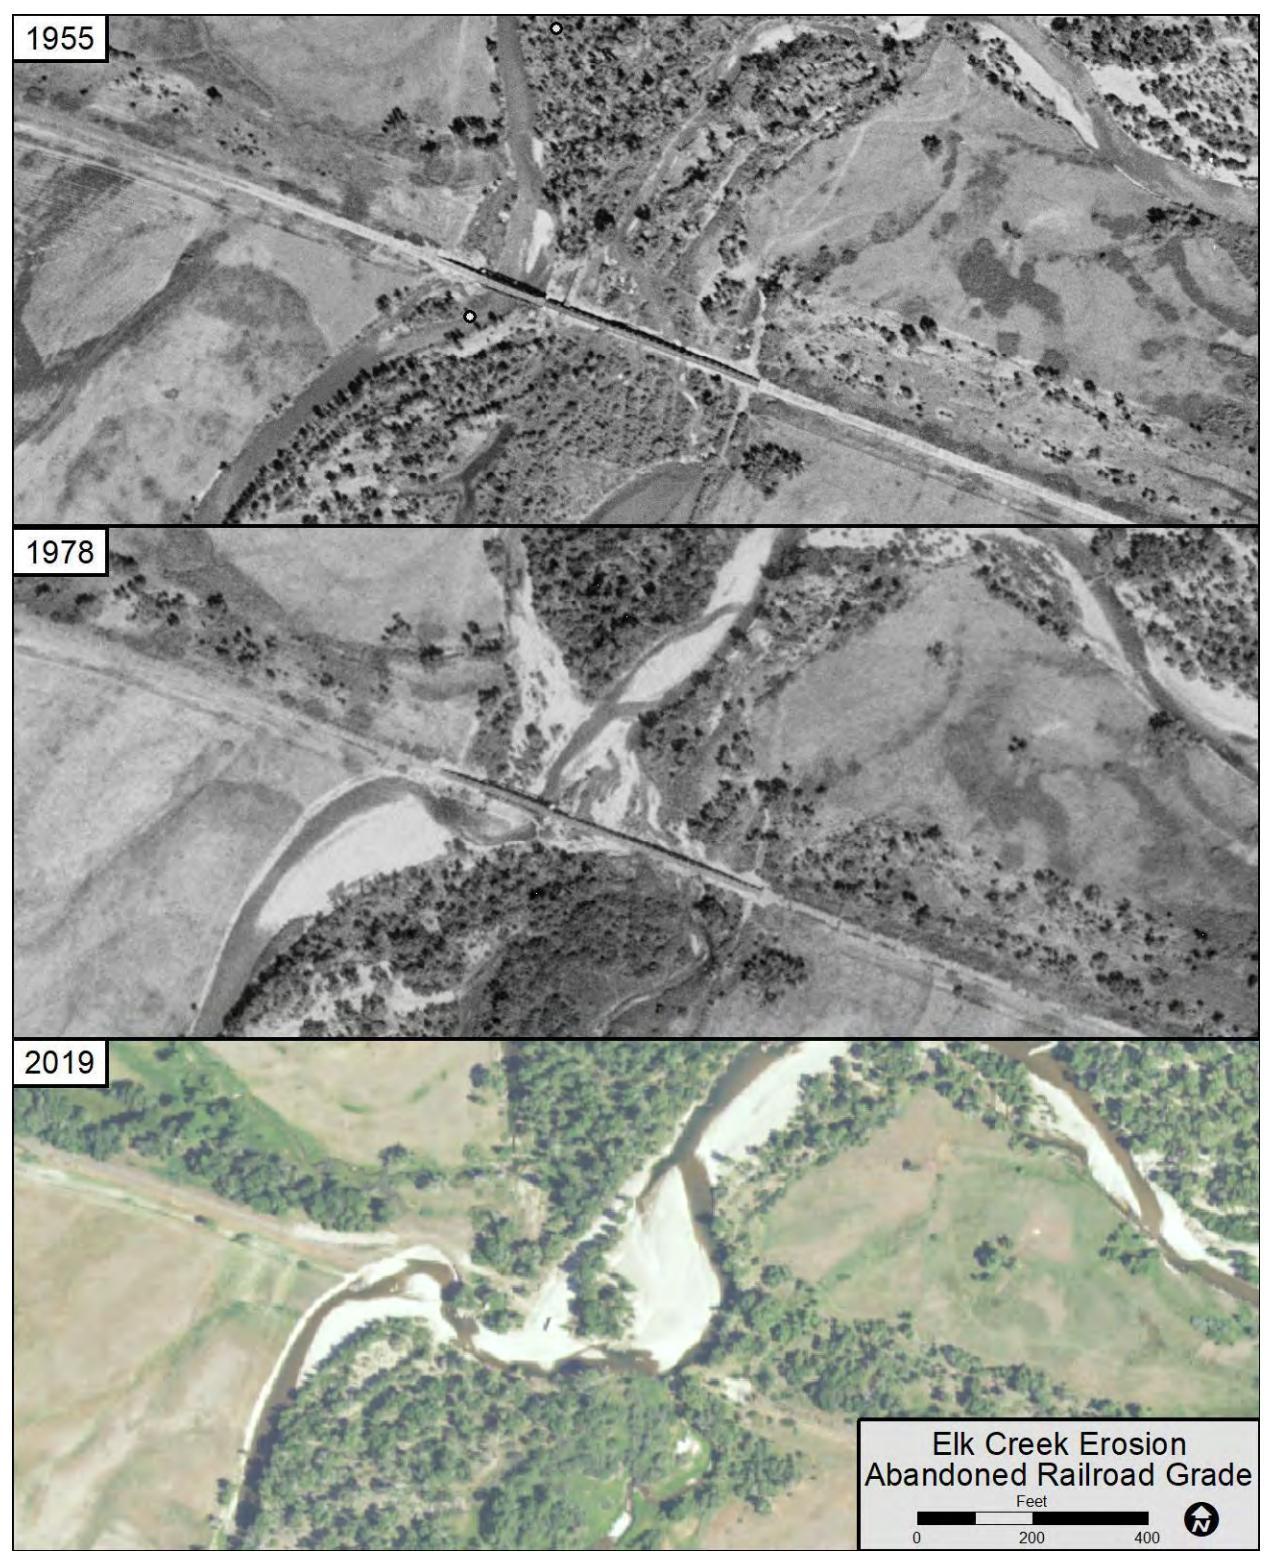
Figure 135. Time series showing progressive erosion at abandoned railroad grade at top of Reach EC1.

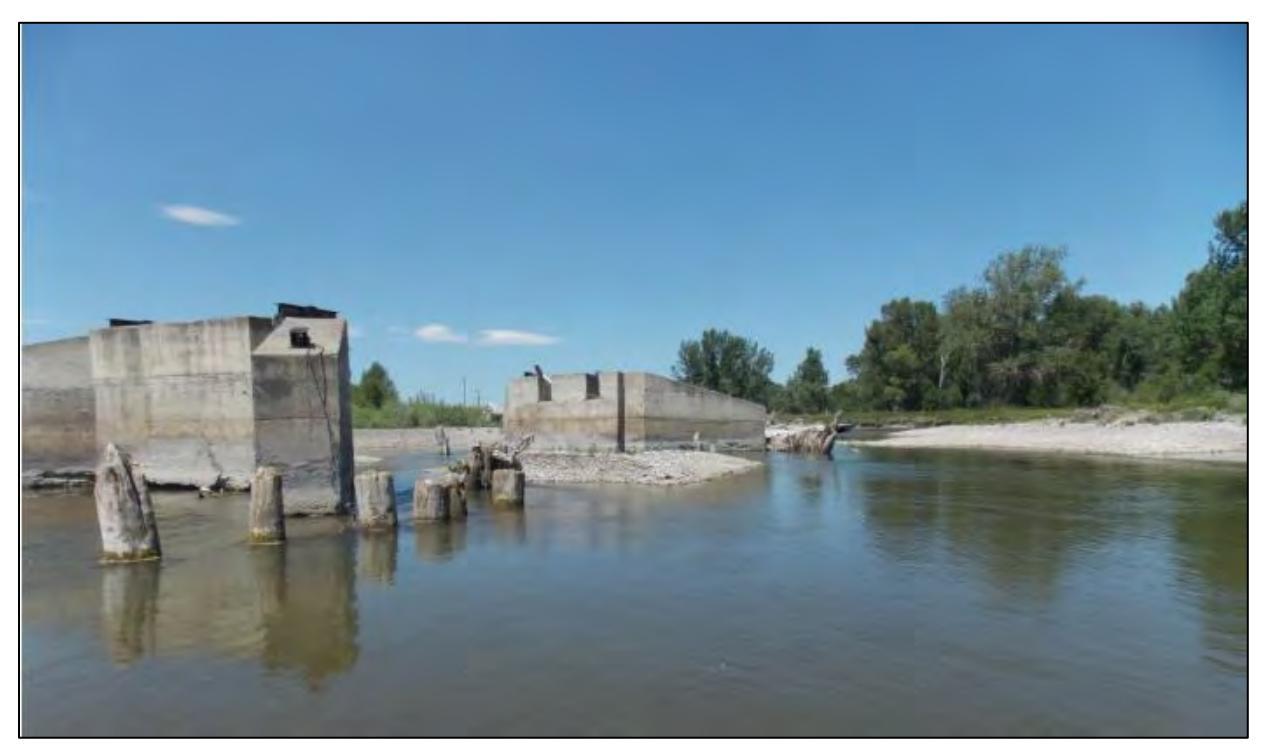
Figure 144. Bridge abutments in channel approximately 1.5 miles downstream from Largent's Bend Fishing Access Site (Kellogg, 2014).
