# ADOBE CREEK EMERGENCY MEETING AGENDA

JUNE 8, 2021

# Adobe Creek Emergency Meeting

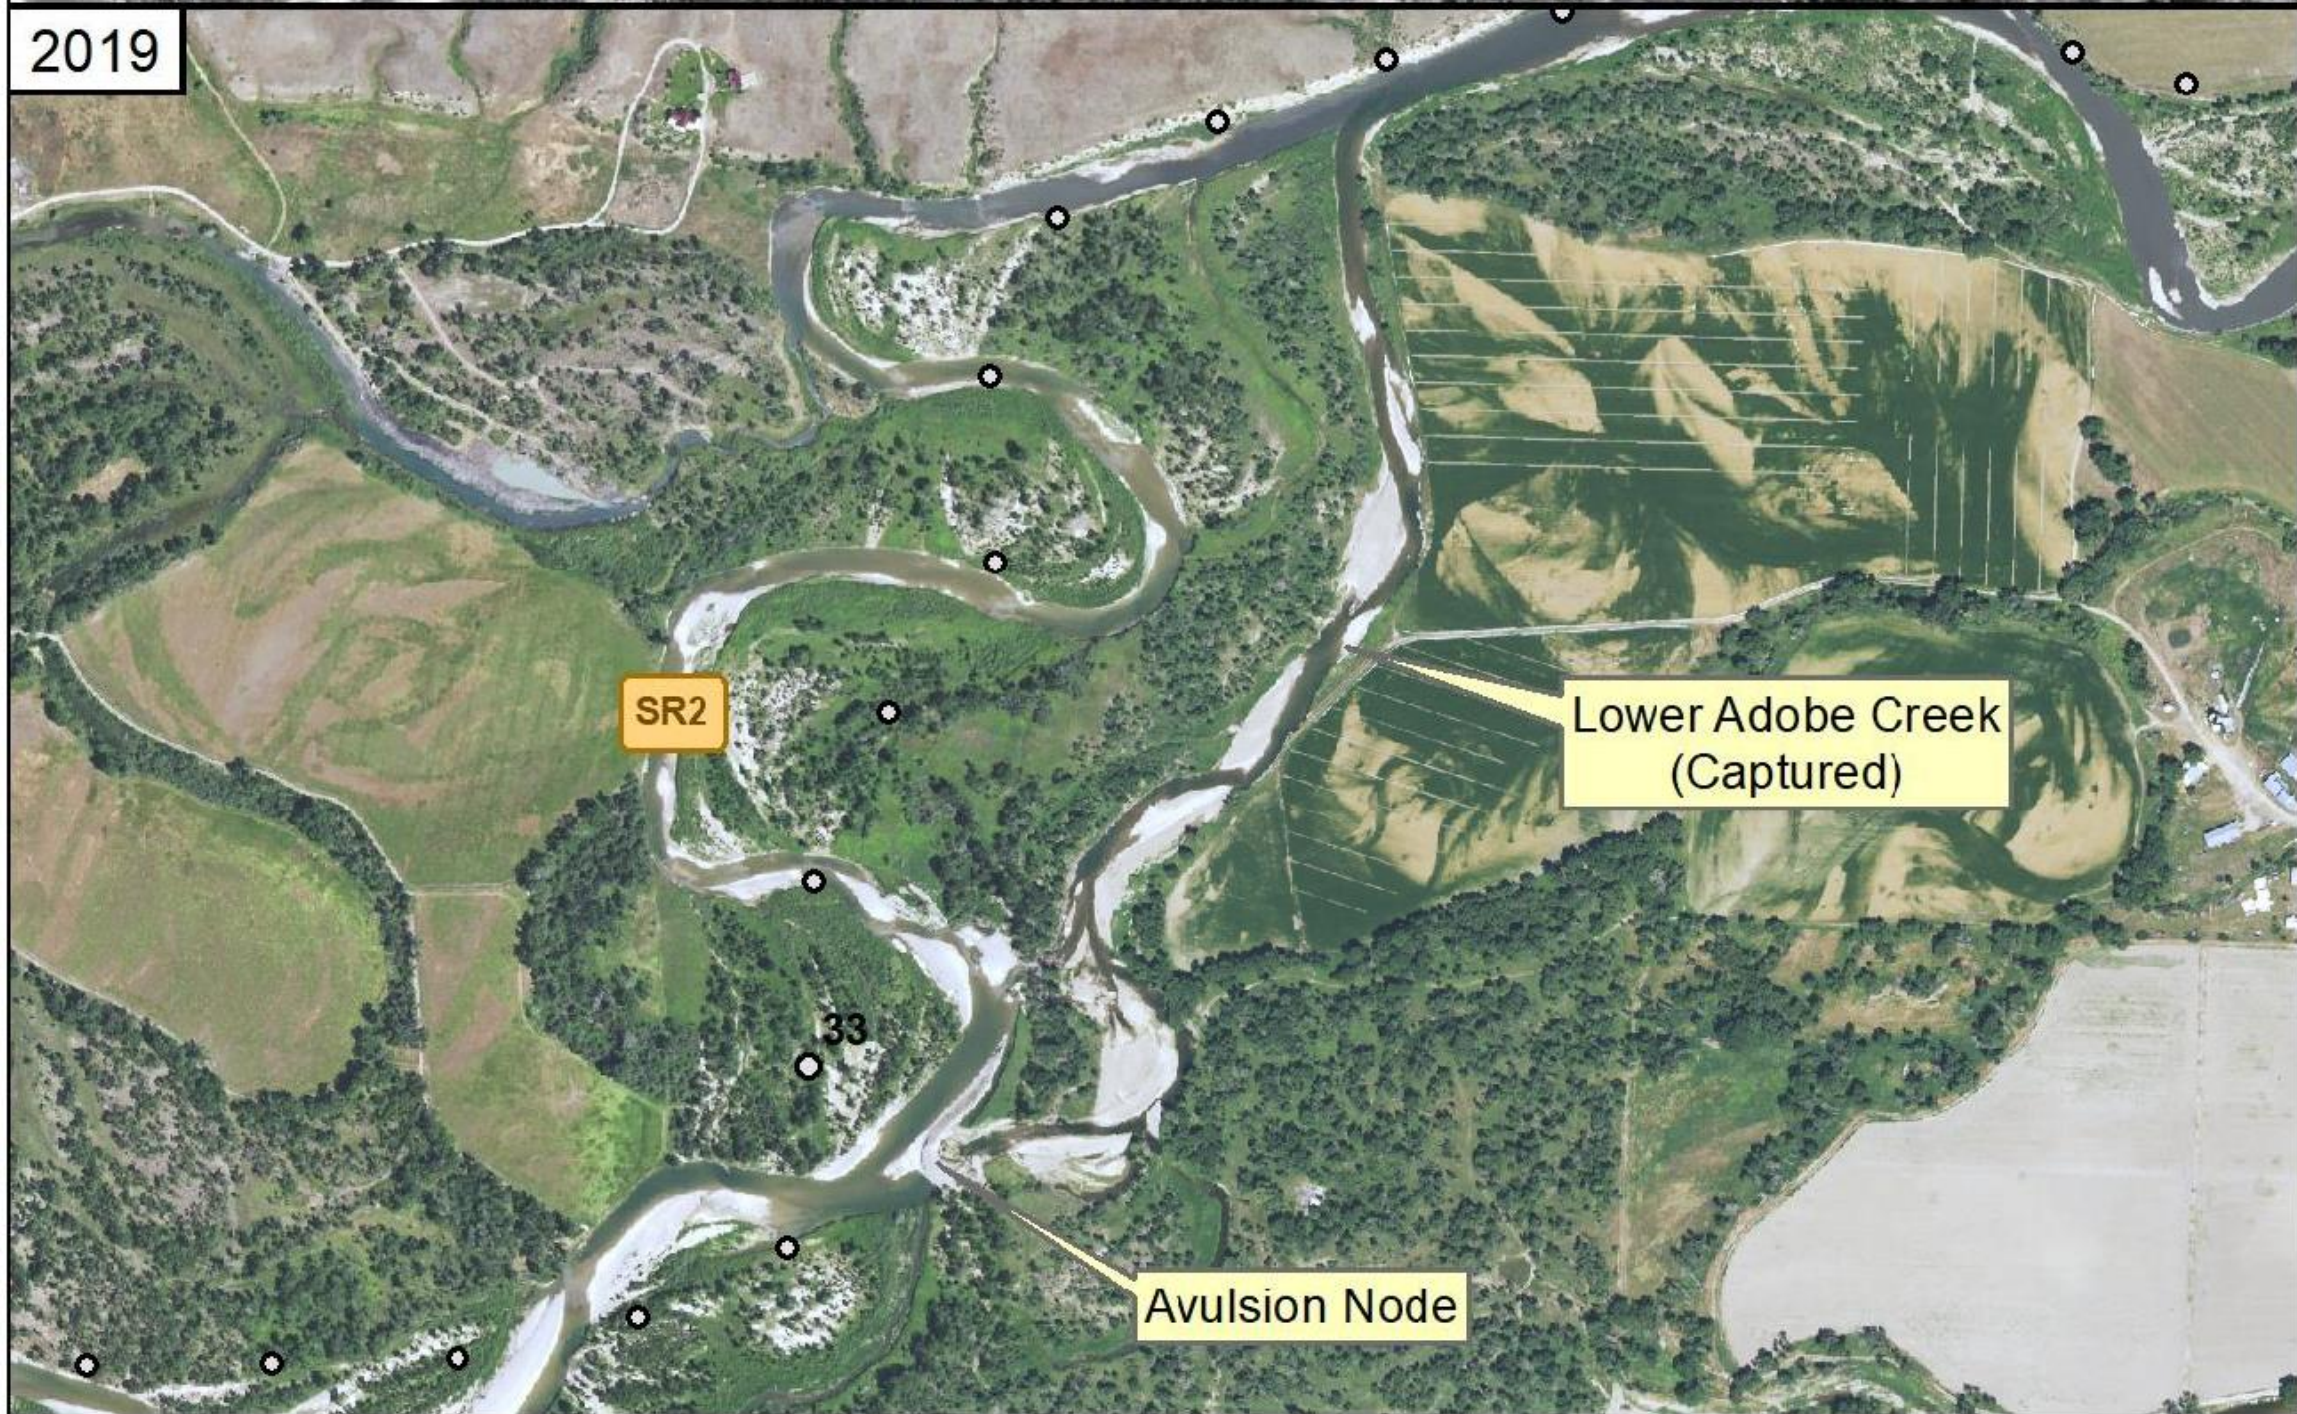
2019

Lower Adobe Creek  
(Captured)

Avulsion Node

- This is a lot of water coming through a narrow point, likely due to slope
- Narrow breach easier to treat – recommend big wood, preferably at lower flows, but sooner is better than later
- May be difficult to prevent Sun River from getting into Adobe Creek
- Adobe Creek channel is undersized for this much water
- Previous treatments in this location have failed in the past and headcuts had established that led to breach (from CMZ Report)
