June 2022

Muddy Creek Master Plan

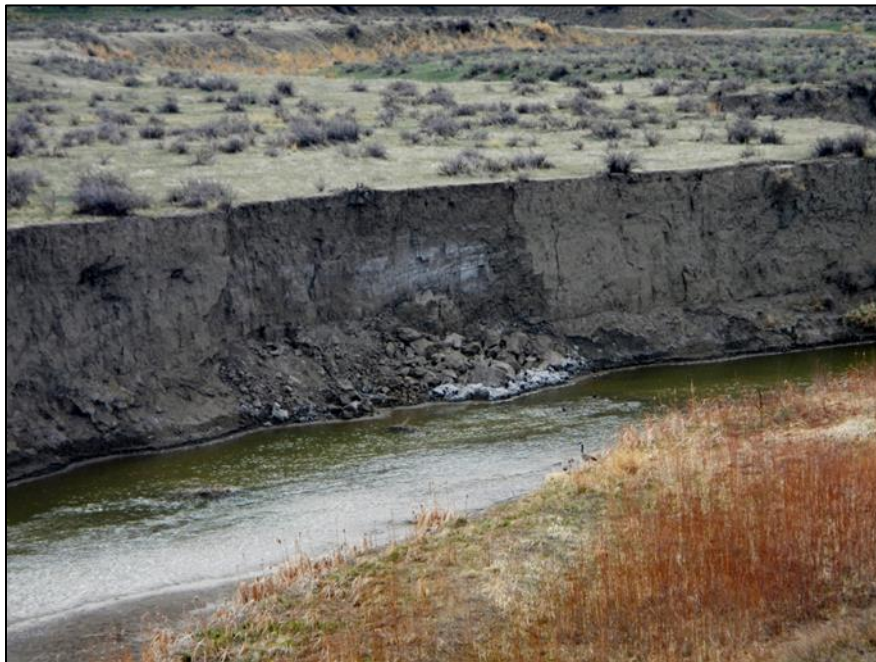
Photo 2-1. Active bank failure following Muddy Creek incision; the historic floodplain is at top of bank (2021 photo).

Muddy Creek has been long-recognized as a highly unstable channel due to decades of downcutting into the fine sediments of the alluvial valley (Photo 2-1). Understanding the drivers of this instability is an important consideration in developing feasible strategies to help restore an equilibrium condition throughout the drainage network. Whereas the delivery of trans-basin diversion water has driven much of the instability, other land uses such as riparian grazing have contributed to the decline in watershed health.

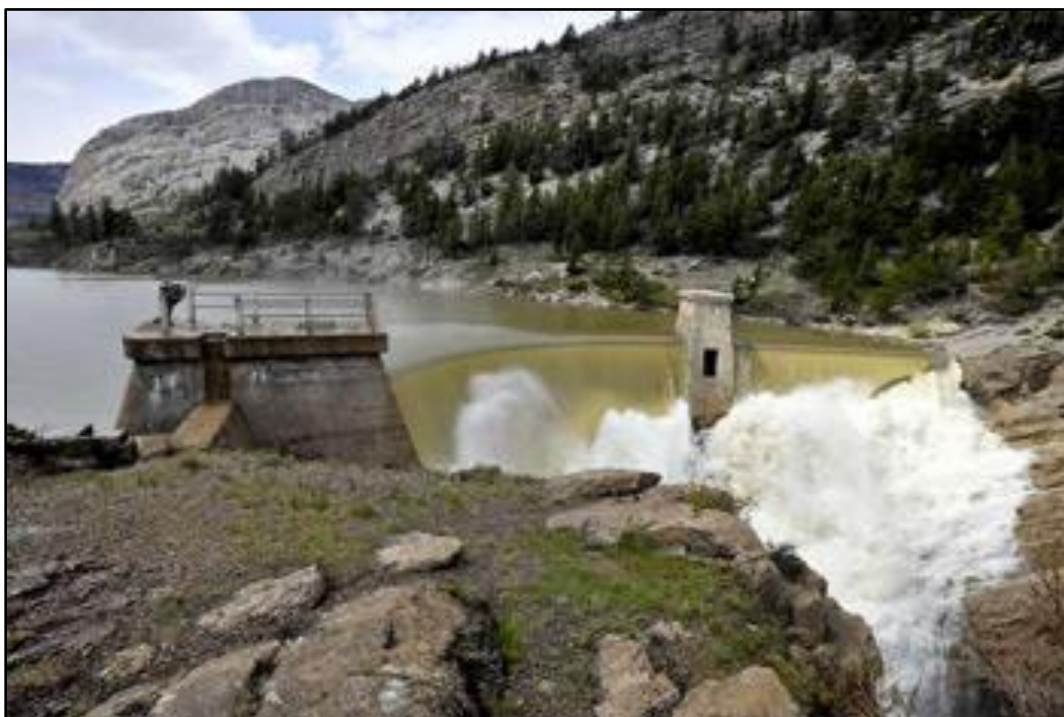
Photo 2-2. Sun River Diversion Dam was constructed in 1916 (USBR).

The capacity of the outlet works at the Sun River Diversion Dam feeding the Pishkun Supply Canal is 1,400 cfs and as of 2004, the system was delivering an average of about 250,000 acre-feet of irrigation water per year (MTDEQ, 2004). The gravel cap on the bench makes it especially prone to flow infiltration and lateral groundwater flow at the gravel/shale contact. Groundwater in the gravel aquifer generally flows east and north towards Muddy Creek at an estimated rate between 3.7 and 26 feet per day, or from 0.25 to almost 2 miles per year (Nimick and others, 1996). Osborne (1983) estimated that 56,770 acre-feet of water ended up as recharge to the Muddy Creek system which was 39% of the total water delivered that year. Local reports indicate that it would take 10 years of no irrigation for the aquifer to naturally drain and stop contributing diverted flows to Muddy Creek.

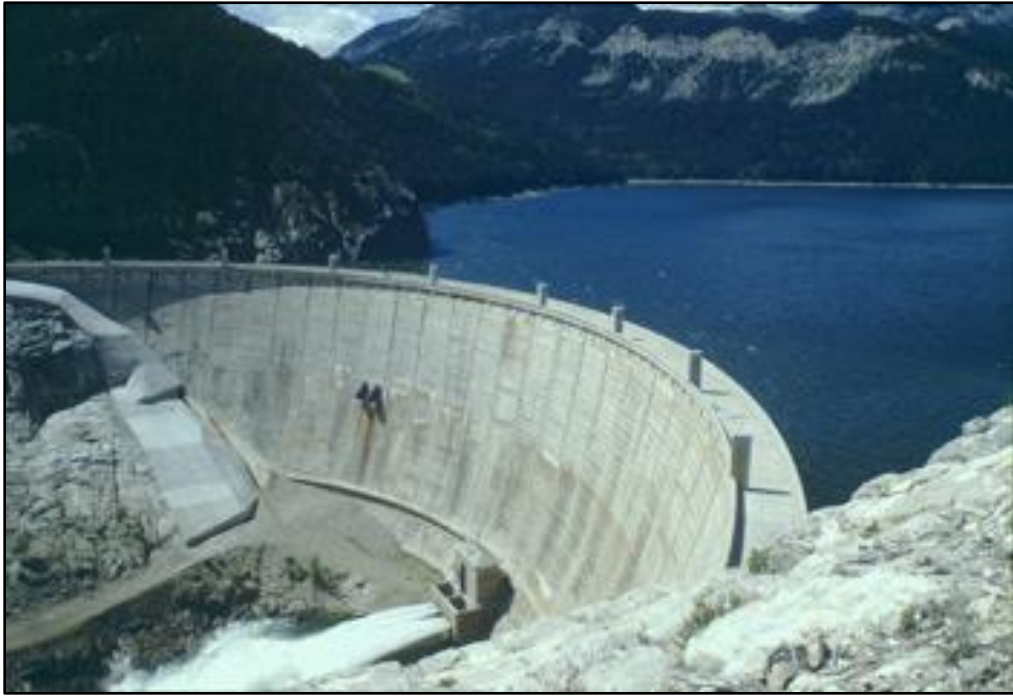
Photo 2-3. Gibson Dam was constructed in 1929 (USBR).

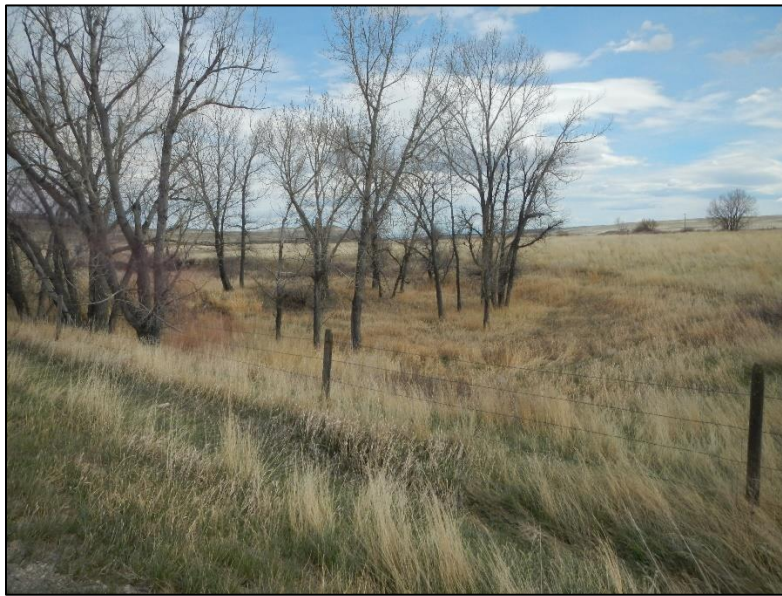
Photo 2-5. Perched historic Muddy Creek remnant at Gordon Road Bridge crossing (RM 11.7).

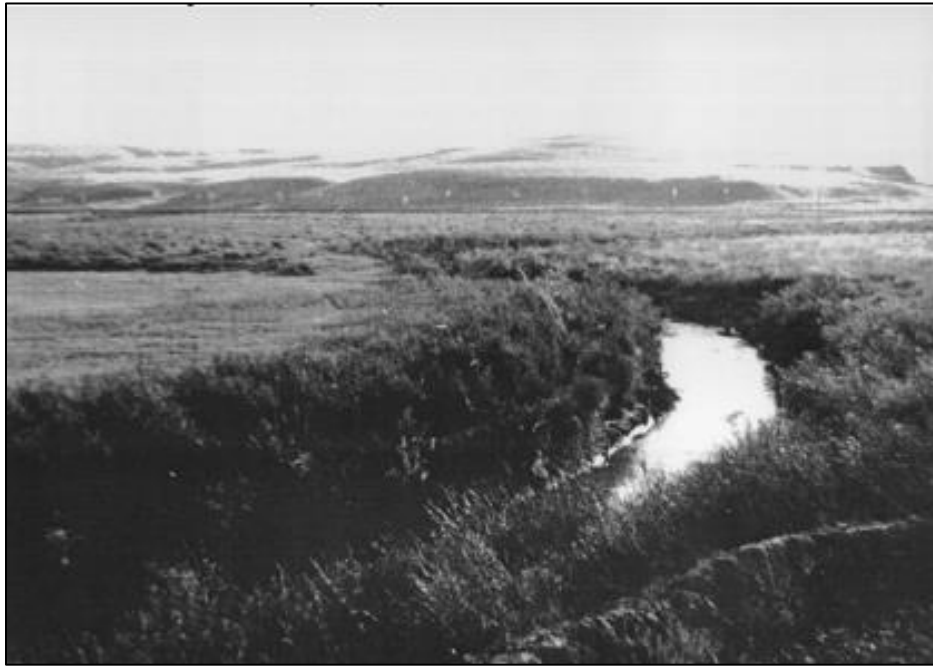
Photo 2-6. Muddy Creek in early stages of downcutting, 1936 (MT DEQ, 2004).

The first photograph of Muddy Creek found in available documents is from 1936 (Photo 2-6). The creek is small in this photo but clearly already entrenched and detached from its older floodplain. Some woody riparian vegetation is growing on the upper banks. The historic floodplain is visible in the photo as an expansive grassed flat, indicating wide valley bottom hydrologic connectivity prior to the entrenchment. Photo 2-7 shows Muddy Creek at a point of intense destabilization, probably in the 1970s. The banks are fine grained and prone to gravitational collapse, especially when saturated. Fine sediment loading is clearly high, and the floodplain is perched such that there is no riparian zone on the channel margins. The lower banks are too erodible and/or steep to provide riparian colonization areas. All of these processes can be amplified by rapid flow fluctuations as banks are continually saturating and draining.

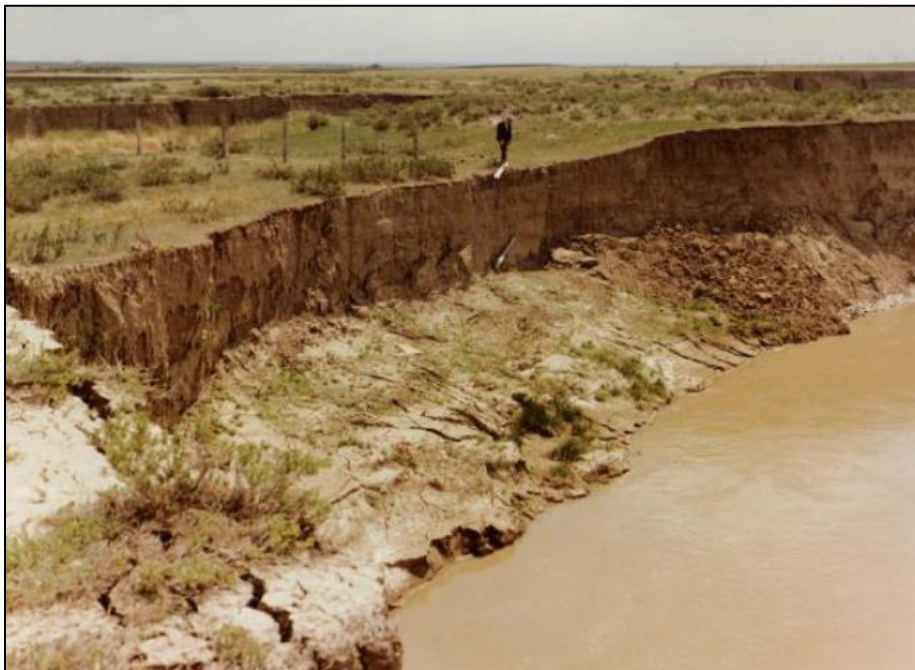
Photo 2-7. Massive bank failure driven by Muddy Creek incision at height of instability.

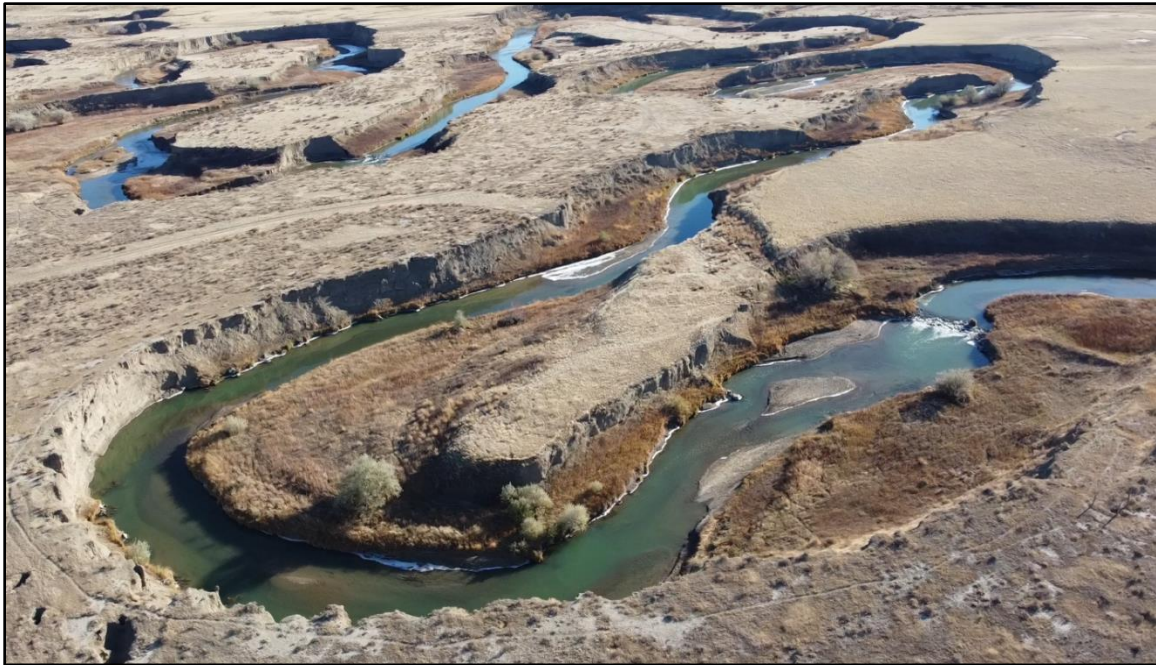
Photo 2-8. Fall 2021 drone flight clip showing deep incision along Muddy Creek (~RM 5).

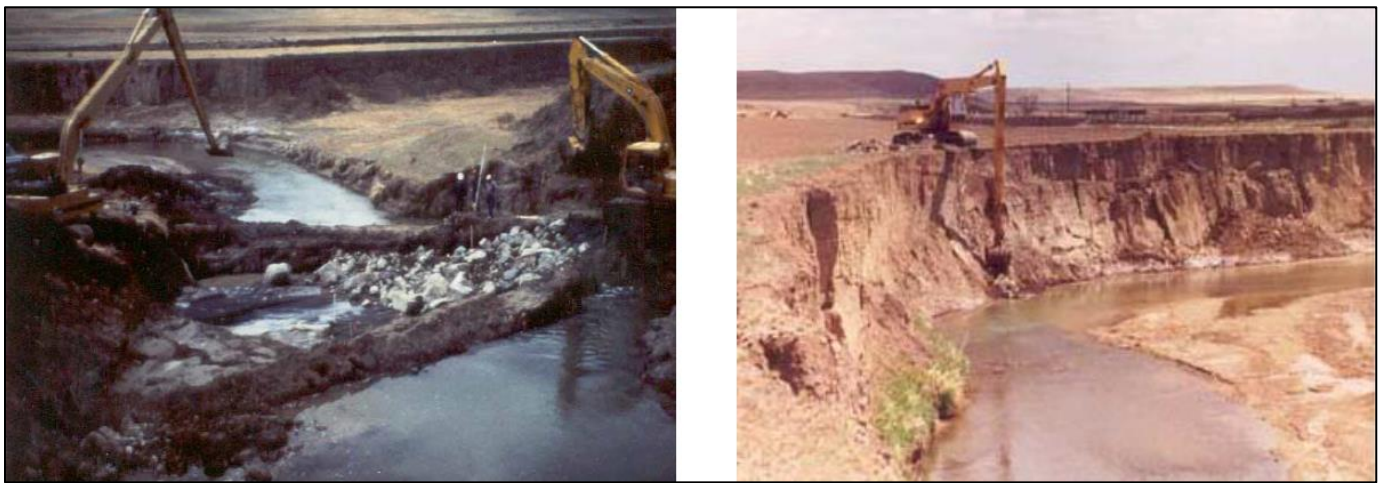
Photo 3-1. Demonstration project including rock drops (left) and barbs (right) constructed on Muddy Creek in the early 1990s.

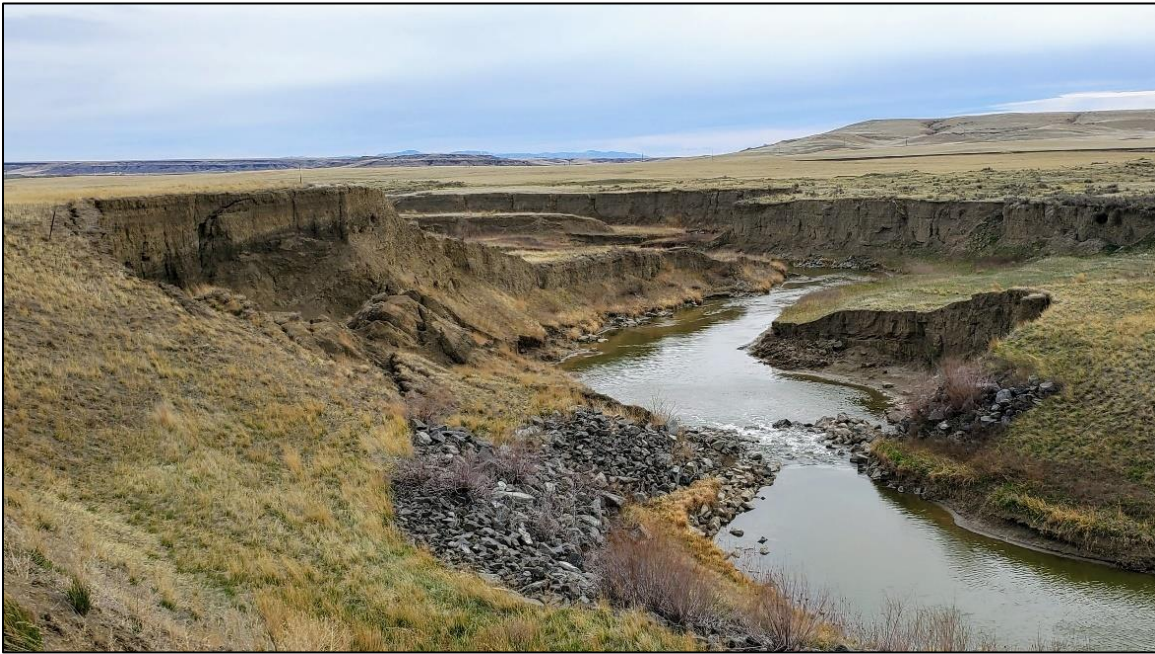
Photo 3-2. View downstream of lowermost sill at RM 3.15; note mass failure on left bank and erosion on right.

placed at grade (they were buried so their crests matched the bed profile), by 1996 they had formed steep chutes on their downstream sides (Photo 3-2). This reflects the bed adjustments post-project evolving towards a stepped profile, with a relatively flat channel between drop structures and a steep drop at each grade control. Figure 4-3 shows the water surface profile (from LiDAR) for an approximately 1.5-mile-long segment of Muddy Creek within the demonstration project reach. The lowermost, sill built by the Corps of Engineers at the bottom of the project holds several feet of drop at RM 3.1, although it was originally designed for zero drop (Wittler, 1998, Photo 3-2). Upstream, there are an additional five rock drops over 1.5 miles that have between less than a foot to about 1.5 feet of drop as captured by the water surface profile. The channel in between the drop structures is relatively flat. This evolution to a stepped profile may help explain why the riparian planting efforts that started in the early 1990s were reportedly unsuccessful. If the profile had not fully stabilized, the areas amenable to riparian vegetation would have been constantly shifting.

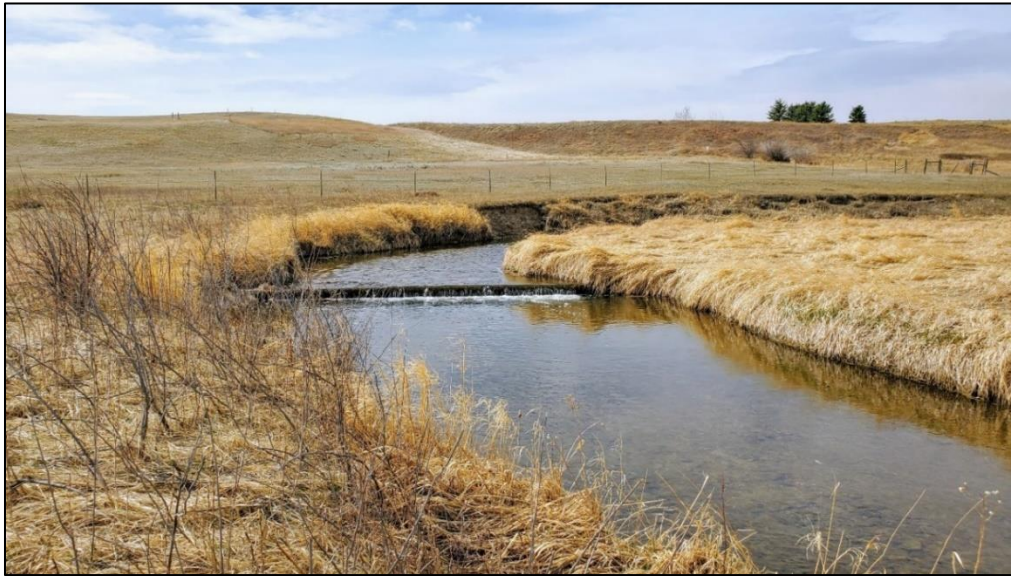
Photo 3-5. View upstream of log drop structure on Spring Coulee, 2021.

In the late 1990s, the Future Fisheries program funded an aquatic habitat restoration project on Spring Coulee. The project is about 3.5 miles upstream of the mouth and includes riparian fencing, grade control structures, and bank treatments. Log drop structures were placed over about 1,300 feet of channel to control grade, and banks were rehabilitated (Photo 3-5).

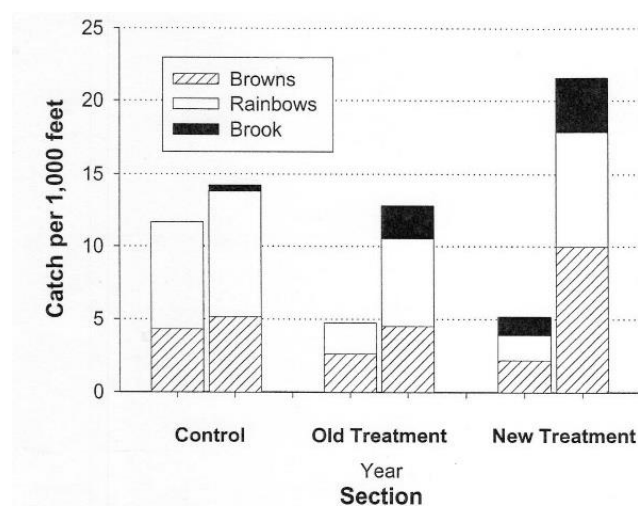
Figure 3-1. "Relative catch data" from a Montana Future Fisheries project located along 1-mile of Spring Coulee; bars reflect 1998 and 1999 data (Shepard, 2000).

In comparing data through time, the treatment sections show an increase in trout numbers from 1998 to 1999, although that may be in part related to better sampling efficiencies due to cooler water temperatures in 1999 (Figure 3-1; Shepard, 2000).

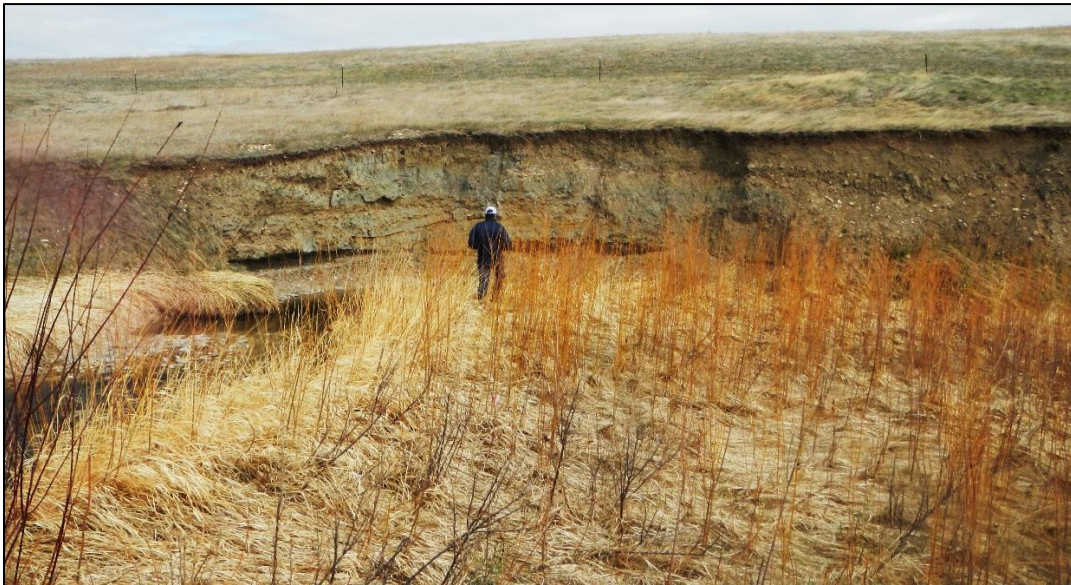
Photo 3-6. Riparian expansion on Spring Coulee floodplain bench where livestock are excluded.

Two decades after the completion of the Spring Coulee project, low floodplain surfaces adjacent to the channel that are protected by riparian fencing were supporting robust stands of willows (Photo 3-6).

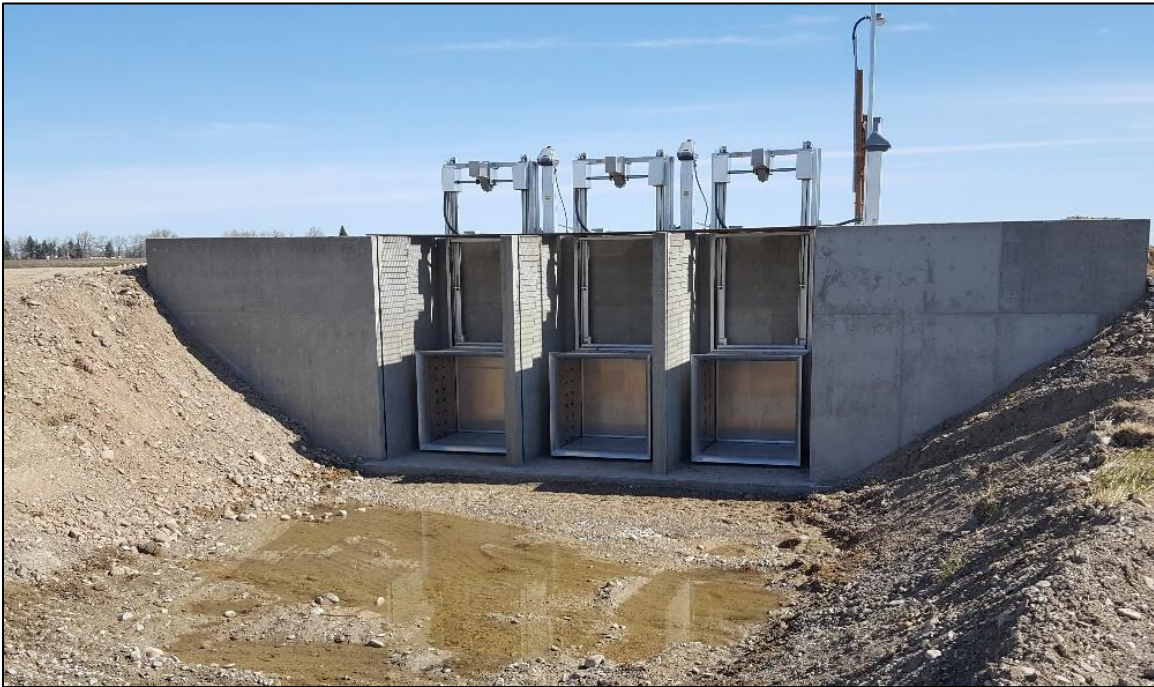
Photo 4-1. New smart headgate at head of GM-100 at J-Wasteway outlet, Spring 2020 (E. Juel).

J-Wasteway is a regulating reservoir located at the head of Upper Spring Coulee. It has two outlet controls, one into Upper Spring Coulee (J-Wasteway) and the other into the Greenfields Main Canal Lateral 100 (GM-100). Both headworks controls have been prioritized for replacement and automation. Phase 1 of the project consisted of replacing the GM-100 headworks with a smart headgate. The project was completed in 2020 and will improve management of J-Wasteway and associated overflows into Spring Coulee (Photo 4-1).

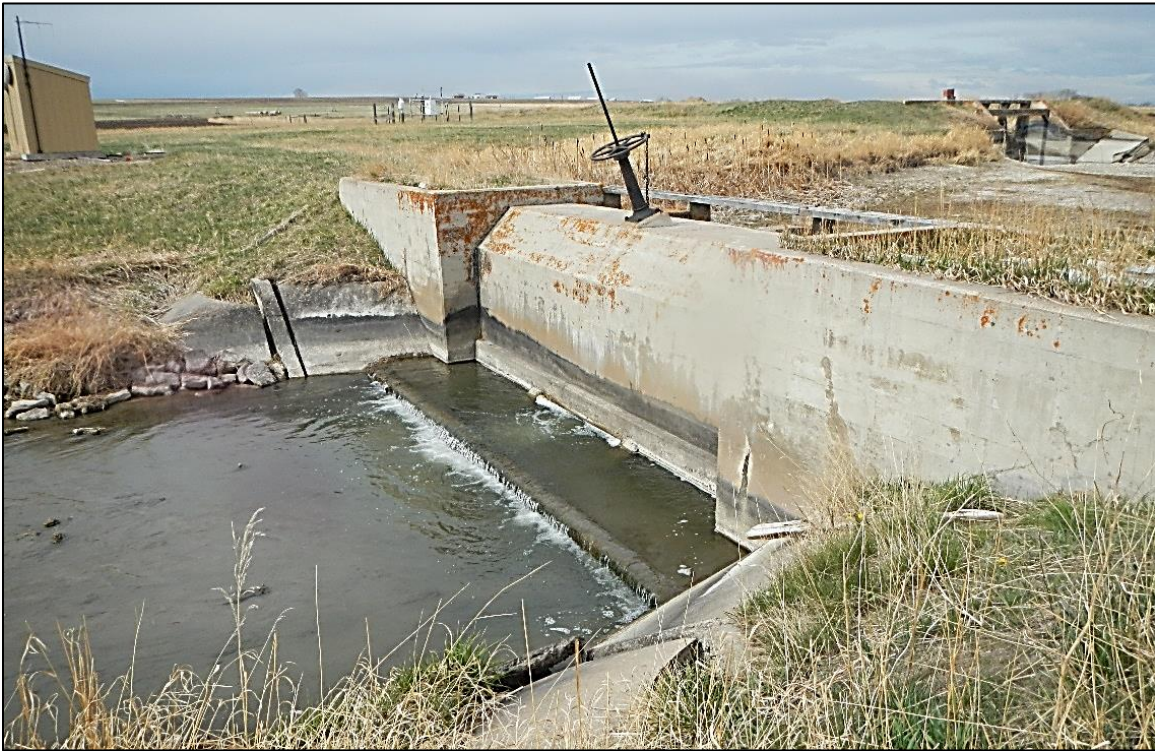
Photo 4-2. Spring Coulee Headworks (May 2021).

The Spring Coulee Headworks control flows at the second outlet for J-Wasteway (the other outlet is controlled by the GM-100 headworks described above). The structure was originally constructed in the 1930s to convey excess water into J-Wasteway/Upper Spring Coulee and prevent overtopping of the GM-100 canal. The Montana DNRC Renewable Resource Grant 2022-2023 biennium budget ranked the Spring Coulee Headworks Replacement project as 21st out of 76 projects and recommended that it receive full funding of \$125,000 (MTDNRC, 2021). Replacing the structure will allow GID operators to reduce the amount of water spilled into the Spring Coulee drainage via J-Wasteway. The project is anticipated to realize an additional 5,471 acre-feet of water annually for crops from the additional storage while reducing sediment loads generated from Spring Coulee flows by about 1,700 tons per year. Phase 2 of the project, which will complete the headworks replacement, is under construction as of spring 2022. The overall project won't be fully implemented until Phase 3 is completed, which is the expansion of confinement berms to expand the operational capacity of J-Wasteway. A photo of the older headworks is shown in Photo 4-2; a March 2022 photo of the ongoing construction of the foundation slab is shown in Photo 4-3.

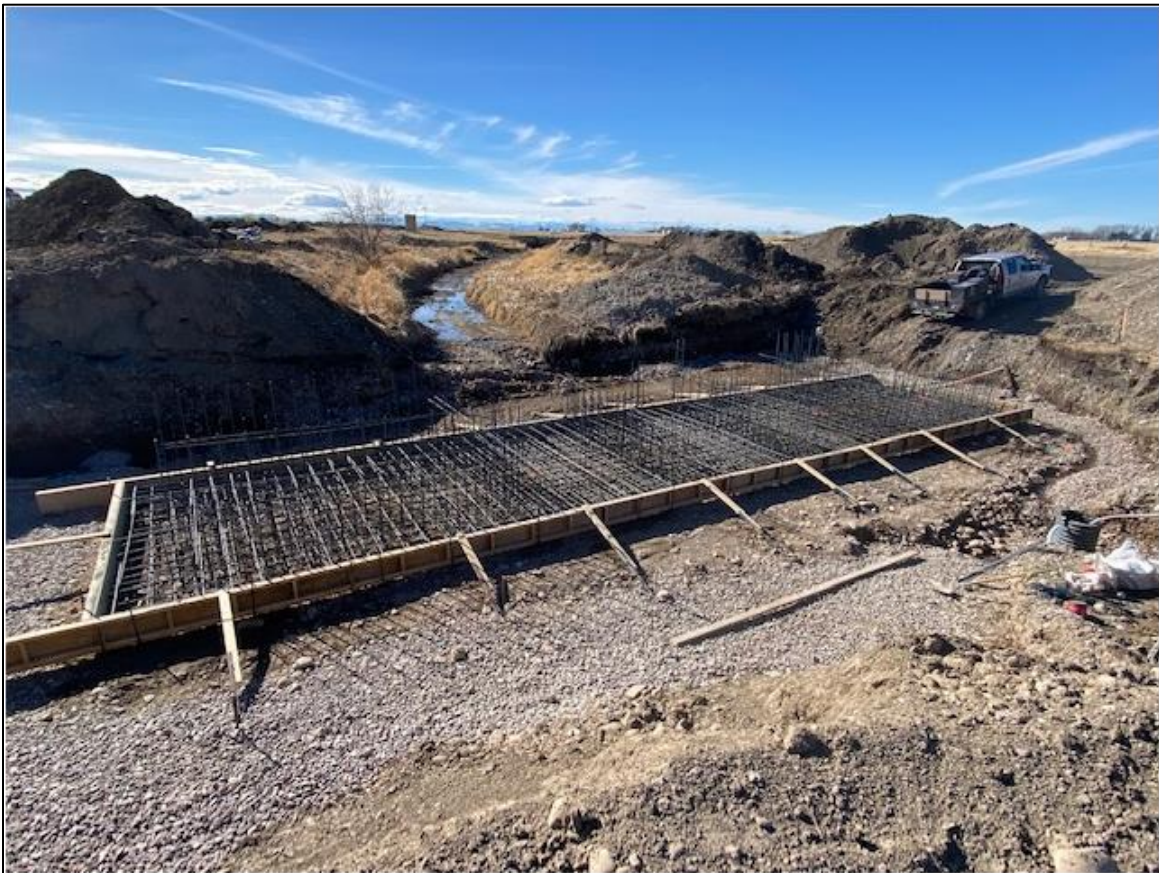
Photo 4-3. Foundation slab construction at Spring Coulee Headworks on March 22, 2022 (E. Juel).

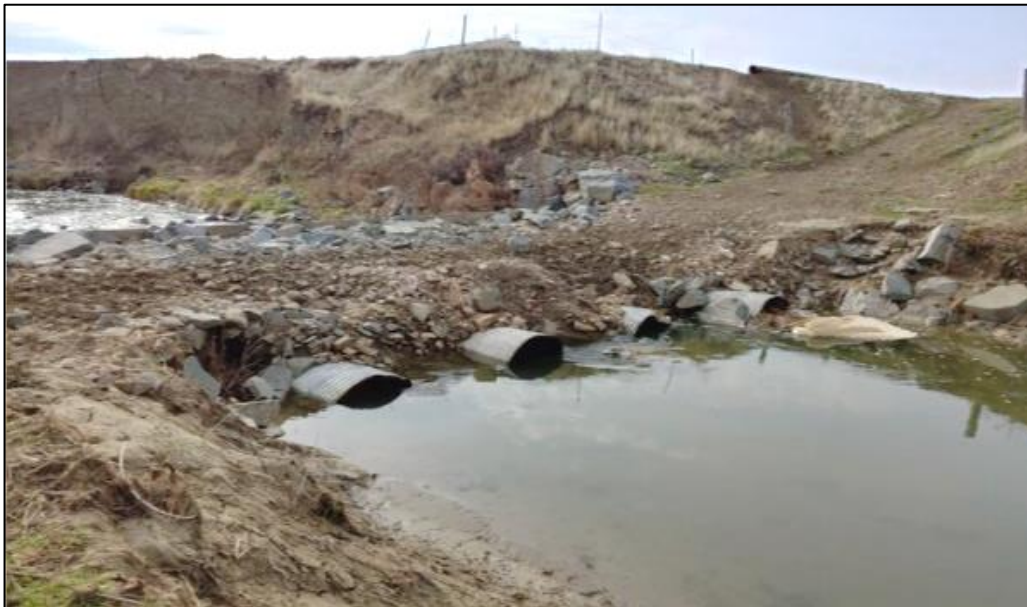
Photo 4-4. Muddy Creek Crossing Project (Bison Ranch) shown before bridge installation.

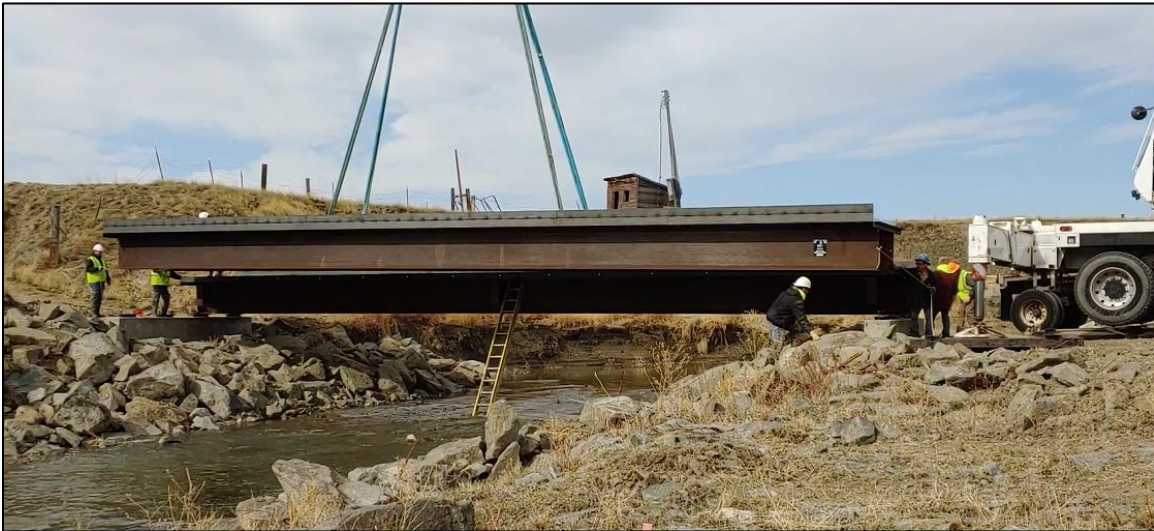
Photo 4-5. View upstream of the bridge placement following culvert removal.

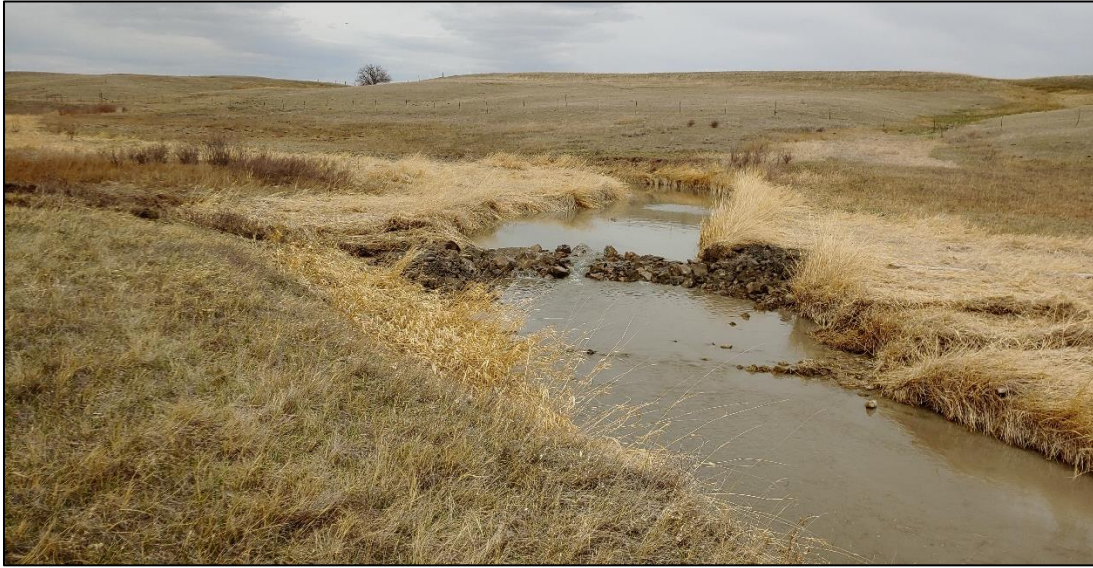
Photo 4-6. View upstream of 2022 project work on Spring Coulee showing rock drop designed to stabilize grade, increase diversity, and improve floodplain access.

Because of the noted success of previous restoration work on Spring Coulee, this project is currently being expanded (Photo 4-6). This expansion has been driven by the landowner's interest in continuing work that will further reduce erosion and improve aquatic and riparian habitats.

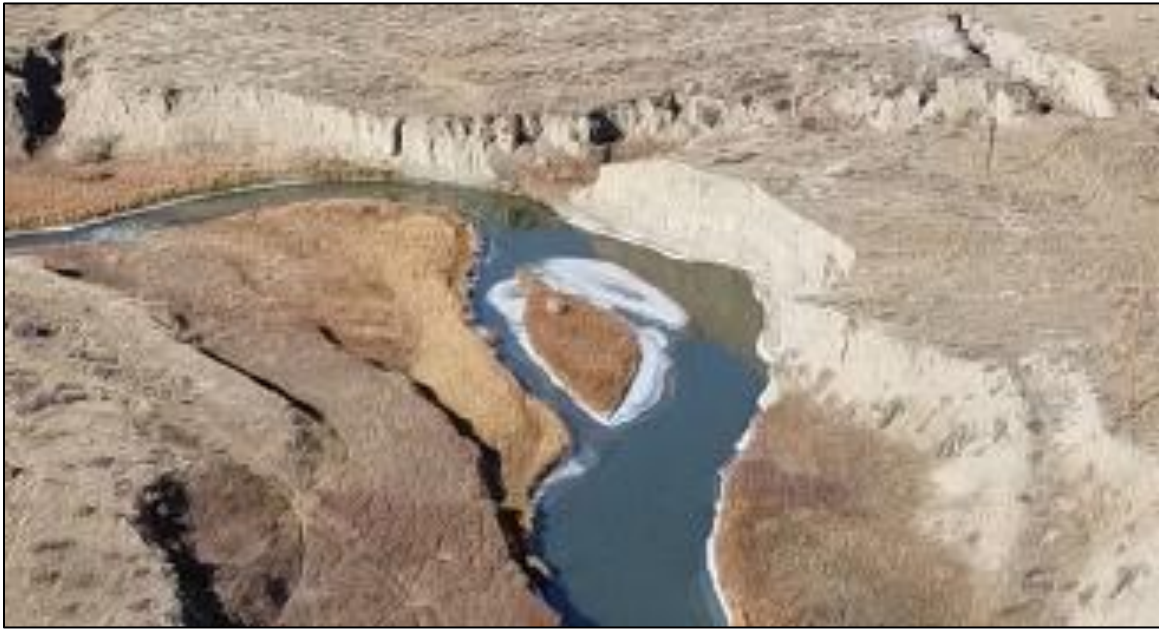
Photo 4-7. View upstream showing relatively flat terraces against channel above grade control on straight segment.

As Muddy Creek downcut, it created some perched, relatively flat surfaces (terraces) along fairly straight segments (Photo 4-7). It also created sloped surfaces on bendways where downcutting was rapid and the channel migrated as it incised (Photo 4-8). As a result, the current Muddy Creek corridor has a complex series of sloping and flat surfaces adjacent to the channel that have wide variability in terms of their potential to disperse flow energy or support riparian vegetation. Several old meanders have become perched and somewhat isolated from the channel, although some support wetlands indicating a high potential for restoration and expansion (Photo 4-9). This current state of the channel is an important consideration in the development of strategies to increase geomorphic resilience.

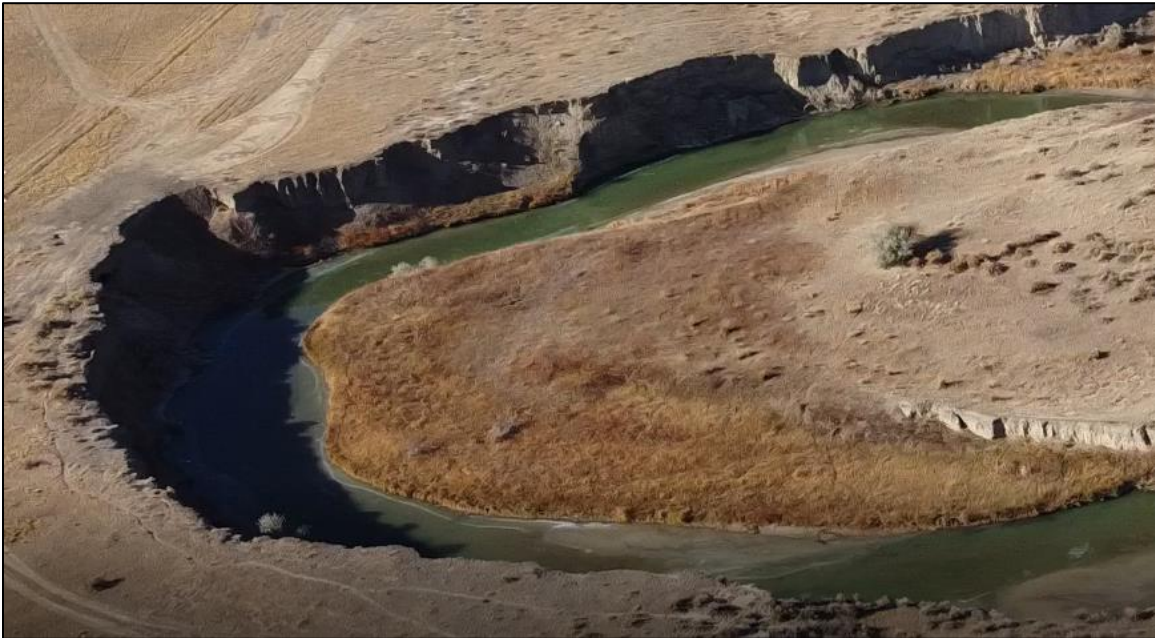
Photo 4-8. View upstream showing sloping point bar where the channel migrated laterally as it downcut.

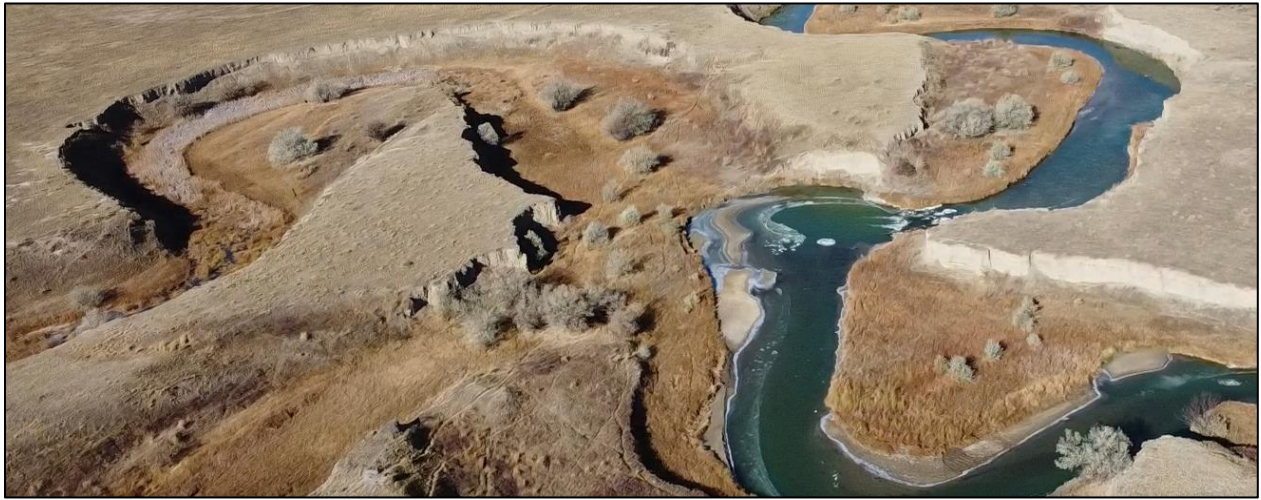
Photo 4-9. View upstream of abandoned meander that supports an emergent wetland.

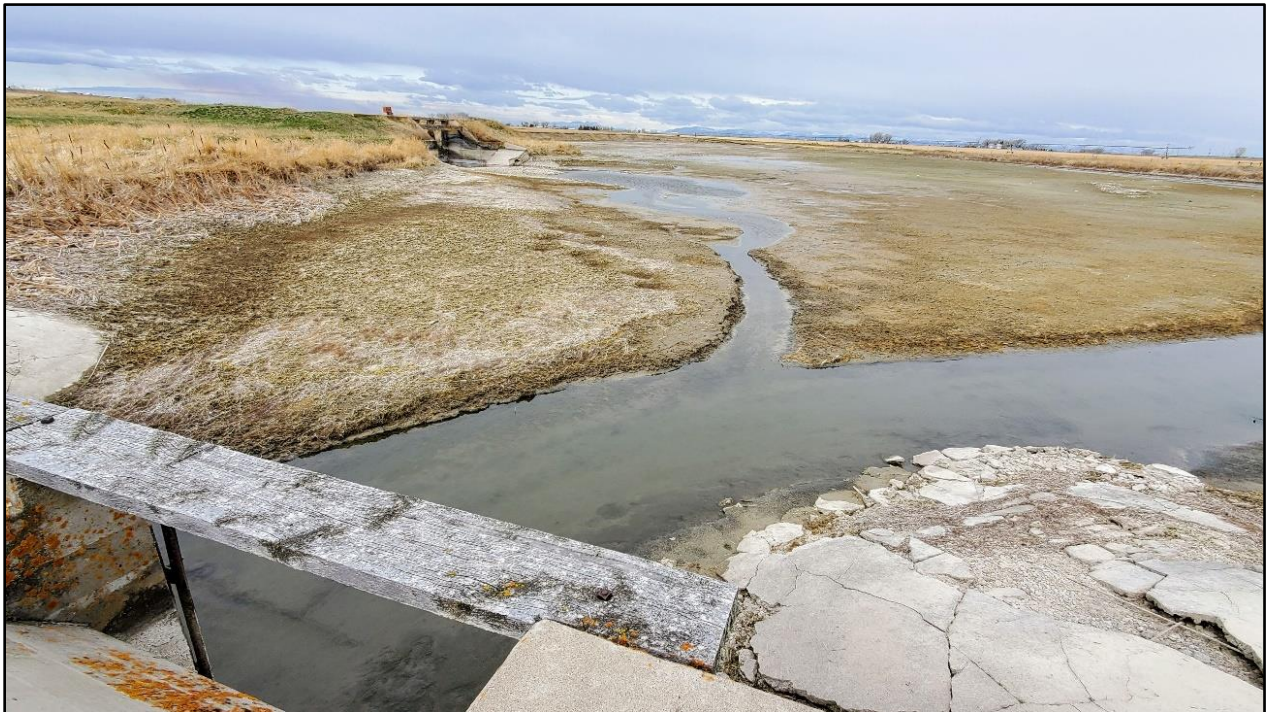
Photo 6-1. View to the west of J-Lake from the original J-Wasteway Control Structure (May 2021).

J-Wasteway is a small reregulating facility at the head of Upper Spring Coulee that is on-line with the Greenfields Main Canal Lateral 100 (GM-100). It has two outlets including J-Wasteway, which feeds Upper Spring Coulee, and GM-100, which is a large canal that flows northwest for over 5 miles across the Greenfields Bench. The project consists of re-building the headworks on each of the two outlets and enlarging J-Wasteway by enlarging lateral containment berms. The two outlet controls will be able to communicate via automation upgrades. Phase 1 of the project replaced the GM-100 headworks with a smart headworks and was completed in 2020 (Section 4.1.3). Phase 2, which is the Spring Coulee headworks replacement, is under construction as of March 2022 (Section 4.1.4). The project will be fully functional when Phase 3 is completed, which is the expansion of J-Wasteway by raising the existing confinement berms. This project will allow for much better reregulation of irrigation water on the Greenfields Bench, which will reduce tailwater inputs into Upper Spring Coulee. As such, the project will generate substantial opportunities for Spring Coulee habitat restoration work.

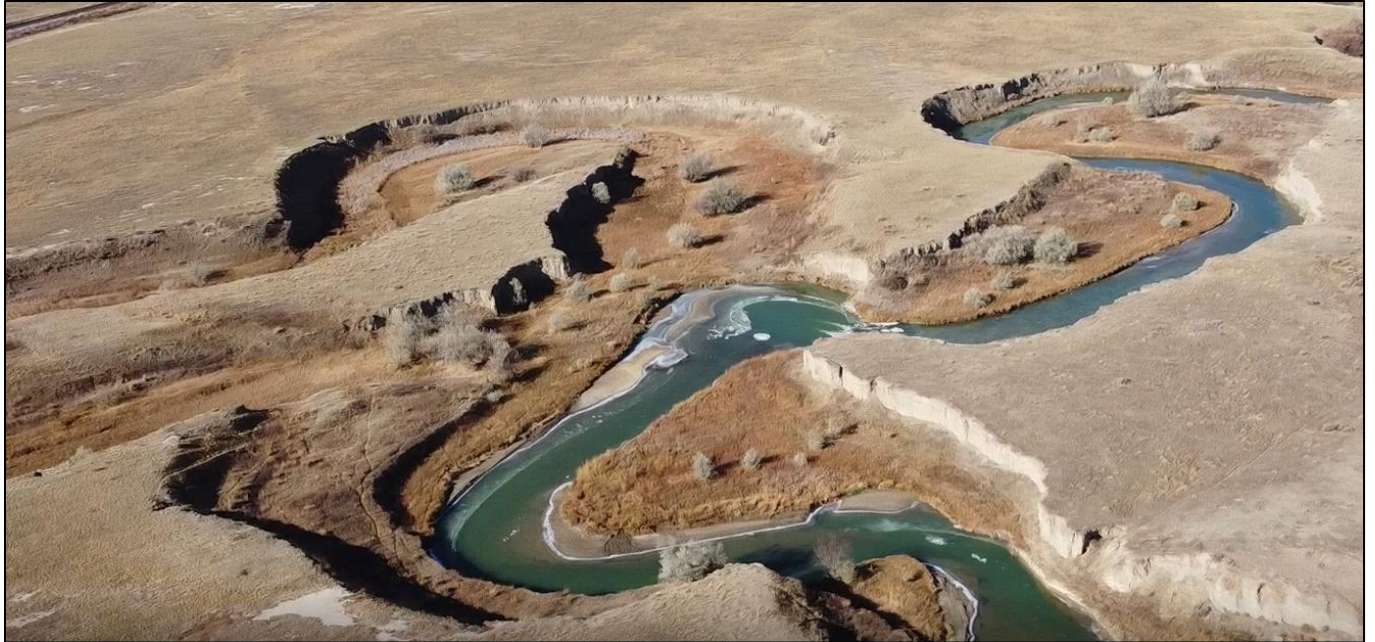
Photo 6-2. View upstream of perched meander with high potential for reactivation and restoration.

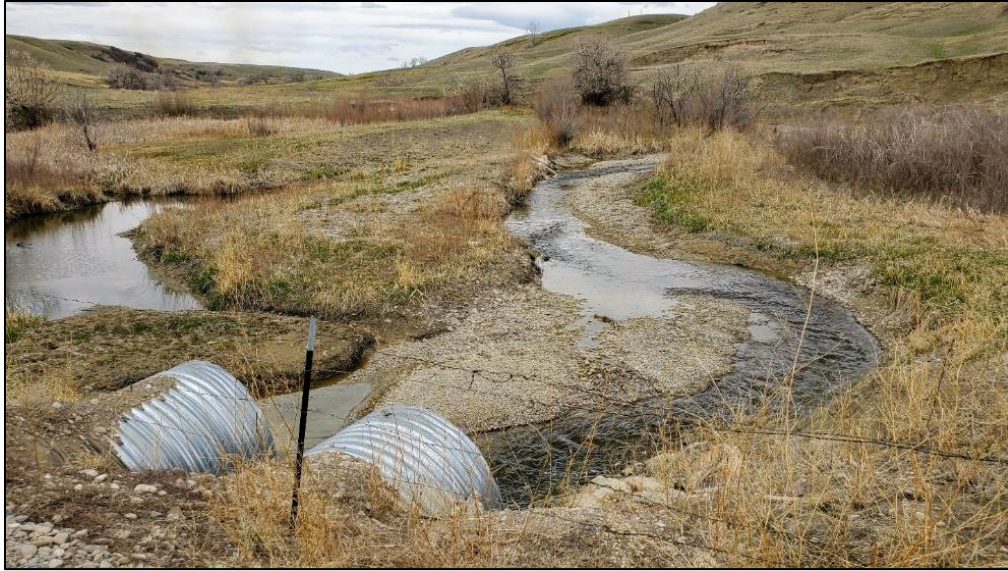
Photo 6-3. View downstream of Lower Spring Coulee and road crossing culverts at 13th LN NE.

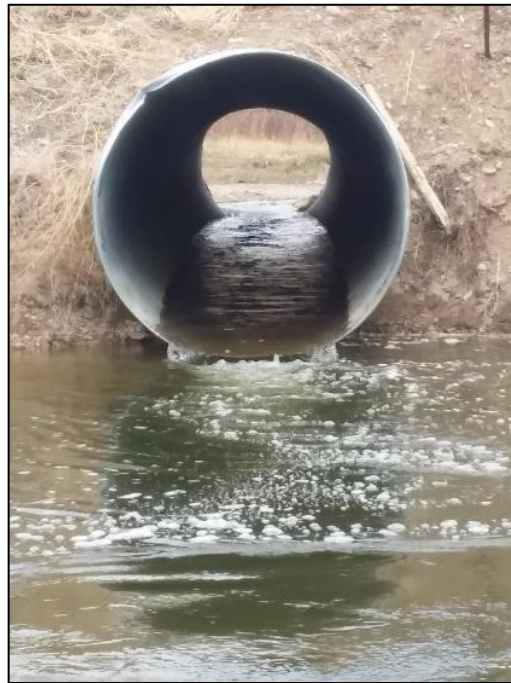
Photo 6-4. View upstream of Lower Spring Coulee and road crossing culverts at 13th LN NE.

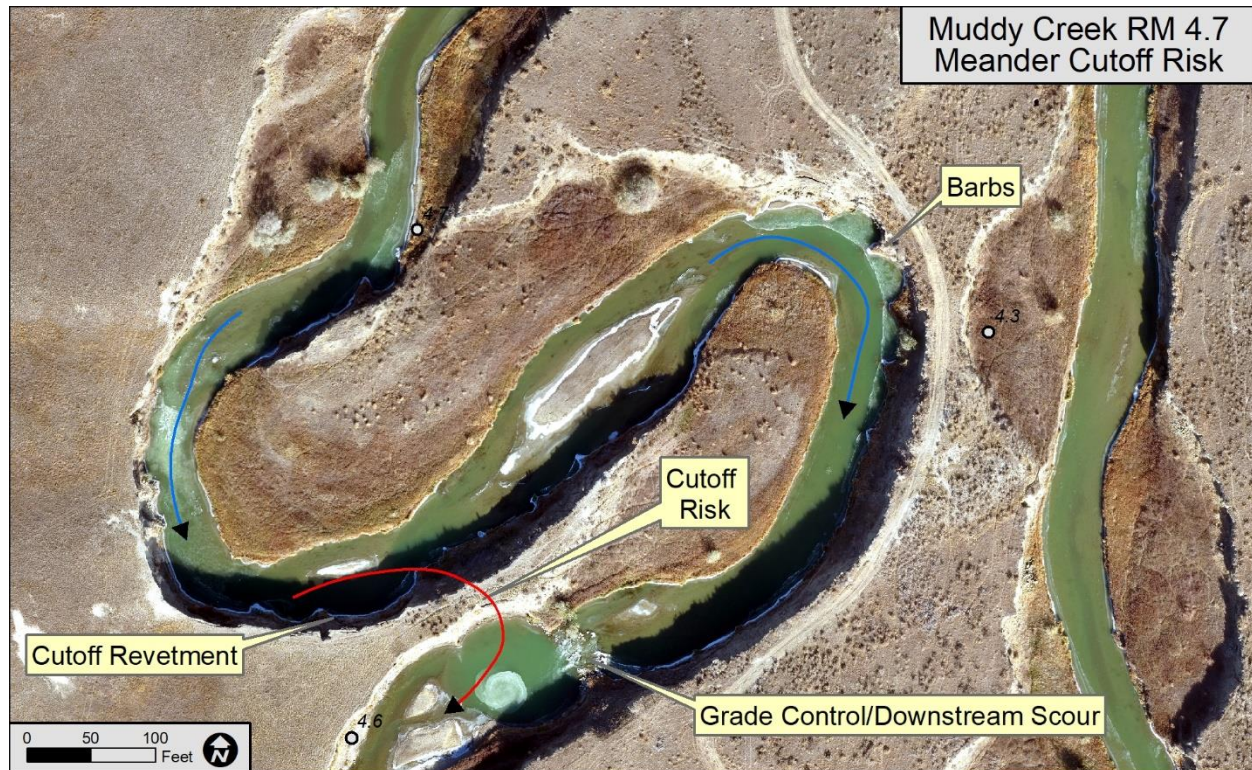
Figure 6-4. Muddy Creek meander cutoff risk, RM 4.7; note scour hole-driven bank erosion on downstream limb of meander below grade control.

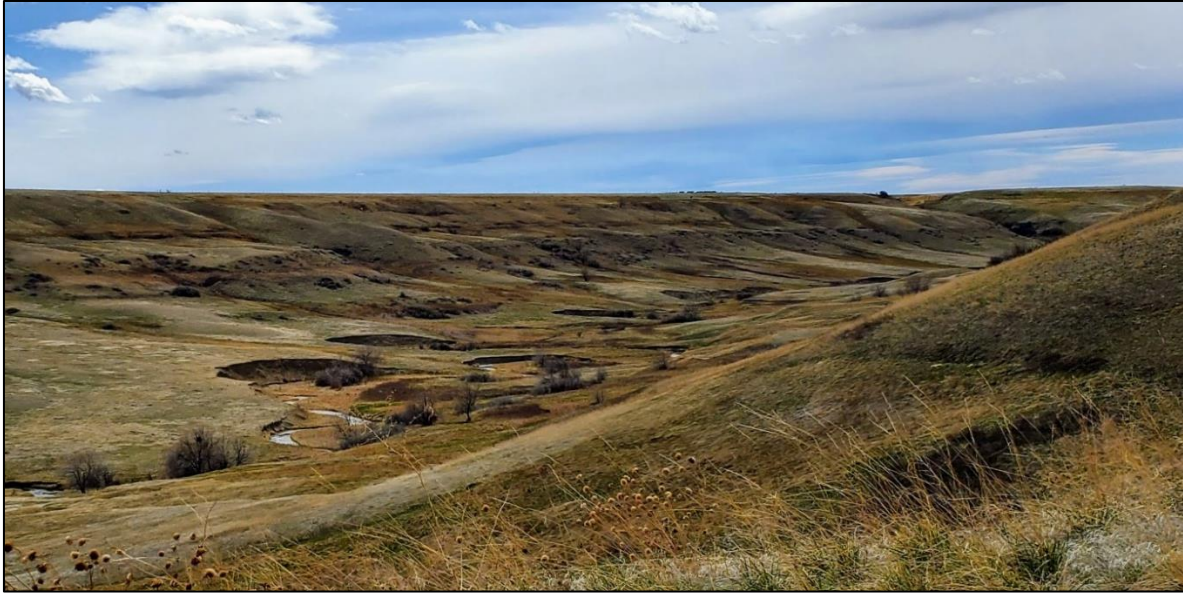
Photo 6-5. View upstream of Lower Tank Coulee segment owned by the State of Montana.

Tank Coulee is a ~6-mile-long tributary that enters Muddy Creek at RM 17, about a mile downstream of Spring Coulee. Similar to Spring Coulee, Tank Coulee has enlarged and incised in response to irrigation tailwater inflows. The coulee has extensive swaths of public lands (Bureau of Reclamation and State of Montana) within a wide valley bottom which makes it especially amenable to large scale restoration efforts that can benefit the public (Photo 6-5). There are currently no established plans to mitigate inflows into Tank Coulee in a similar fashion to Spring Coulee. As a result, the proposed Tank Coulee Habitat Enhancements Study is a multi-pronged evaluation of the potential to reduce stressors on the system (reduce flow augmentation) and improve resilience and habitat. Tank Coulee has a gravel-rich sediment load which will benefit fisheries restoration projects.

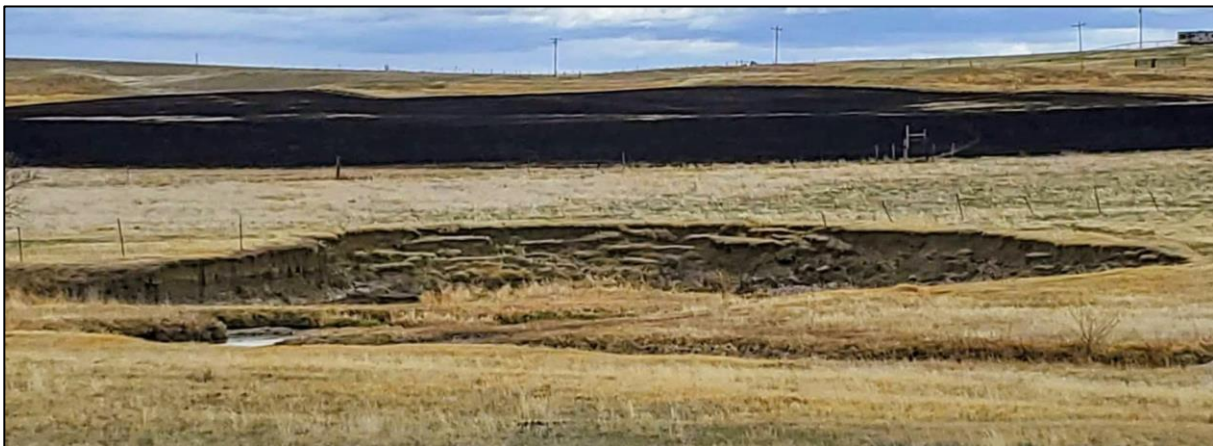
Photo 6-6. Mass failure of streambank on Little Muddy Creek below Thompson Drain.
