June 2022

Muddy Creek Master Plan

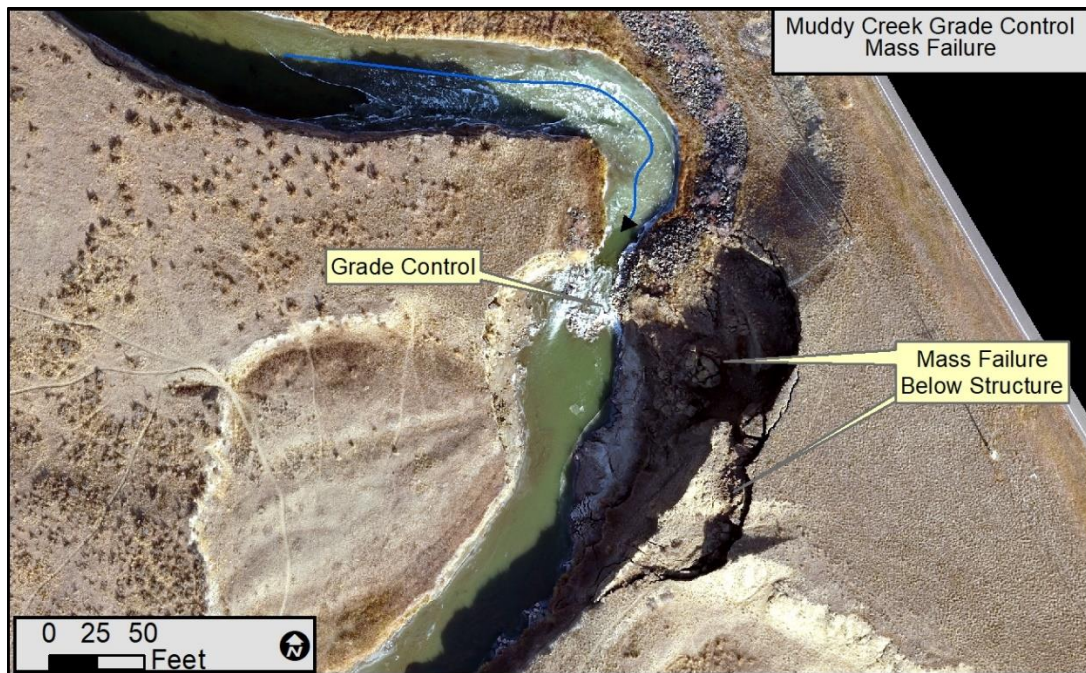
Photo 6-7. November 2021 drone image of hillslope destabilization below lowermost grade control sill, Muddy Creek RM 3.1.

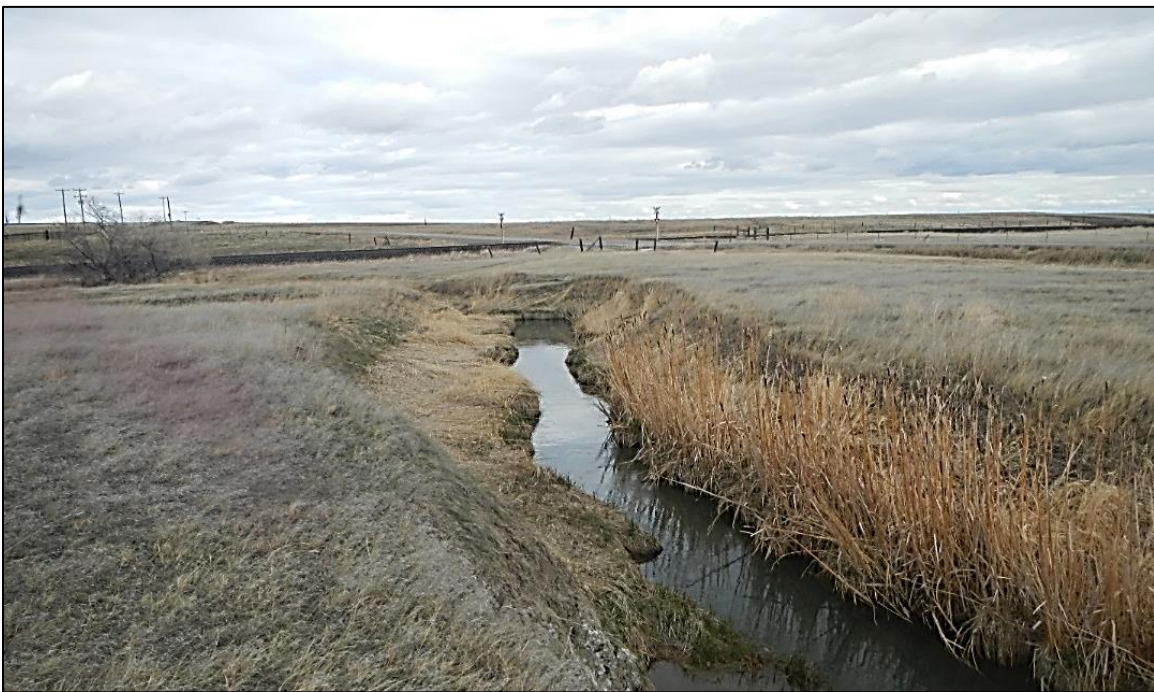
Photo 6-8. Upper Muddy Creek showing small inset floodplain surface (RM 34.4).

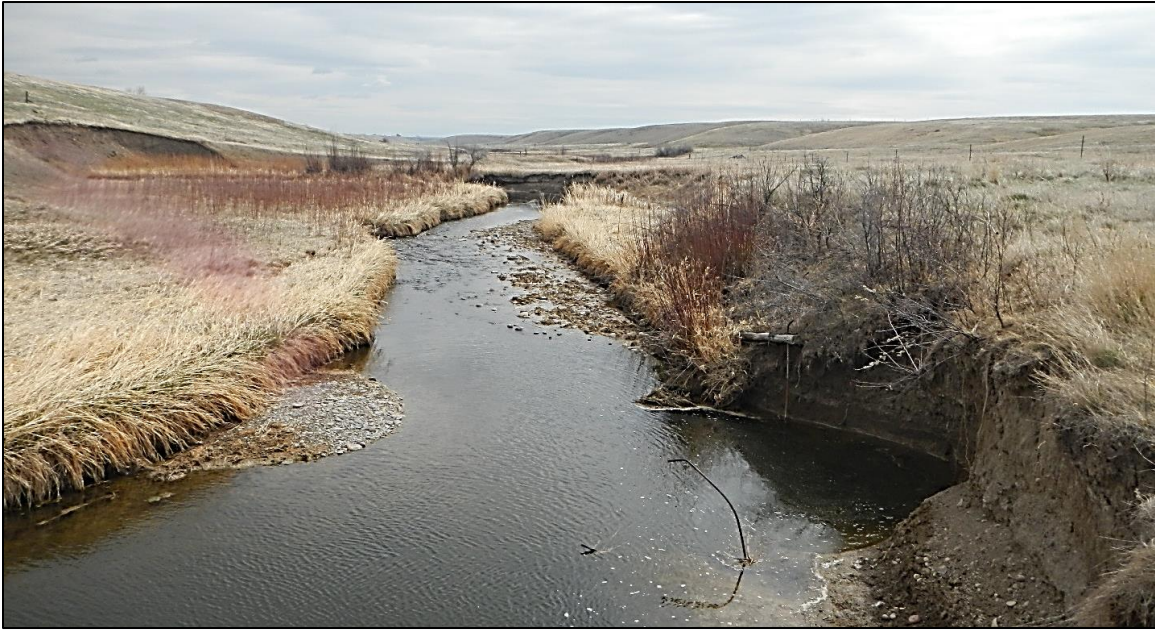
Photo 6-9. View downstream, Upper Spring Coulee project site.

Section 3 describes a habitat improvement project on Upper Spring Coulee that was initiated in the late 1990s (Photo 6-9). The project has been successful and there are ample opportunities for its expansion. Project elements discussed for Upper Spring Coulee include reed canary grass removal/replacements, fisheries enhancements, grade control, bank reshaping, channel realignment and riparian protections. This is an excellent project to couple with ongoing GID work upstream at J Wasteway. Currently, low tech process-based restoration approaches, such as beaver dam analogs (BDAs), would be inappropriate on Spring Coulee due to the high flows delivered through J-wasteway. However, if that project can effectively mitigate flow pulses, there

is excellent opportunity to apply relatively low-cost approaches that have proven to yield excellent results (e.g. bioengineered bank treatments to narrow the channel, BDAs to raise the bed and slow flows).

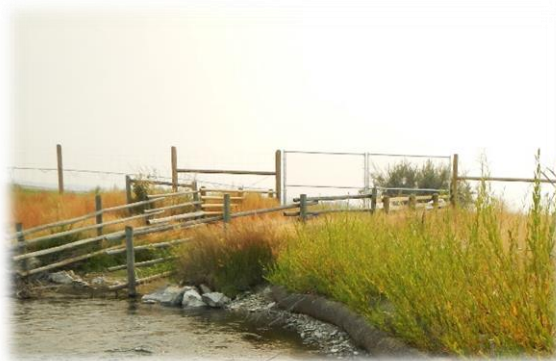
Water Gaps

Water gaps control livestock access to drinking water on a stream by creating a controlled access point. The NRCS recommends that water gaps be designed to admit only one animal at a time.
