# Sun River Assessment

# Sun River Assessment Final Report

Sun River Watershed Group  
and  
Cascade Conservation District

March 2014

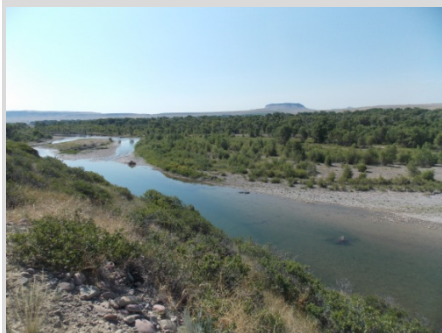
The low gradient channel, wide floodplain, and large gravel bars are typical along this reach (photo looking downstream near Site SR-5). The gravel bar in this photo is an important “nursery” for new cottonwood and willow growth, critical for sustaining a healthy riparian plant community.

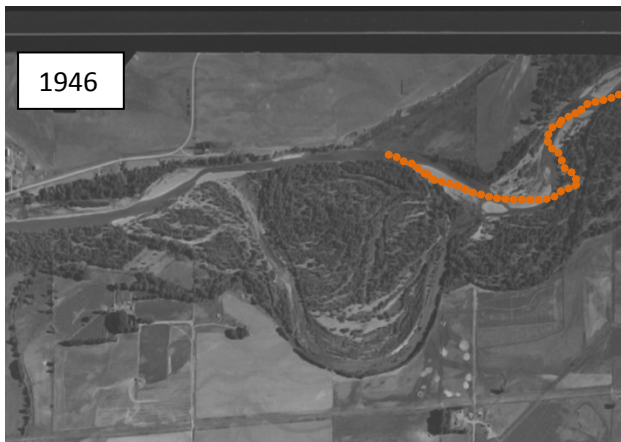
1946 Aerial Photo showing the main river channel nearly 1,000 feet south of where it is today (orange dashed line).

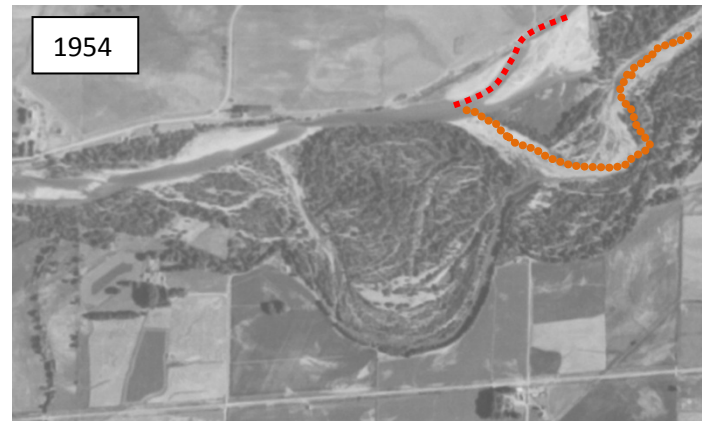
1954 Aerial Photo showing the new river channel (red dashed line) where a major avulsion occurred across a field. The 1946 channel (orange dashed line) became a secondary channel. The avulsion may have occurred during either the 1948 or 1953 flood.

- 2) Option 2: Preventing the Sun River from accessing the north overflow channel will be a substantial investment of time and money with uncertain results. An alternative approach is to invest resources into preparing the north overflow channel (the old 1946 river channel) to again become the main channel. This option would require that all restrictions (large logs, excessive gravel deposits) be removed from the channel and a dense riparian vegetation buffer be maintained along its banks.

- 3) South channel: It may be unacceptable to the property owners and the Rocky Reef water users to have the river recapture the south overflow channel. Agricultural operations along the south channel would be threatened and the Rocky Reef Diversion would be completely by-passed. The upper end of the south channel was not evaluated during this assessment, but it may require bank armoring and grade control to prevent headcutting and over-bank scour. Redesigning some channel crossings to better accommodate flood water passage should be considered.

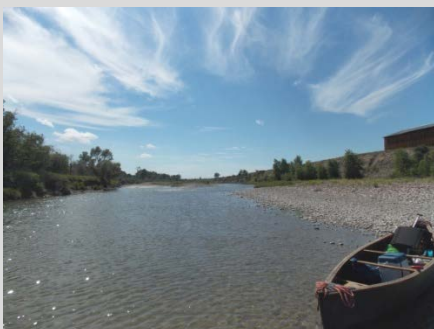
Looking upstream between Sites SR-7 and SR-8. Throughout most of this reach the river flows along the north valley wall (glacial lake and alluvium deposits overlying shale bedrock). A wide floodplain lies to the south.

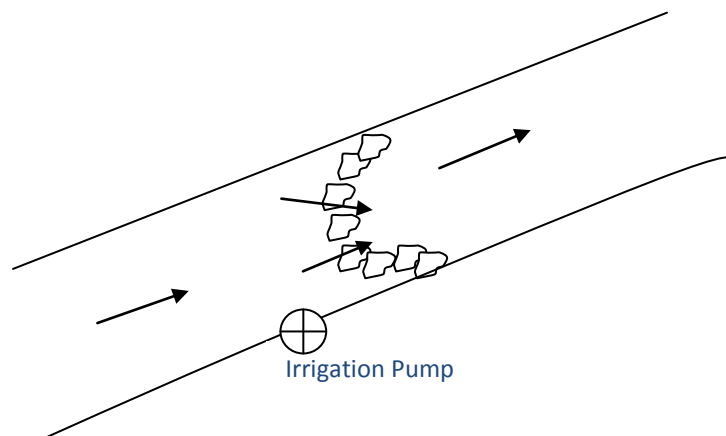
Looking downstream on the side channel below the irrigation pump. The photo shows a berm in the side channel intended to elevate the water level for an upstream irrigation pump.

Side Channel: Below the irrigation pump, 700 feet of side channel was shaped in 2013. Gravel was pushed up against the east channel bank. It is recommended that no further channel work be done. The channel will eventually narrow and deepen, creating meanders and point bars within the shaped channel. Install a permanent rock check structure for the irrigation pump instead of continuing to push-up a gravel berm each summer. See diagram below.

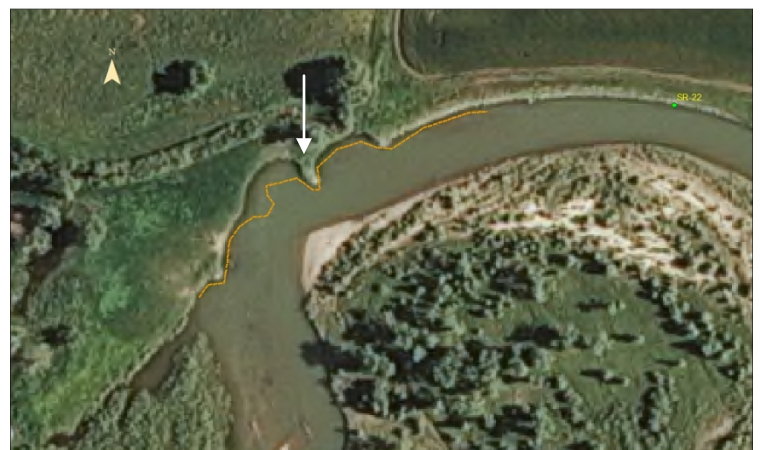
1995 bank lines overlain on 2011 aerial photography. This photo is a close-up of the rock jetties at the upstream end of Site SR-22. The river has moved about 40 feet behind the jetties over the last 18 years.

- 1) Remove the jetty marked with the white arrow (photo above). After the jetty is removed, shape the bank to a 3:1 slope and place angular rock along 350 feet of bank. Use salvaged rock from the jetty for the new rip-rap. Key the rip-rap into the existing downstream rip-rap. See the photo diagram below.
- 2) Aggressively control the leafy spurge infestations on the upper bank.

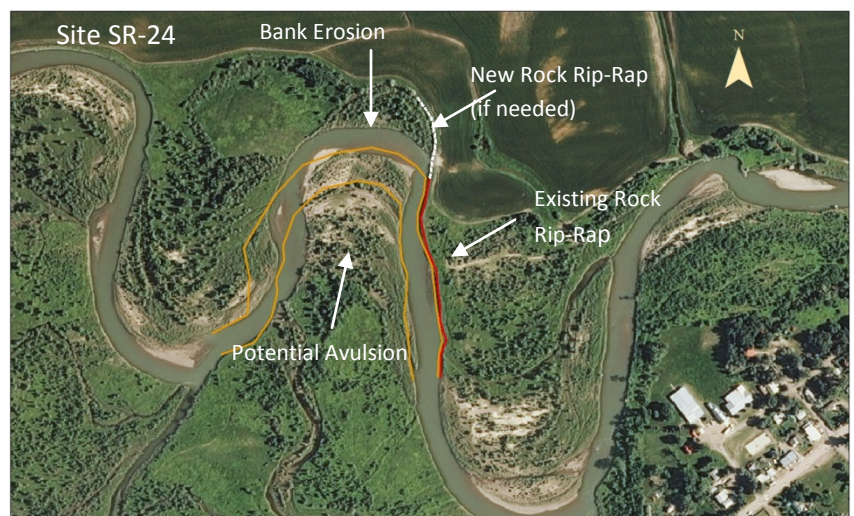
South of Site SR-24, the river is cutting into a meander. A future avulsion could shift the main river channel south, away from the eroding bend, but it is uncertain if or when this might occur.

1995 bank lines (orange lines) superimposed on a 2011 aerial photo showing the rate of channel migration over the last 18 years. The red line is existing rock rip-rap.

- 1) Along the apex of the north bend, 260 feet of riparian buffer separates the river from the irrigated hay field. It would be expensive to rip-rap the bend. If the river continue moving north, instead of reinforcing the bend, extend the existing rock rip-rap up the east bank along the field border to prevent flanking of the existing rip-rap (white line on the photo above).
- 2) Aggressively control the leafy spurge infestations on the upper bank.

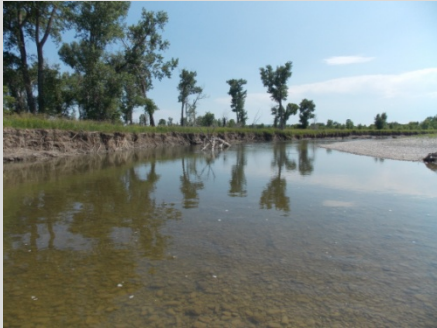
Looking downstream at Sites SR-22. Due to the dynamic nature of the river, bank erosion and channel migration are common. Because fields have been developed in the floodplain and on adjacent benches large amounts of bank armoring has been installed. Most bank stabilization has proven to be both expensive and difficult to maintain.

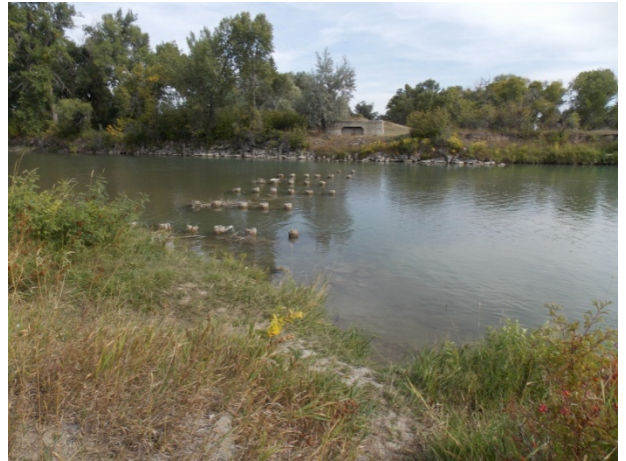
Support posts from the old railroad trestle were cut off after the trestle was removed. The piling stumps are exposed most of the year.

- 1) Cut the old trestle support posts as low as possible to lessen the safety hazard to river recreationists.
- 2) Aggressively control noxious weeds and remove Russian olive trees on the floodplain.

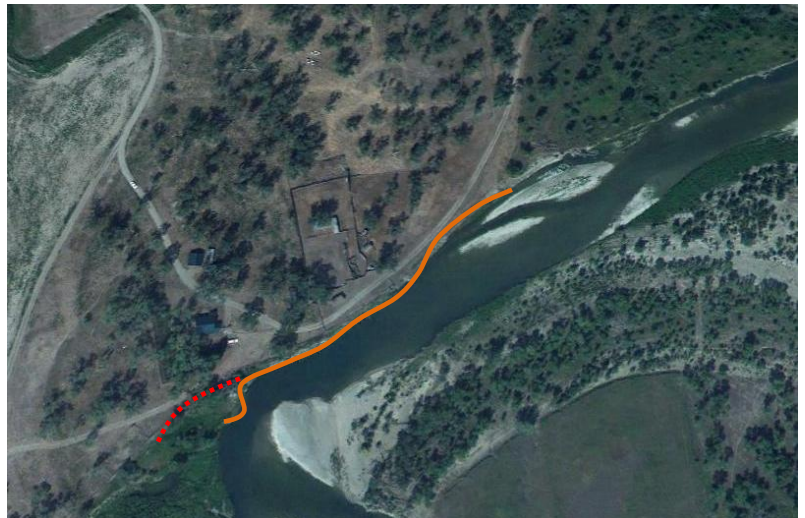
520 feet of rock rip-rap and jetties line the north bank, mostly built with large cobbles and concrete slabs. The bank stabilization was installed to protect a farmstead and corrals on the north floodplain of the river. The bank stabilization is intact except for the upper 30 feet which is need of repair.

The orange line depicts the existing rock/concrete rip-rap. The red dashed line is where additional rip-rap could be installed if the river begins to flank the upper jetty and rip-rap.

Monitor the bank erosion at Site SR-32 and upstream river migration to determine if additional rip-rap will be necessary. There is 80 feet of riparian buffer separating the river from a high floodplain bench. If the river begins to flank the upper jetty and rip-rap, it may then be worth installing 140 – 160 feet of rip-rap along the floodplain bench. The additional rip-rap would extend west from the existing rip-rap along the floodplain bench. Rock could be salvaged from the upper jetty and used on the extended rip-rap. See photo diagram below.

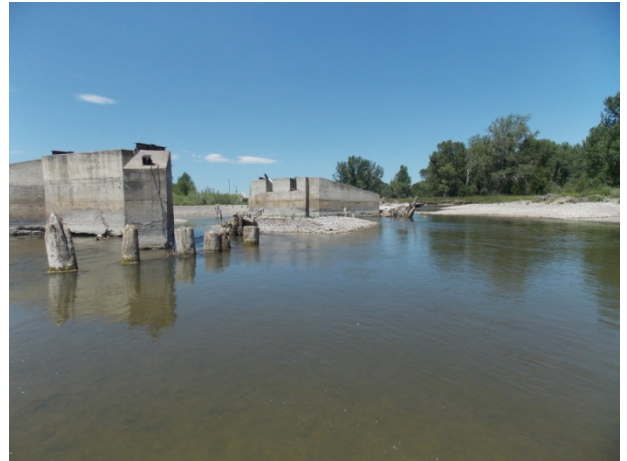
The 1995 aerial photo shows these abandoned structures lying alongside the east bank of the river. Over the last 18 years, the river moved 230 feet east, flanking the structures, and leaving them in mid-channel. They currently pose a safety hazard to river recreationists.

Old bridge abutments, concrete ramp approach, and wood pilings in the middle of the river.

Option 1: Remove the concrete bridge abutments and ramp approach from the river. Cut off the pilings as low as possible. This is a costly option, but it would immediately remove a safety hazard.

Option 2: Monitor the river to see if it will continue migrating east. If it does, the structures may eventually be on the west side of the river and will no longer pose a hazard.

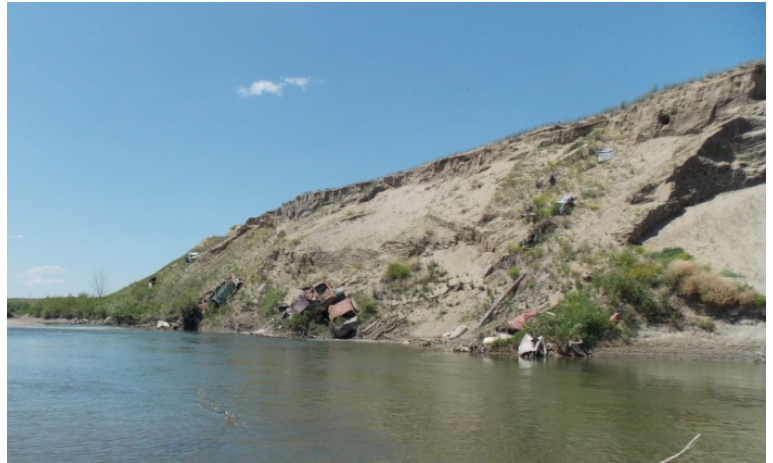
Old car bodies and miscellaneous scrap metal are strewn across about 1,000 feet of the north terrace bank. This site includes 600 feet of side channel and 400 feet of the active river channel. Immediately downstream from Site SR-40, car bodies are embedded in the river bottom. These car bodies pose a considerable hazard for river recreationists.

Old car bodies on the side of the terrace and in the river.

Winch the car bodies off the terrace bank and out of the river channel. Salvage or dispose of metal off-site. The steep terrace bank is alluvial deposits consisting of loose sand that is inherently unstable. Attempts to revegetate the terrace bank upon removal of the car bodies will not be successful. However, disturbed areas along the side channel bank should be revegetated after the car bodies and scrap metal are removed.

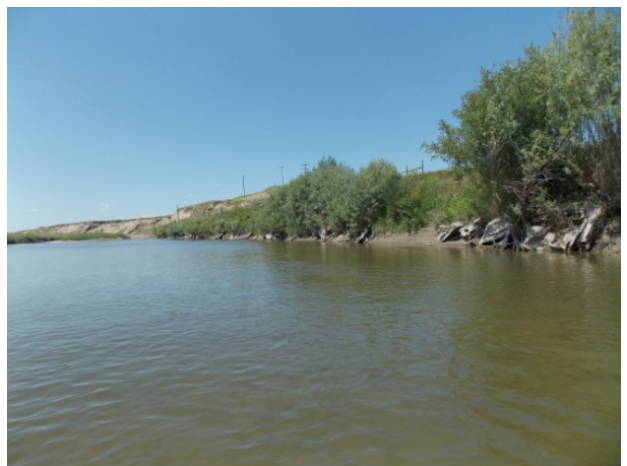
Downstream from the pump site, there is 450 feet of river bank lined with old car bodies and scrap metal. A narrow band of willows grows along the bank intermixed with the car bodies and scrap metal.

Old car bodies and scrap metal lining the north river bank.

- 1) Move the pump site downstream about 300 feet to a straight and more stable section of channel. Remove the jetty to stop the back eddying and to slow the terrace erosion.
- 2) Remove the car bodies and scrap metal along the bank where significant disturbance to the river bank and willows can be avoided. Plant willow cuttings along the bank after removal.

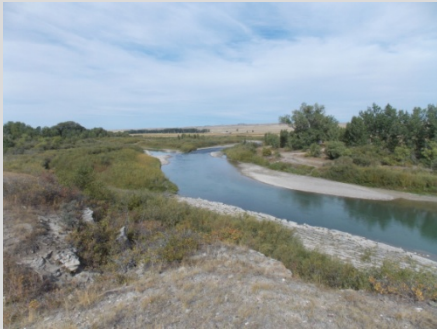
Looking upstream and across the river towards Largent's Bend. (Site SR-35). Dense stands of willow are common along the banks of the lower Sun River. The exposed bedrock shown in the foreground serves as a natural channel grade control.

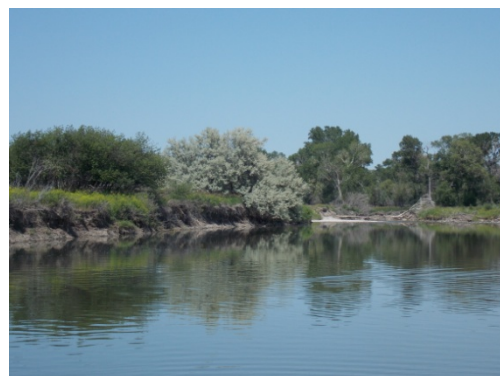
4. Russian Olive Encroachment: Russian olive tree densities in the Sun River corridor are relatively light. Along some Montana rivers, Russian olive encroachment on the river corridors is creating a devastating ecological and economic impact. Some densities have become so high that it is now cost-prohibitive to treat them. To prevent Russian olive from expanding and encroaching on the Sun River native riparian plant communities, landowners should be encouraged to eliminate all Russian olive plants along the Sun River, tributaries, and irrigation canals.

Mature Russian olive tree next to the Sun River.
