August 24, 2021

# Channel Migration Mapping Sun River (Phase 1) Elk Creek (Phase 2)

### **Executive Summary**

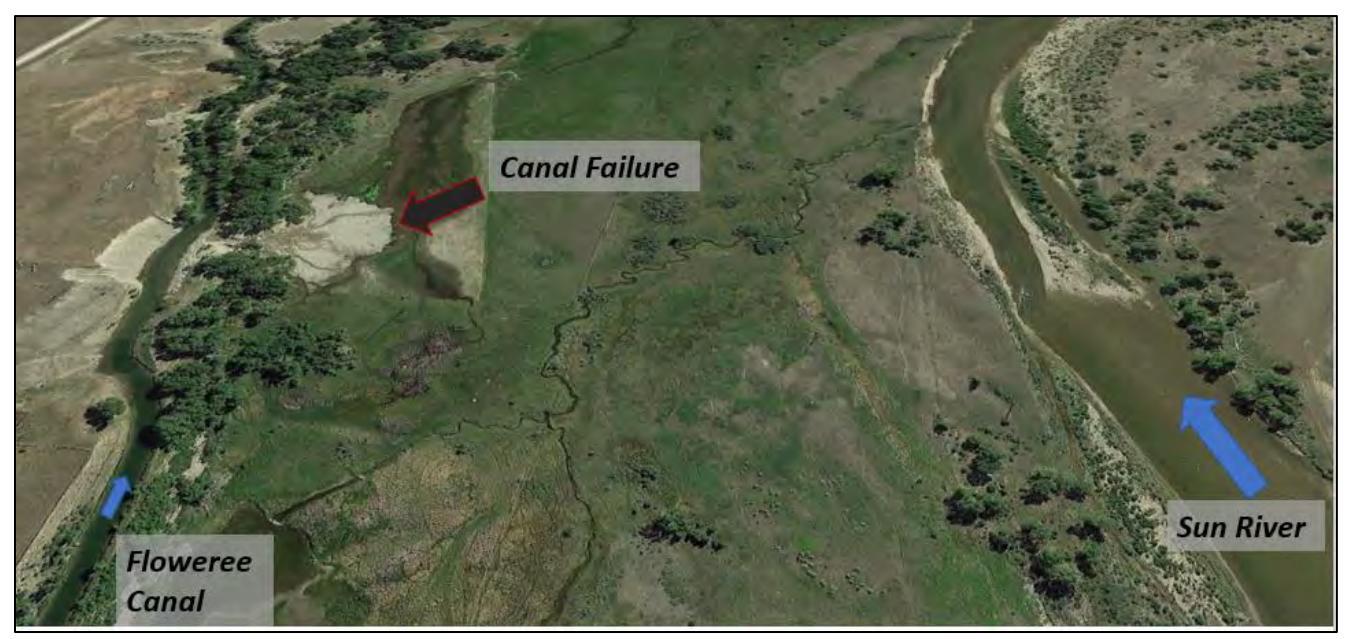
The Floweree Canal closely parallels the river in the upper few miles of Reach SR6, and sometime between 2011 and 2014 there was a substantial hillslope failure along the canal that caused it to breach at RM 66.6, forming a distinct alluvial fan on the Sun River floodplain (Figure 53). Canal seepage supports numerous wetlands on the floodplain as well. In some areas such as just below the mouth of Spring Creek, the stream corridor is tightly confined between pivot fields, and in several locations the streambanks have been armored to protect those pivots (Figure 54).

Figure 53. View downstream showing Floweree Canal breach forming alluvial fan on Sun River floodplain (Google Earth).

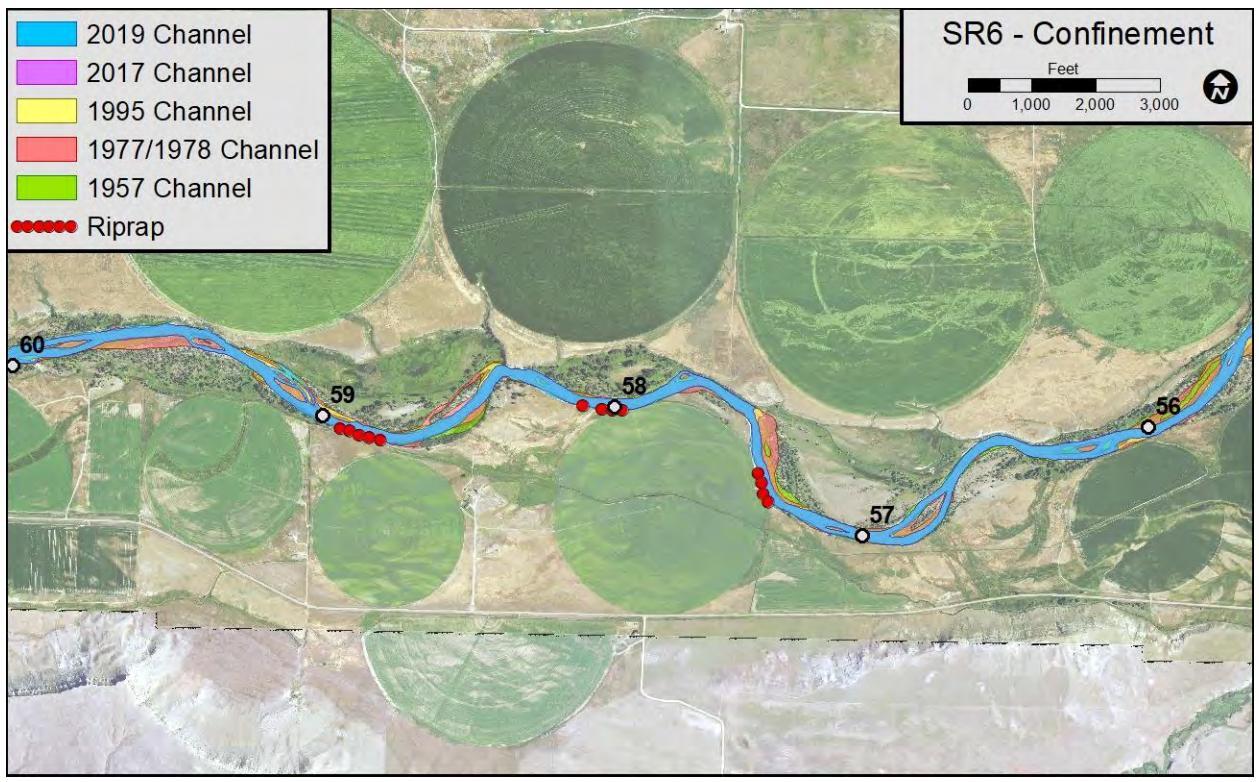
Figure 54. Bankline mapping showing armor and minimal channel movement between pivots in Reach SR6.

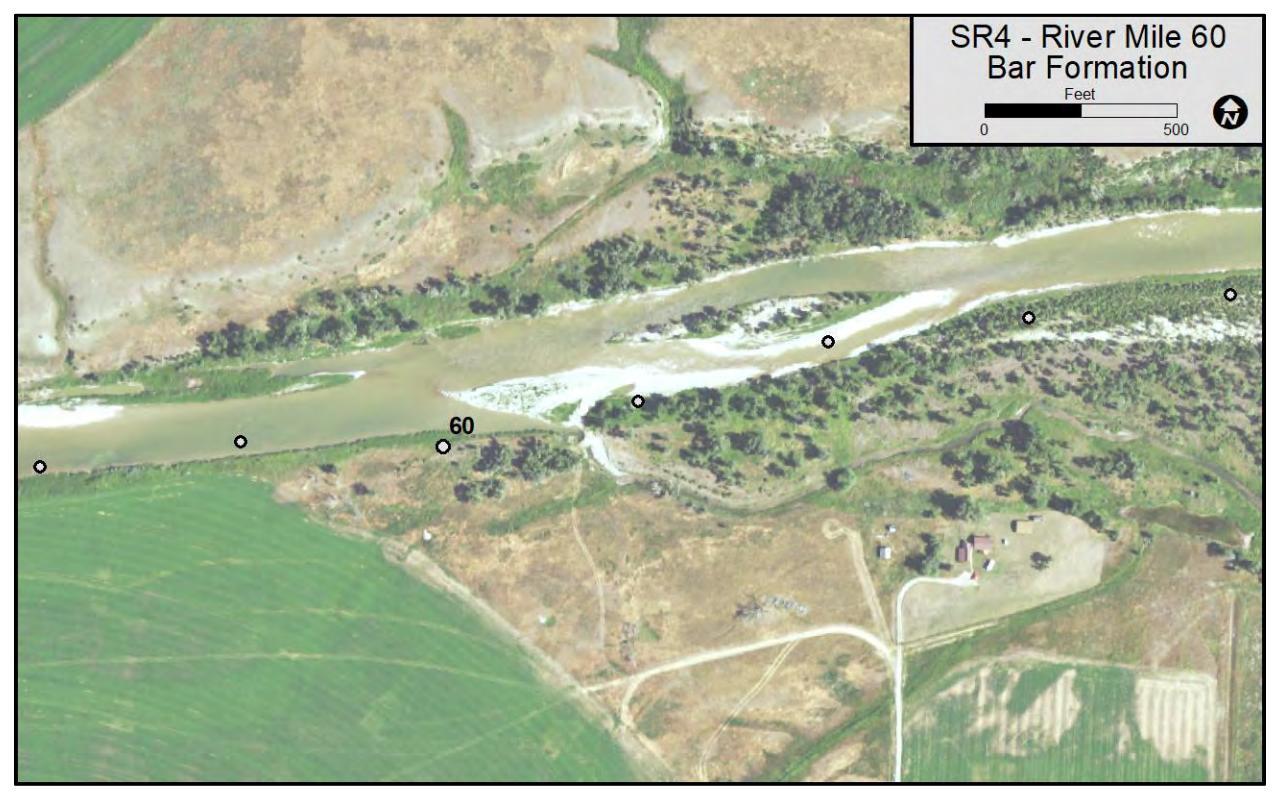
1. A diversion structure at RM 60R, which is about a mile below the mouth of Spring Creek, appears to have some sedimentation issues at its entrance. A large bar has formed but it appears that the flow split into the ditch has been effectively managed by hardening the upper face of the bar to form a deflector (Figure 55). In 1978, a rock weir extended into the river to deflect flows towards the ditch, this is probably what drove the sedimentation just downstream. The bar has been established since at least 1995. A return flow channel at the headgate will be important to maintain so the ditch is not overrun in high water. The ditch itself poses an avulsion hazard as it flows parallel to the river across a low meander, it should be monitored for that risk.

Figure 55. Bar formation at diversion, RM 60.

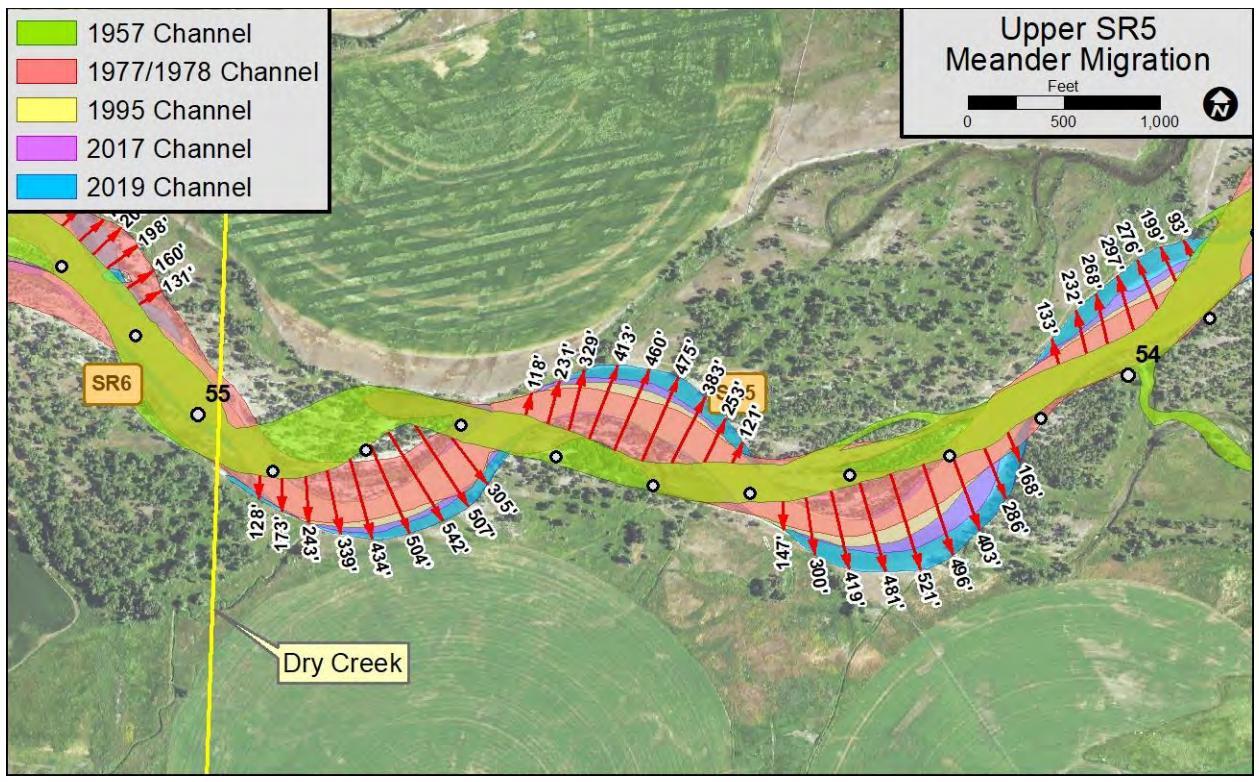
Figure 57. Meander migration in upper SR5 near the mouth of Dry Creek.

- Progressive southward bank movement immediately downstream of the mouth of Dry Creek at RM 54.8 is threatening a pivot field (Figure 57). The river was about 60 feet from the edge of the field in 2019. The banklines show that the most rapid erosion is on the downstream limb of the bend as it translates down valley to the east. This will reduce the erosive pressure on the field with time. As the river is pinned on the north side by a bluff, it will be important to provide some room for channel adjustment in this area to prevent a need for perpetual bank armor expansion. About 9 acres of the pivot field are within the mapped CMZ of the Sun River.

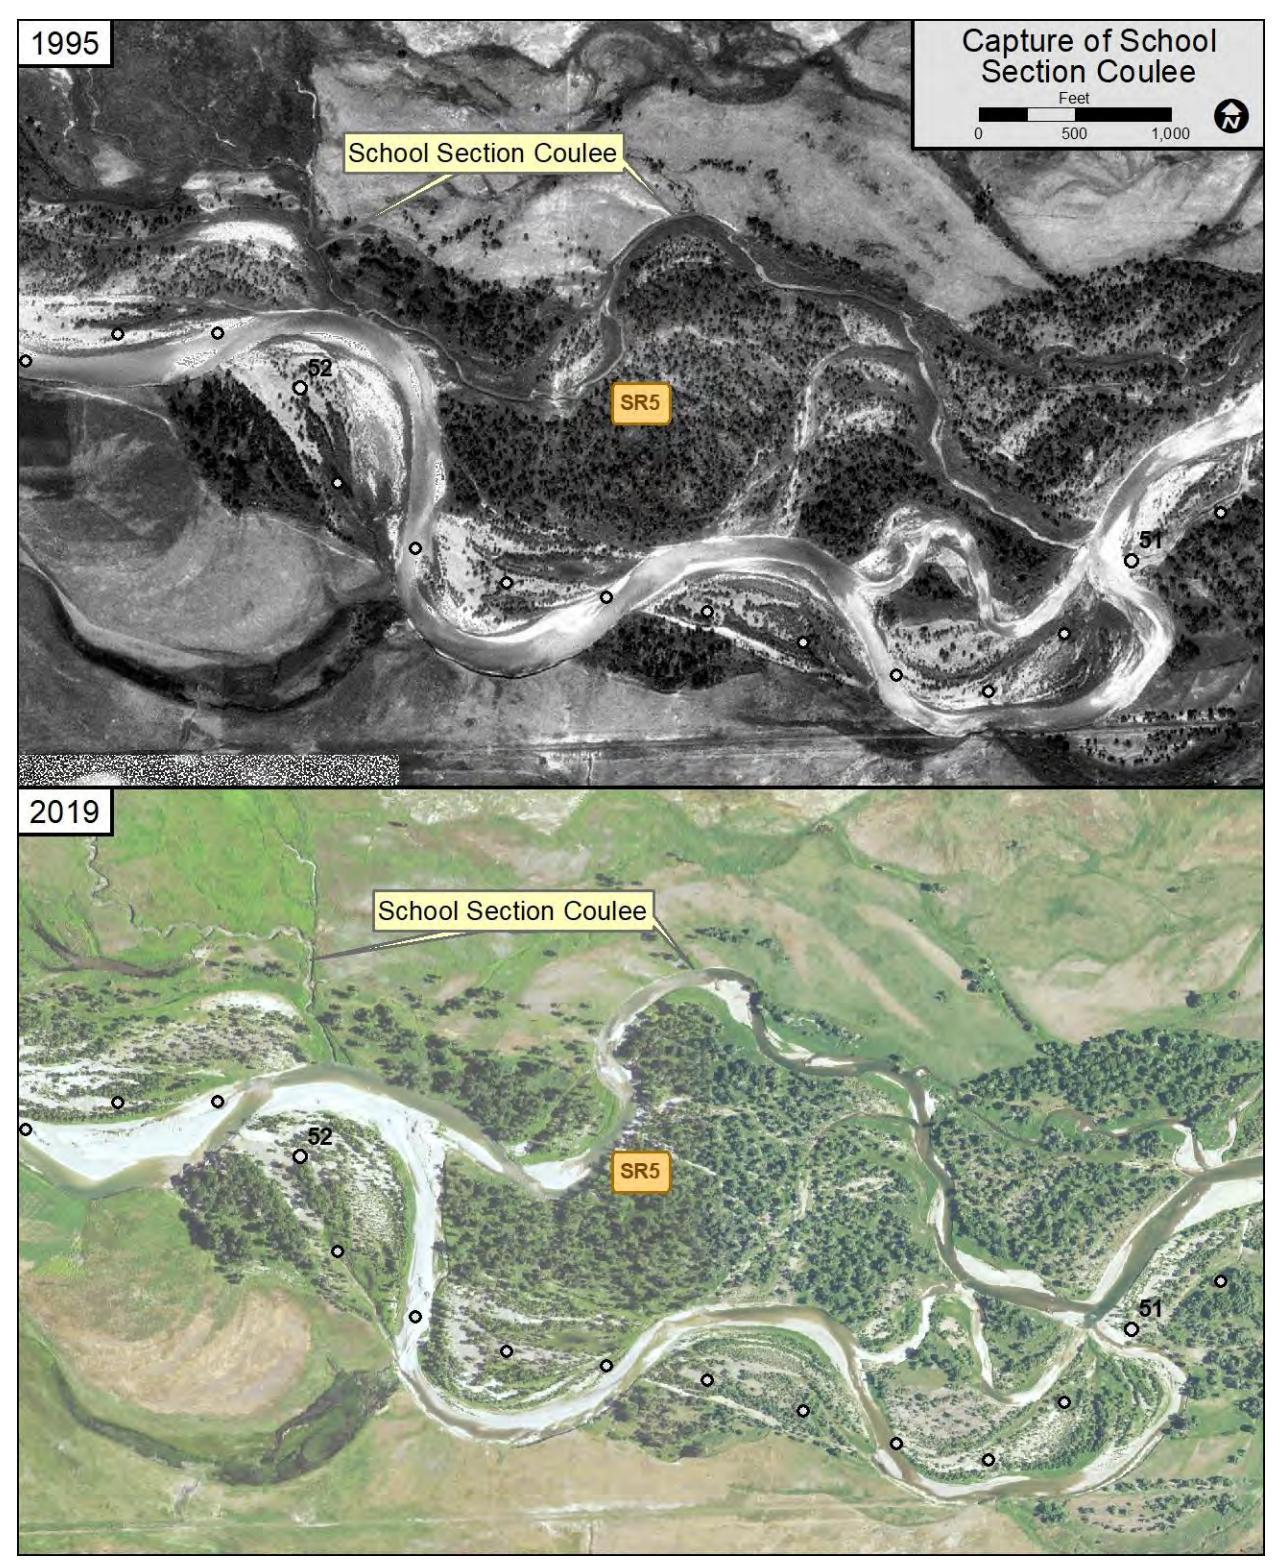
159 feet in Reach SR6 to 475 feet in Reach SR5. Three avulsions were mapped in this reach; one of them occurred around 1999 where the river captured a swale that was carrying the lower portion of School Section Coulee (Figure 58).

Figure 58. Sun River capture of swale that routed School Section Coulee in 1995.

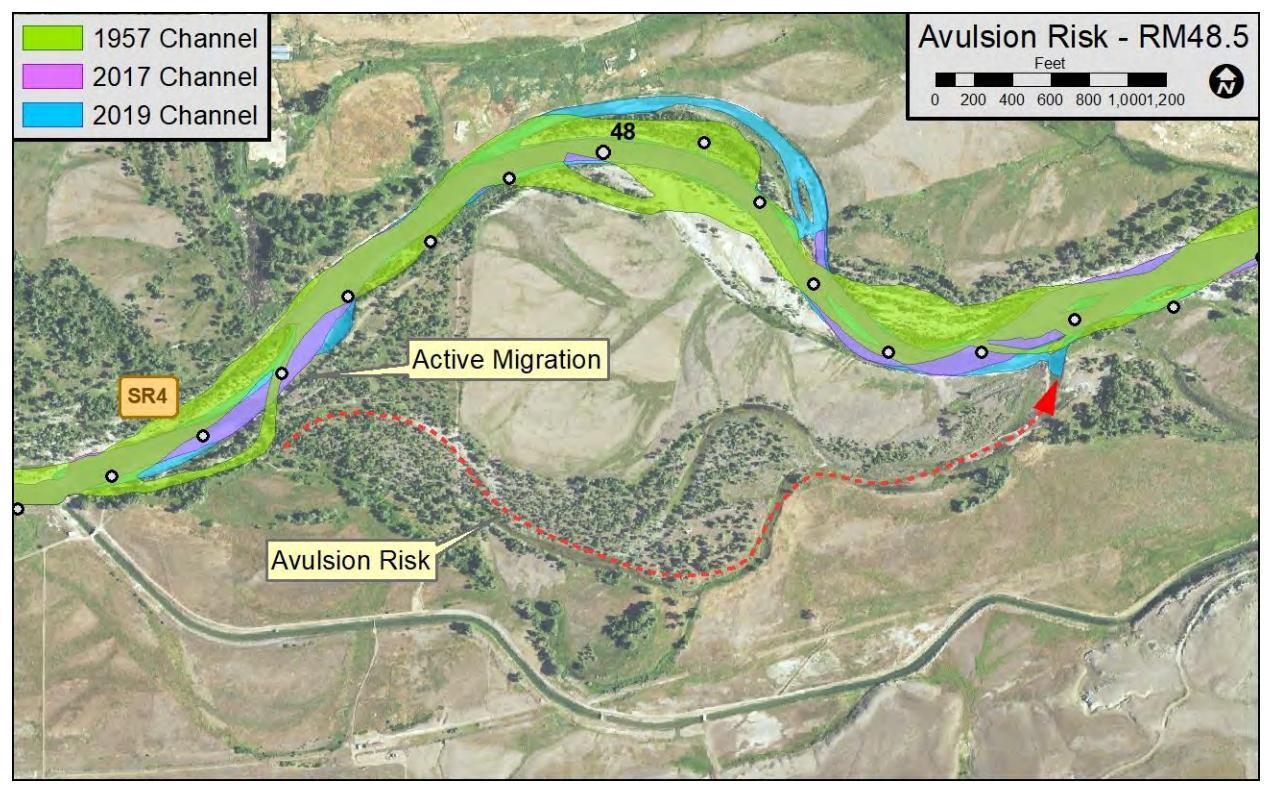
No major issues were identified in Reach SR4. There is a fair bit of bedrock control in this reach, resulting in relatively low migration rates. At the Fort Shaw Canal Diversion, the river location has changed very little since at least the 1950s due to bank armoring upstream. It appears that the river was dredged in 1957 just upstream of the diversion, probably in response to the 1955 flood. Both banks have since seen some armoring upstream of the diversion; some of that armor now sits in the floodplain about 200 feet south of the active river channel. Left bank armoring upstream of the diversion at RM 49.1 appears stable but does have some risk of flanking on its upstream end. Just below the canal there is a growing risk of an avulsion south of the river, where the channel is progressively migrating into an avulsion path made up of a well-defined historic swale of the Sun River (Figure 62).

Figure 62. Example avulsion hazard through floodplain swale below Fort Shaw Canal Diversion; note how river has migrated towards upper end of avulsion path in recent years.

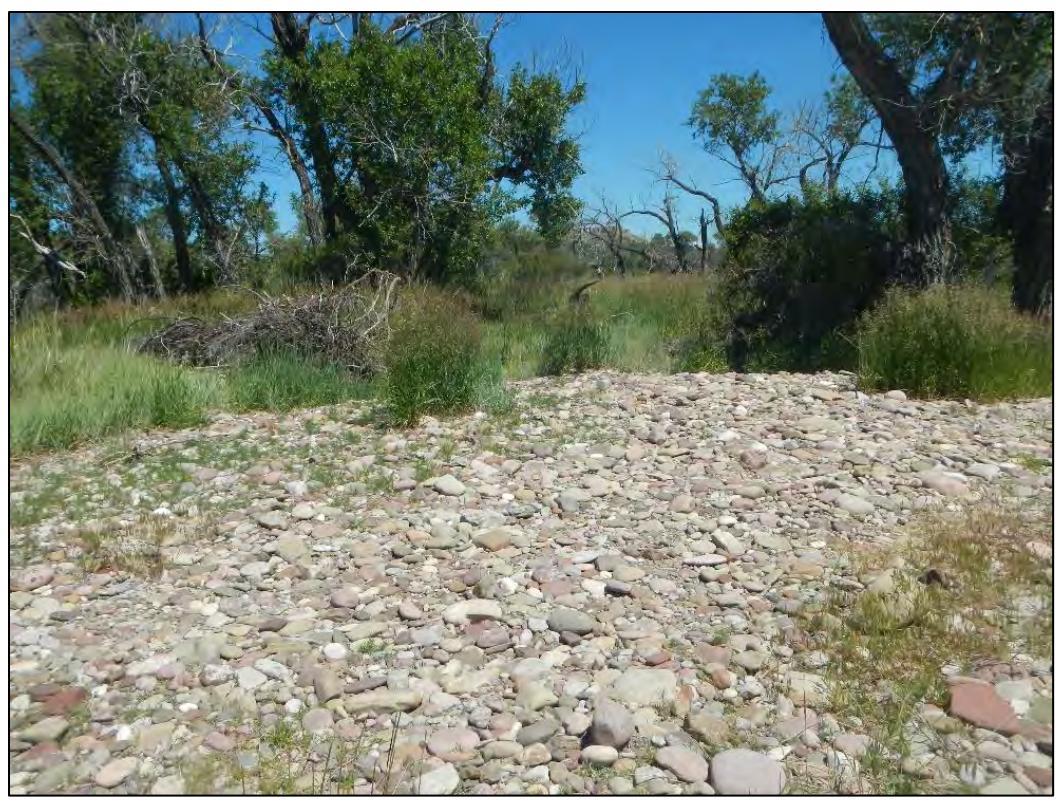
Reach SR3 starts at Lowry Bridge and extends to the Rocky Reef Diversion structure (Figure 63). The reach is 8.5 miles long. A total of 110 migration measurements were collected in this reach, and the maximum 1957-2019 migration distance measured was 439 feet. Bedload remains coarse, and just below Lowry Bridge recent deposits of coarse gravel/cobble was evident on the north floodplain (Figure 64). Coarse dredge spoils just upstream of the bridge

Figure 64. Coarse bedload deposition on floodplain just below Lowry Bridge.

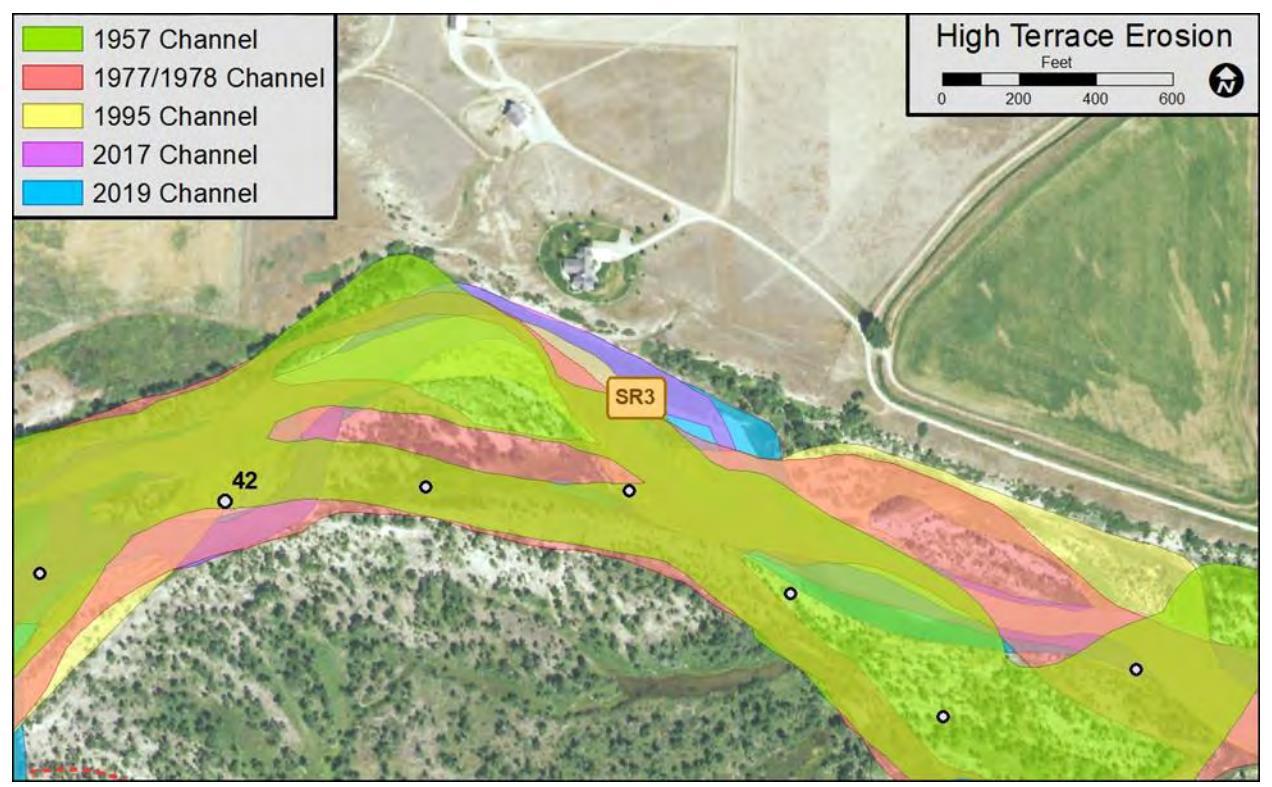
Figure 69. 1957-2019 migration pattern against high terrace at RM 41.8.

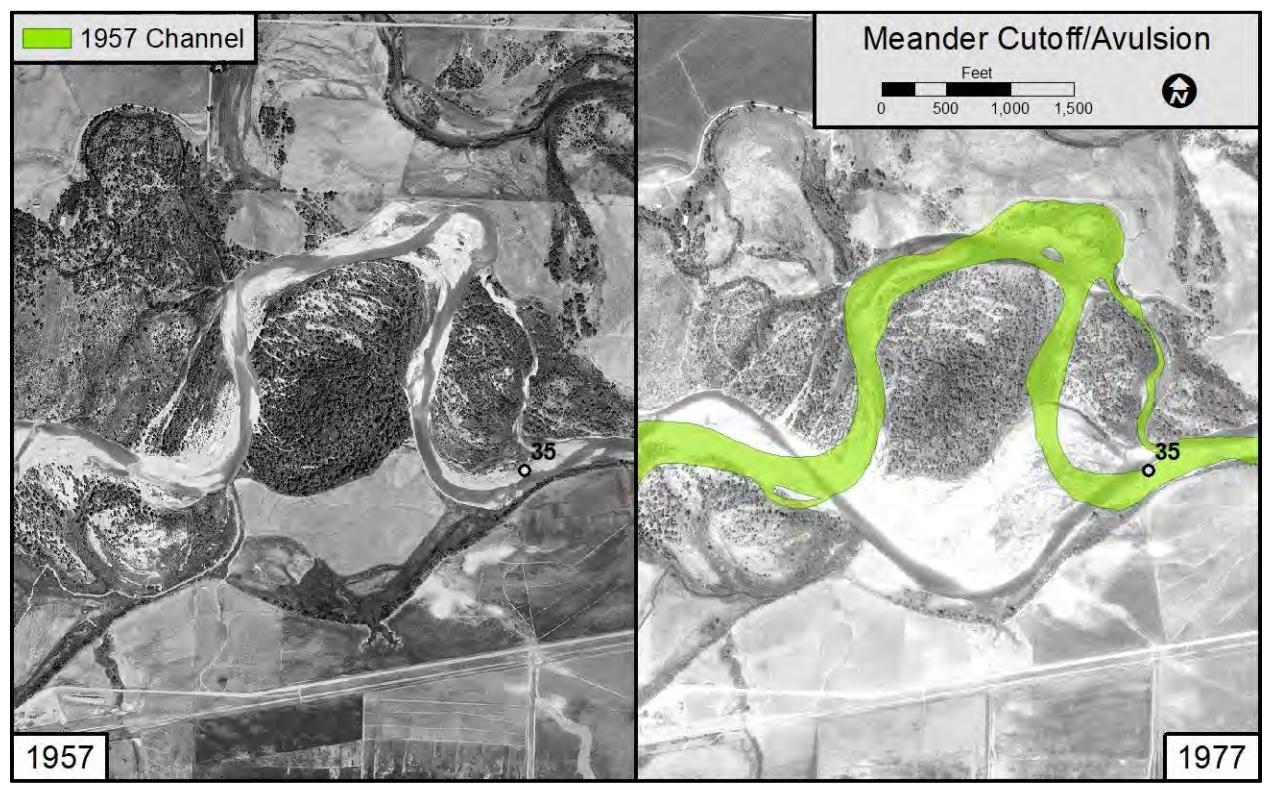
Figure 73 shows an example of an avulsion in Reach SR2 that occurred between 1957 and 1977. The original meander has been abandoned as an oxbow, and about a half mile of new channel has formed to the south, through a field. These types of avulsions tend to be more common through fields than in riparian areas, because riparian forests support floodplain integrity better than hay or other herbaceous crops.

Figure 73. Meander cutoff/avulsion in Reach SR2 between 1957 and 1977.

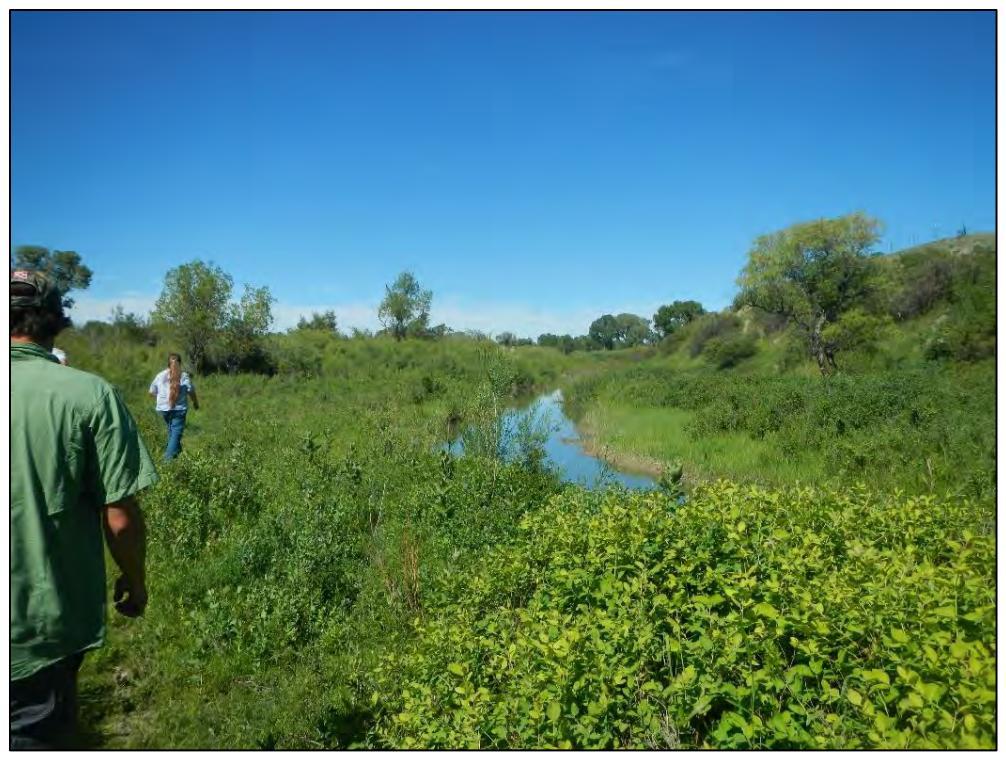
Figure 75. View down Adobe Creek above avulsion point.

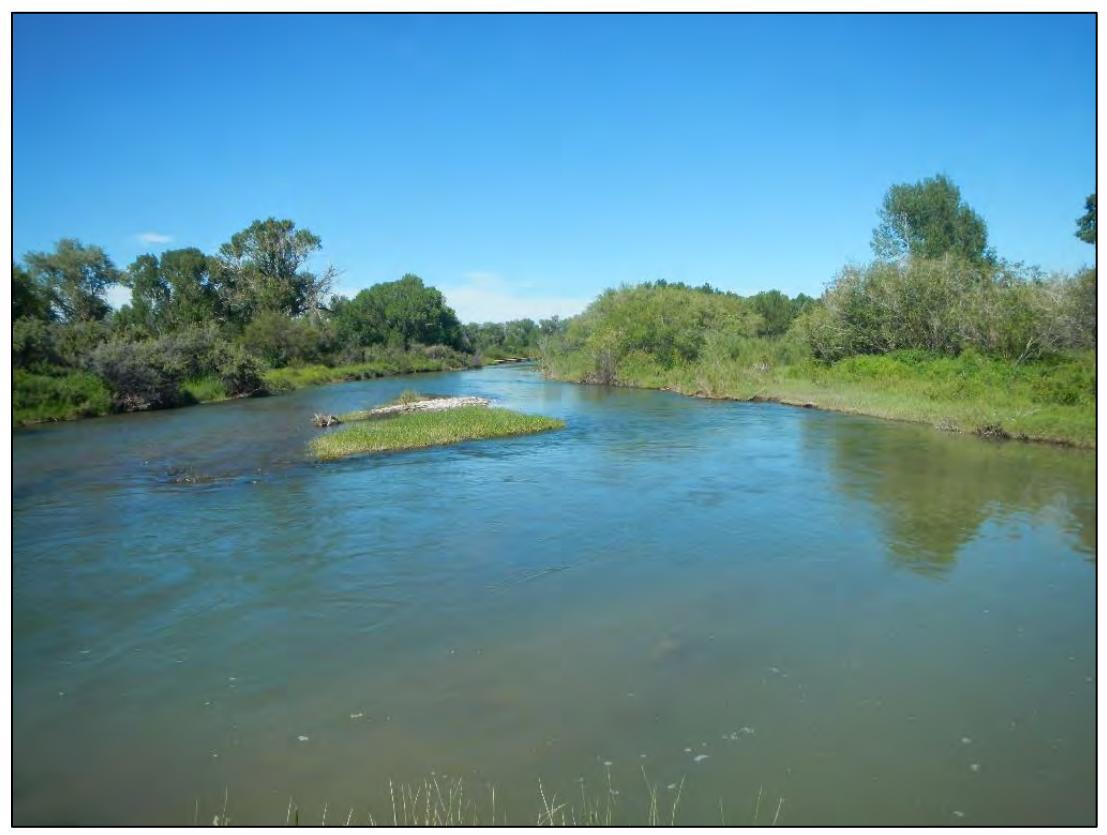
Figure 76. View of Adobe Creek below avulsion point; the Sun River has captured the creek (June, 2020).

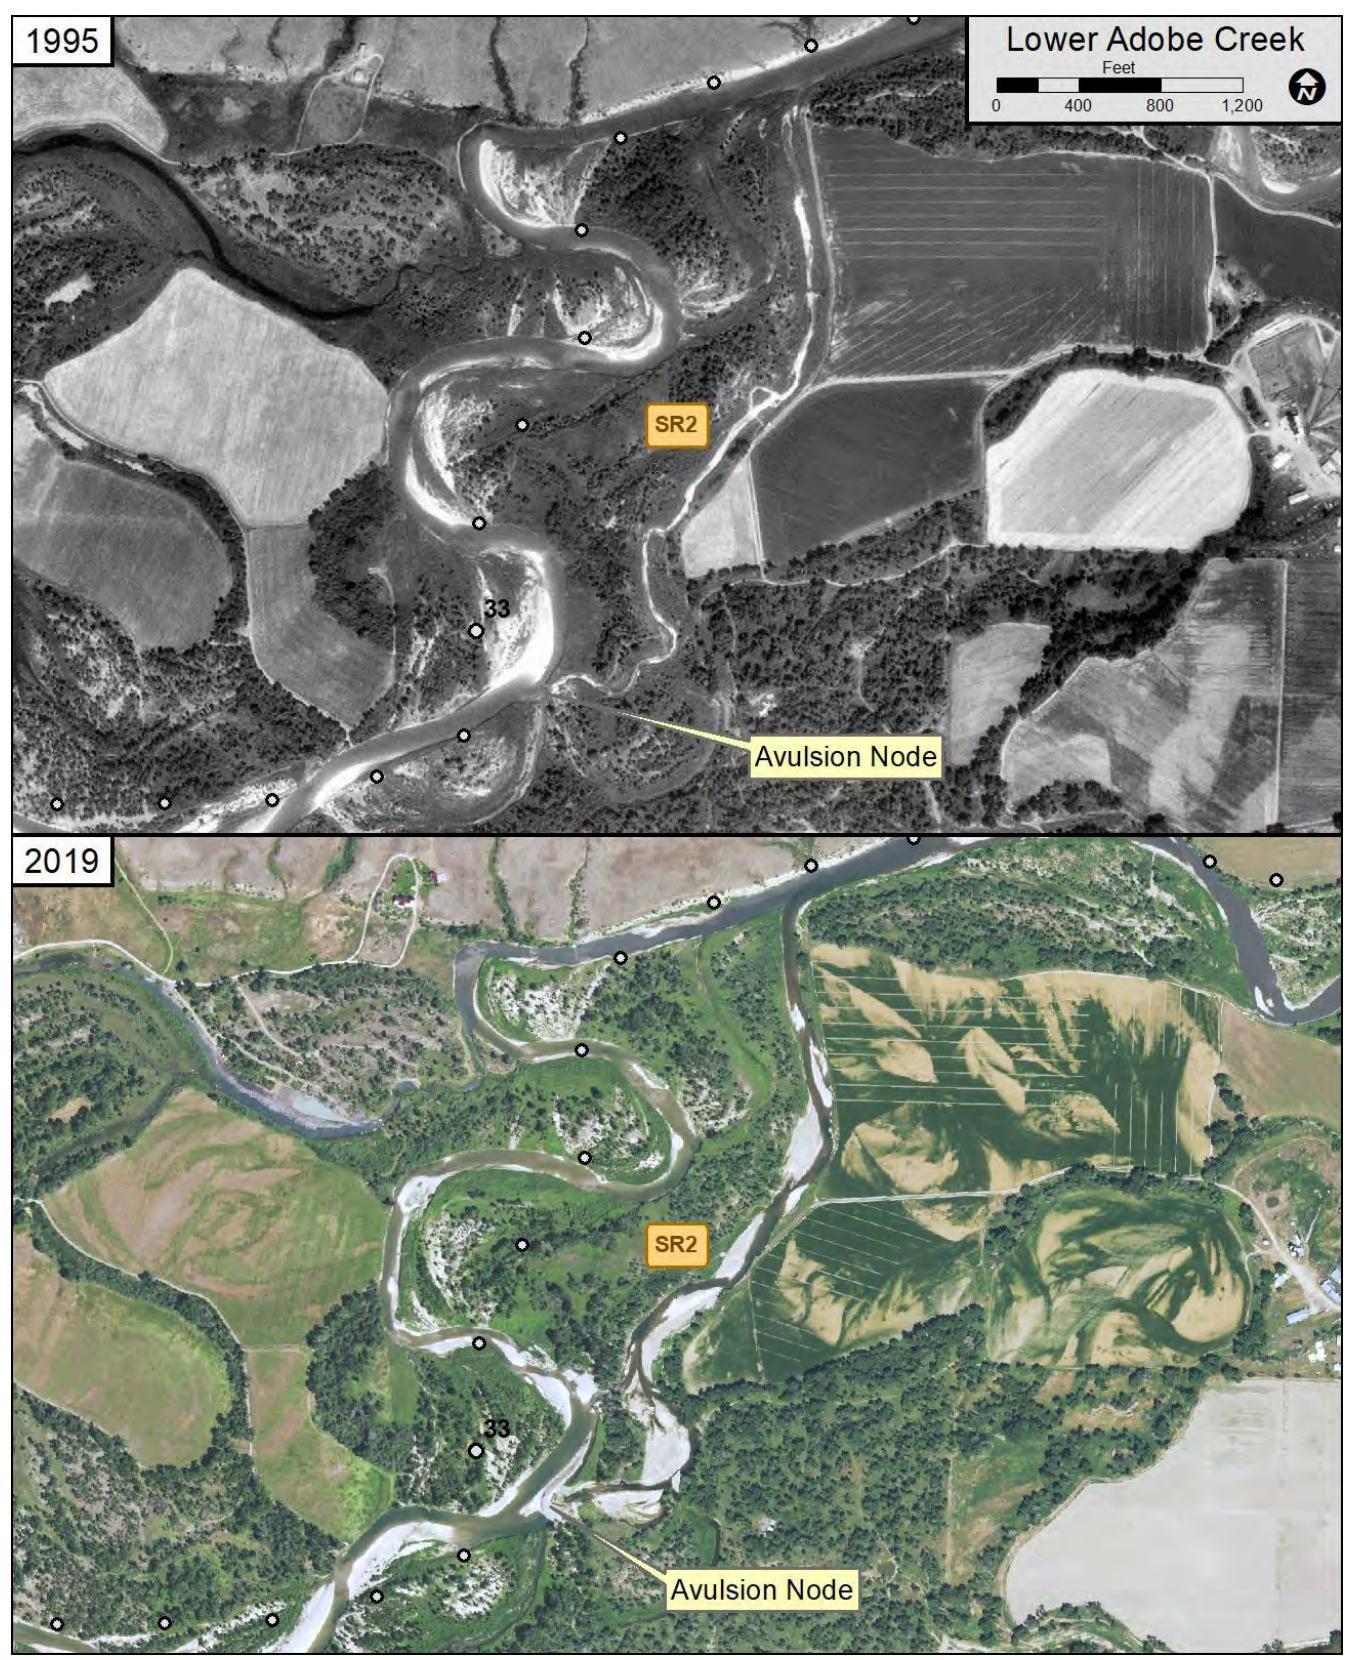
- 2. Another avulsion has established below the mouth of Adobe Creek through what is an old Sun River high flow channel (Figure 78). This was described as High Priority Site SR-16 by Kellogg (2014) who indicated that root wads and riprap were installed over ten years ago on the right bank to prevent the river from breaching into the side channel/tributary (this may have been described as "lower Adobe Creek" in 1995). Recommendations were to reinforce all likely breach locations with rock riprap and flow deflectors. All treatments that were in place in recent years failed, and headcuts that had established between the river and side channel grew and allowed the river to breach into the channel. This site is also discussed further in Section 6.2.

Figure 78. Avulsion into an older Sun River side channel) between 1995 and 2019 showing channel capture/reactivation due to bank erosion at avulsion node.

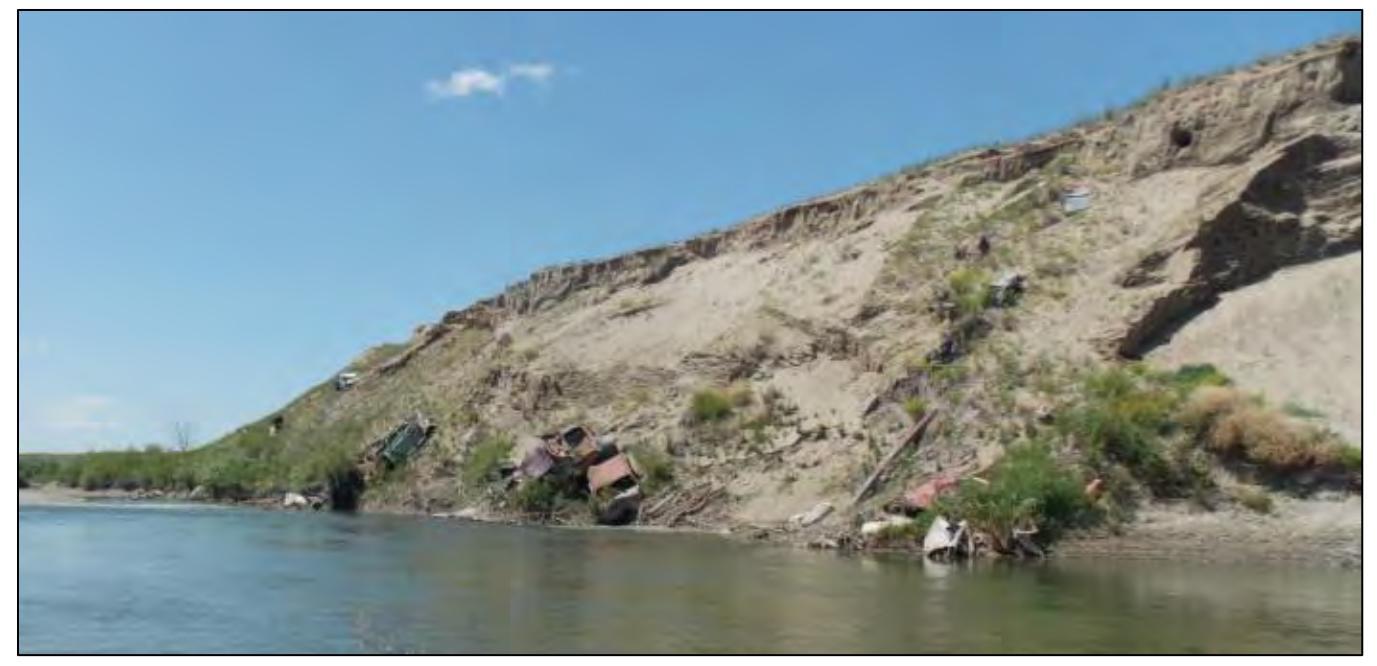
The CMZ mapping shows one place of special concern in Reach SR1. It is an area of high terrace erosion on the left (north) bank at RM 20.5. The terrace has old car bodies and scrap metal strewn along 1,000 feet of bank (Kellogg, 2014). Kellogg recommended that the car bodies be removed and salvaged/disposed of.

Figure 82. High terrace erosion at RM 20.5 (Kellogg, 2014).

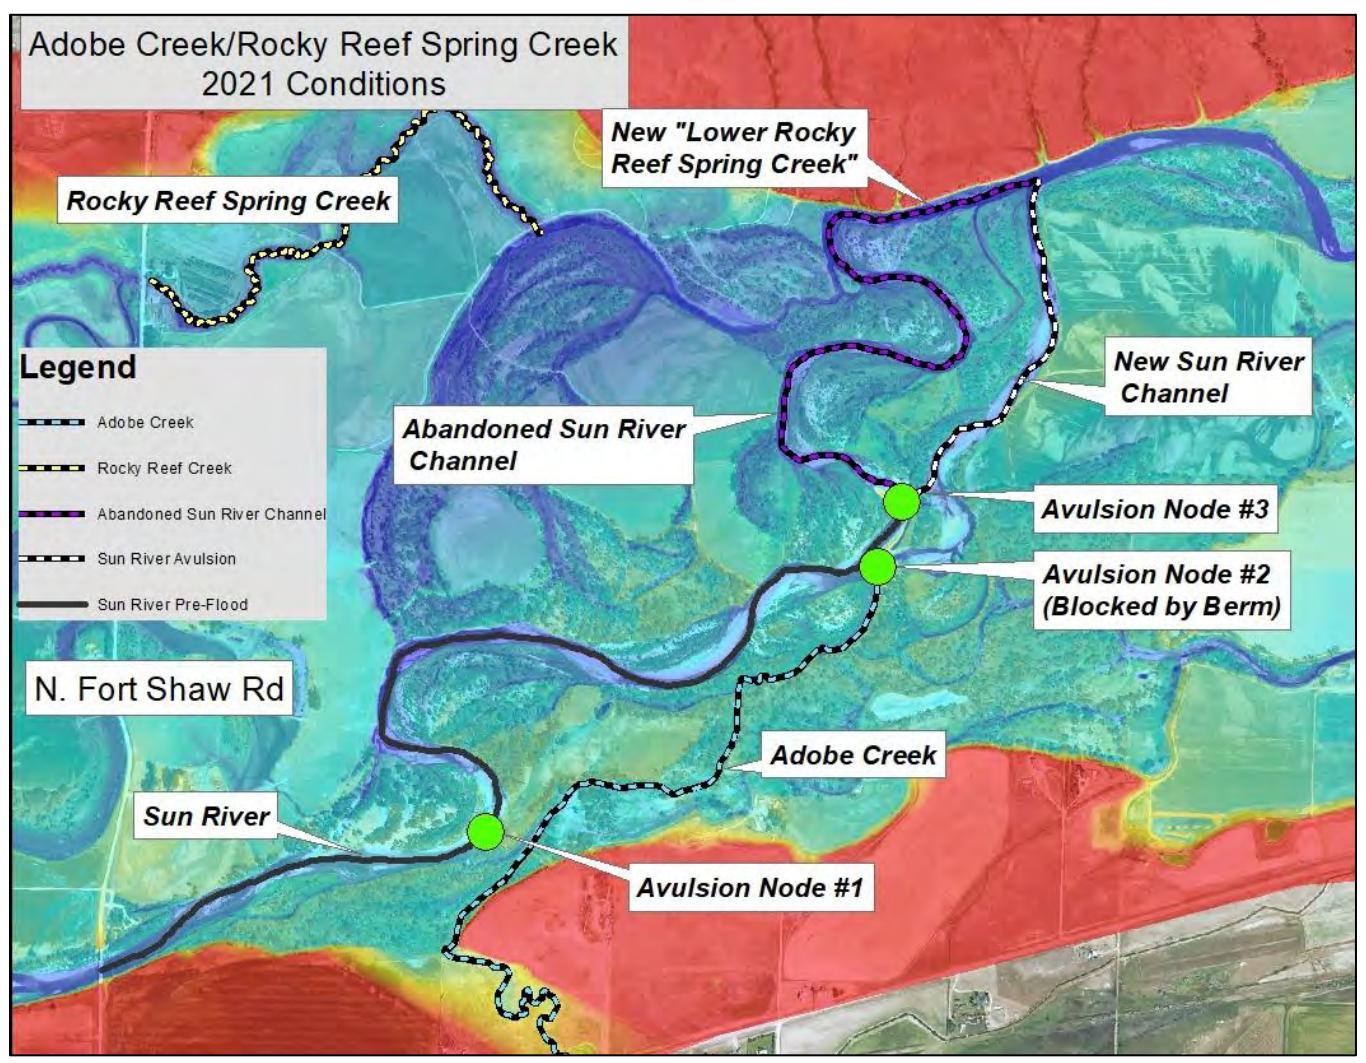
Figure 83 shows a general Relative Elevation Model (REM) map of the area located just downstream of North Fort Shaw Road. In this area, Adobe Creek flows into the Sun River valley from the south. When it enters the valley, it parallels the general trend of the Sun River. Any time a tributary runs parallel to a dynamic, major river, that tributary is prone to capture and enlargement. This process has been ongoing on lower Adobe Creek, as several flow connections between the two have developed in recent years. Most recently, in spring of 2021, a new connection labeled "Avulsion Node #1" in Figure 83 began routing a major portion of Sun River flows into lower Adobe Creek as well as an older Sun River side channel. The river is actively migrating into this channel and will likely cause it to further enlarge and become claimed as a perennial side channel of the Sun River. It could also become the primary thread, as the route down Adobe Creek is currently shorter and steeper than that of the Sun. Downstream, a location marked as "Avulsion Node #2" marks where the Sun River has recaptured an old river channel. This avulsion node was blocked by a gravel berm in 2020. There is another Avulsion Node (#3) just below, that currently contributes flow into the older channel, which, in recent years, has captured the entire Sun River, abandoning the portion shown as a red line in Figure 83. The main issues with these changes are high velocities and intense erosion along the fields that form the right bank of the expanding main thread of the Sun River below Avulsion Node #3.

Figure 83. REM of the Adobe/Rocky Reef Spring Creek area near Fort Shaw showing avulsion path of Sun River (yellow line) and resulting abandoned channel segment that also forms lower end of Rocky Reef Spring Creek (red line).

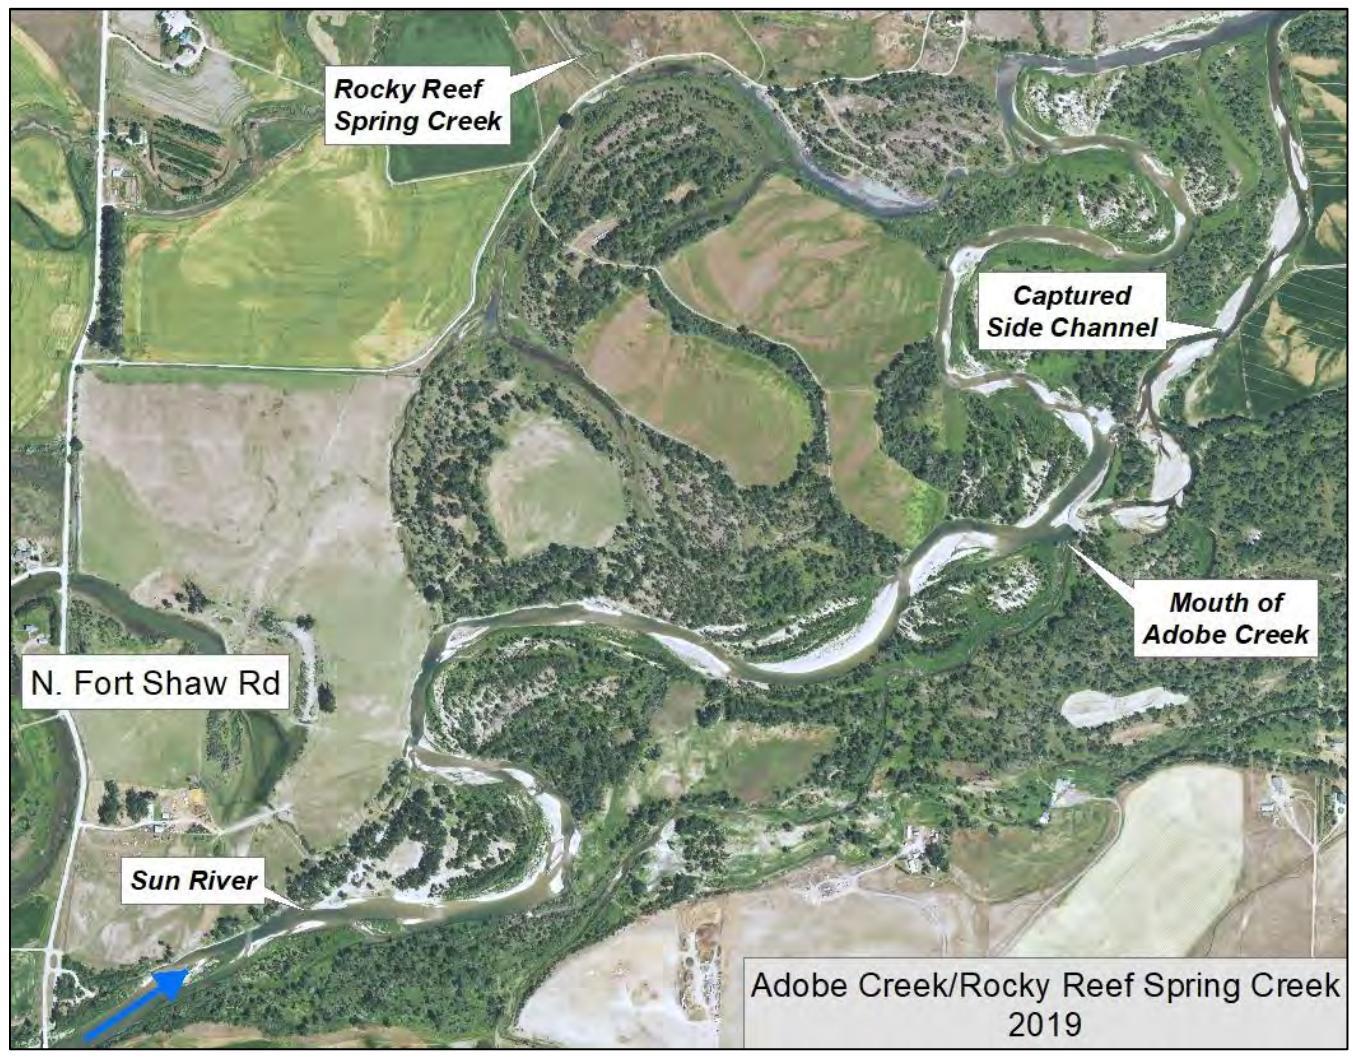
By 2011, the meanders that formed along the straightened segment lengthened enough to come within about 120 feet of breaching through Avulsion Node #3 downstream of the mouth of Adobe Creek (Figure 86). Since then, floods have caused the river to migrate fully into the old avulsion route/side channel. The 2019 image shown in Figure 87 shows the avulsion in process, but by fall of 2020 it had become complete, with low flows heading down the new channel and the old channel that had lengthened so much since the 1950s becoming completely abandoned.

Figure 87. 2019 image of Adobe Creek area showing breach into side channel and creation of large open bars. Note how much shorter side channel route is relative to main thread. The side channel has since captured all flow.

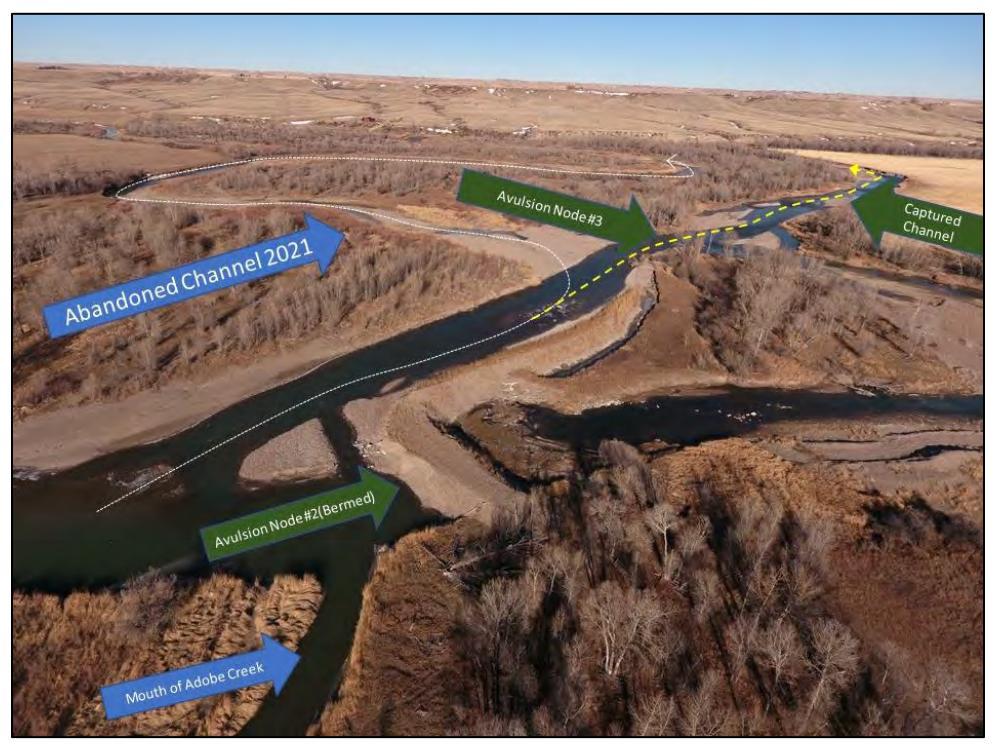
Figure 88 shows the conditions at Avulsion Nodes #2 and #3 in the fall of 2021. The image shows how Avulsion Node #2 was blocked by a gravel berm, but Node #3 is sending all water into the side channel that flows along the farmed fields. The head of the abandoned channel has filled in with sediment, reducing its frequency of activation and thereby sending more flow down into the captured channel.

Figure 88. Drone flight image showing downstream view that captures mouth of Adobe Creek just above Avulsion Node #1 which has been blocked by a berm. Downstream, Avulsion Node #2 has successfully captured the channel to the right and abandoned the long sinuous Sun River channel that persisted until recently. Image captured by Tanner Tompkins, Montana Map Works, December 2020.

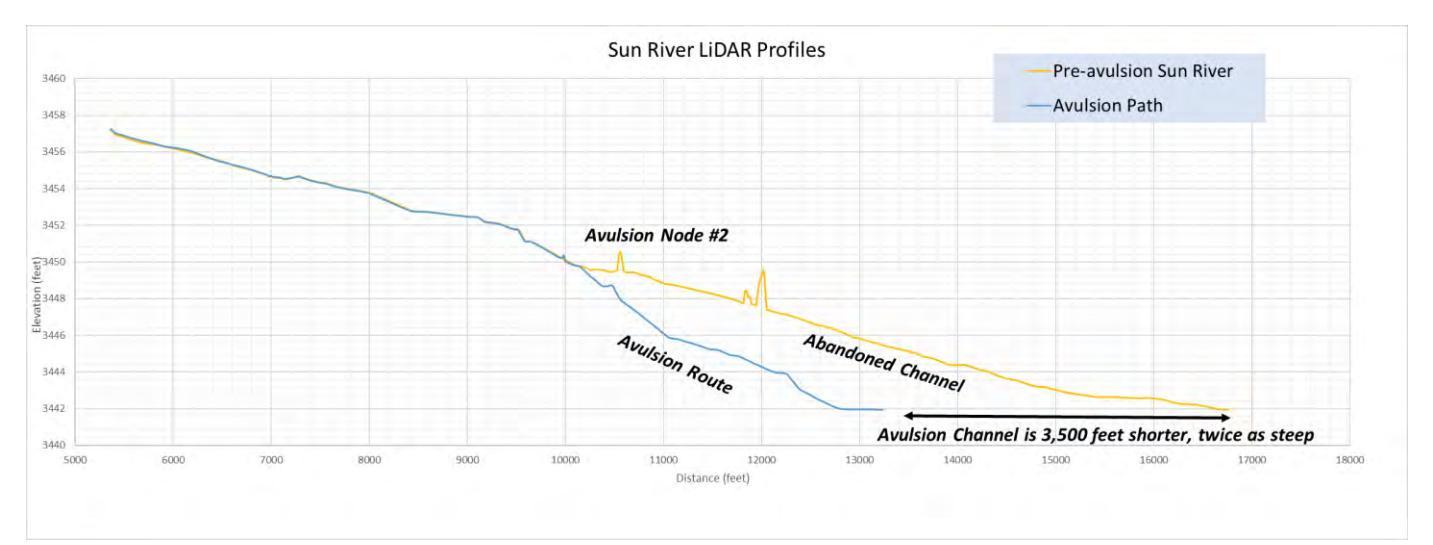
The main issue associated with the avulsion is the rapid geomorphic evolution of the new channel. The new channel is about 3,500 feet shorter than the channel it abandoned, and as a result it is twice as steep (0.29% versus the abandoned channel at 0.14%--Figure 89). The channel carries more flow, it has widened substantially, and right bank erosion has removed most of the woody riparian vegetation as well as a pump site (Figure 90).

Figure 89. LiDAR profiles showing Sun River profiles for recently abandoned segment of Sun River and actively developing avulsion route.

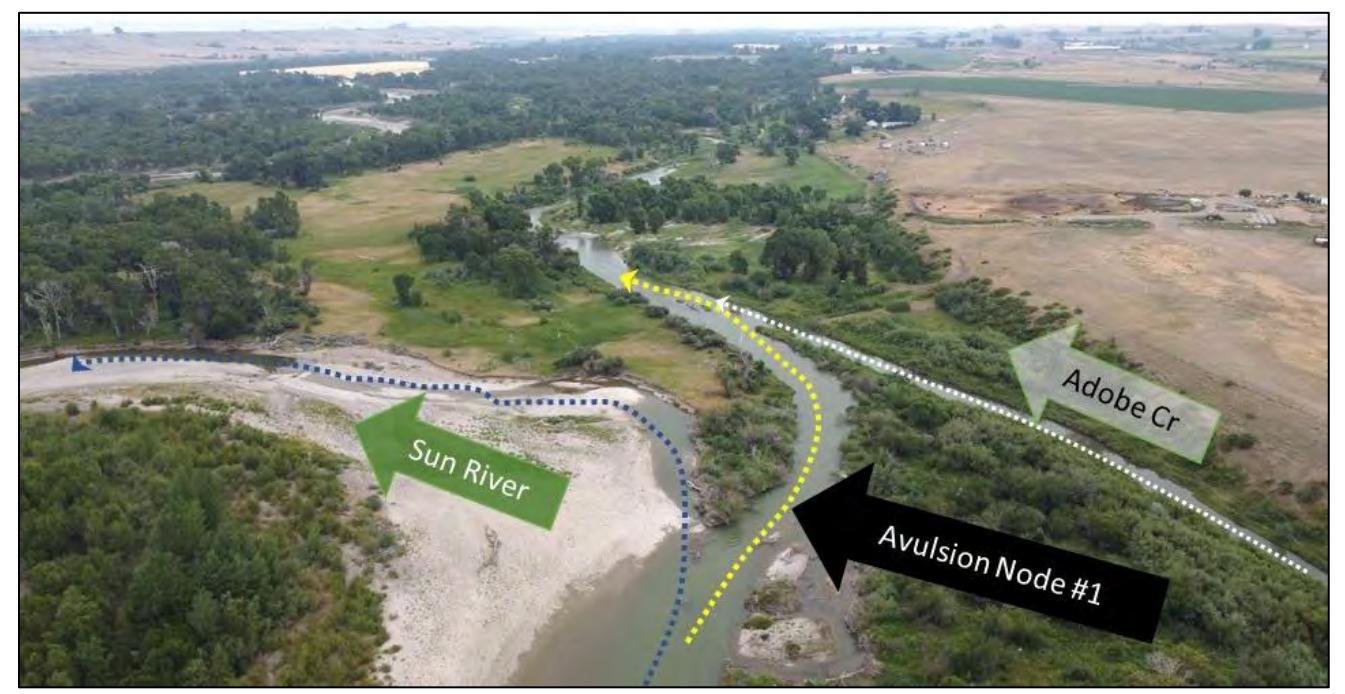
flowing down this portion of Adobe Creek, which if left unchecked will dramatically enlarge Adobe Creek and affect any project implemented downstream (Figure 92).

Figure 92. View downstream showing water flowing from Sun River into Adobe Creek via Avulsion Node #1; note minimal flows in older Sun River Channel (Tanner Tompkins, August 2021).
