August 24, 2021

# Channel Migration Mapping Sun River (Phase 1) Elk Creek (Phase 2)

### **Executive Summary**

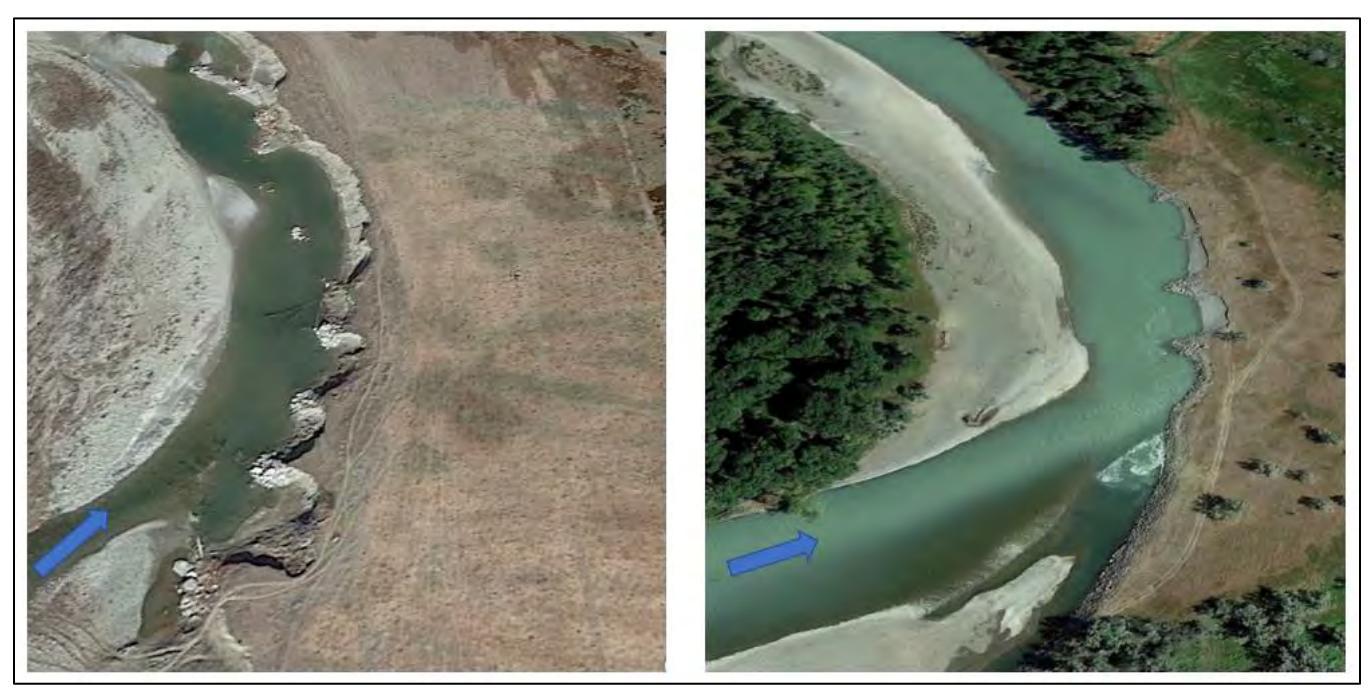
Erosion control professionals may recommend using barbs at this site versus riprap. Barbs can be quite effective, but in our experience, in a dynamic system such as this, they can be especially prone to flanking and scalloping between barbs, which commonly results in the need for riprap between the barbs. This is especially the case where the planform of the river is adjusting such that the angle of attack on the bank can change dramatically with time (Figure 95).

Figure 95. Erosion control barbs on Musselshell River (left) and Yellowstone River (right) showing orientation to flow, and erosion between structures.

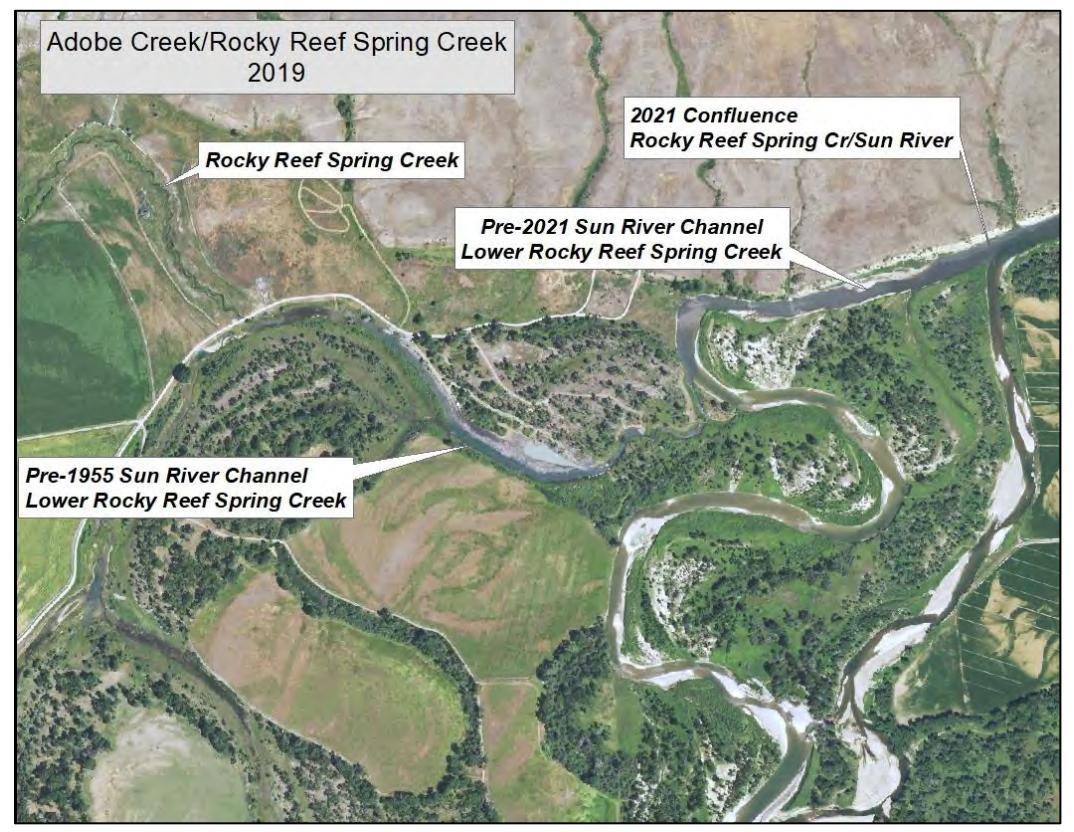
Figure 98. General overview showing Rocky Reef Spring Creek flow path through a small, constructed channel (left), pre-1955 abandoned swale of Sun River (center) and recently abandoned lower Sun River channel. The routing of Rocky Reef Spring Creek through these older swales has increased its length by almost a mile, and the swales are oversized for the creek.

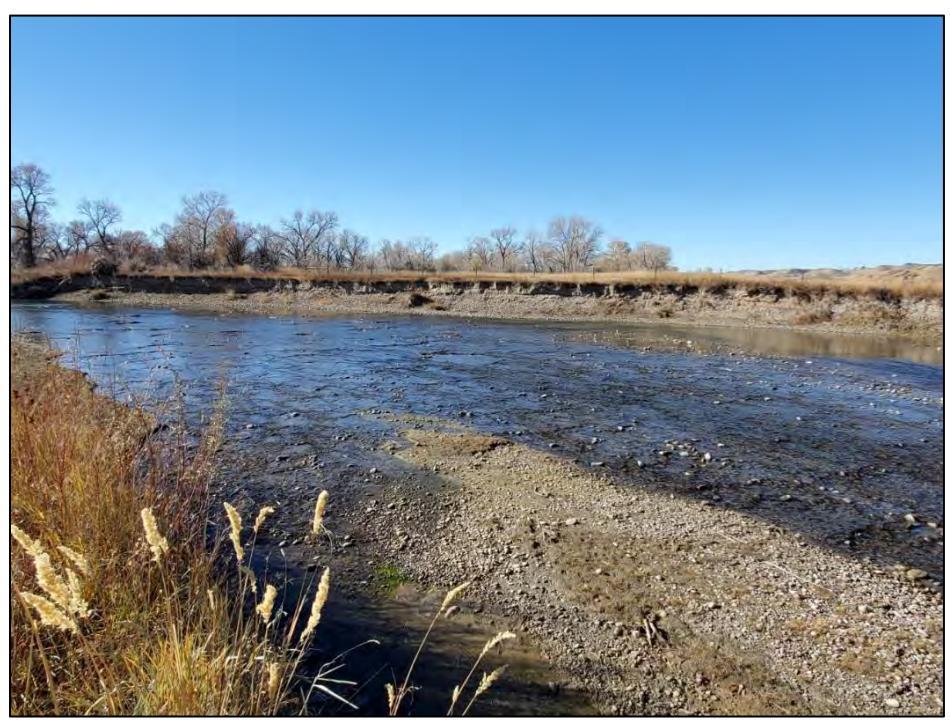
Figure 99. View upstream of shallow Rocky Reef Spring Creek flows in Sun River channel (labeled "pre-2021 Sun River Channel" in Figure 98).
The following concepts have been developed for the lowermost Rocky Reef Spring Creek fish passage barrier:

6.3.3 Alternative 3: Narrow Abandoned Sun River Channel to Provide for Fish Passage As the main issue with lowermost Rocky Reef Spring Creek is that the channel is much too large to maintain water depths amenable to fish passage, one alternative is simply to narrow the channel. This will eventually occur naturally as the channel begins to accumulate fine Sun River sediment during floods, as Rocky Reef Spring Creek will maintain a channel through those sediments, resulting in passive narrowing into a slough. A faster, more active approach to that end game is to either excavate a pilot channel or to construct a floodplain bench in the oversized channel. The excavation of a pilot channel may first appear to be the most cost-effective strategy, but drone imagery shows bedrock reefs in the depth-limited channel that will probably be difficult to work with. Figure 100 shows an example channel narrowing project, where a floodplain bench was constructed to narrow and deepen flows. This is a common approach to restoring over-widened channels, but because of the length of this project, (~2,000 feet) it would require major dirt moving and sod sourcing for the top of bank, making it an expensive option. For example, if the channel were narrowed to a 20 ft top width with a 2.5 ft inset floodplain bankline, it would require about 13,000 cubic yards of fill. In addition to that, the project would likely require bank treatments and floodplain bench sodding/vegetating as shown in Figure 100.

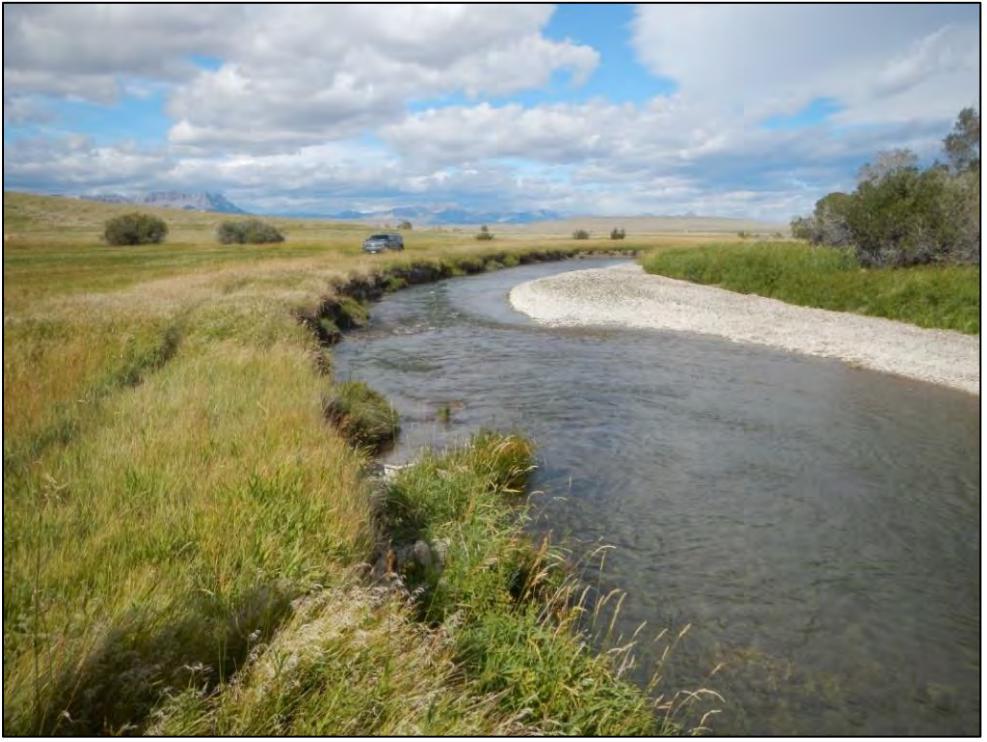
In general, bank erosion tends to be along bendways that have growing point bars that drive opposite bank erosion. Much of the erosion is into cleared hayfields where root reinforcement of the banks is minimal (Figure 115). Several bendways have developed chute channels through their cores, which increases their propensity for cutoff during future floods (Figure 114).

Figure 115. Typical bank erosion into hayfield, Reach EC1.

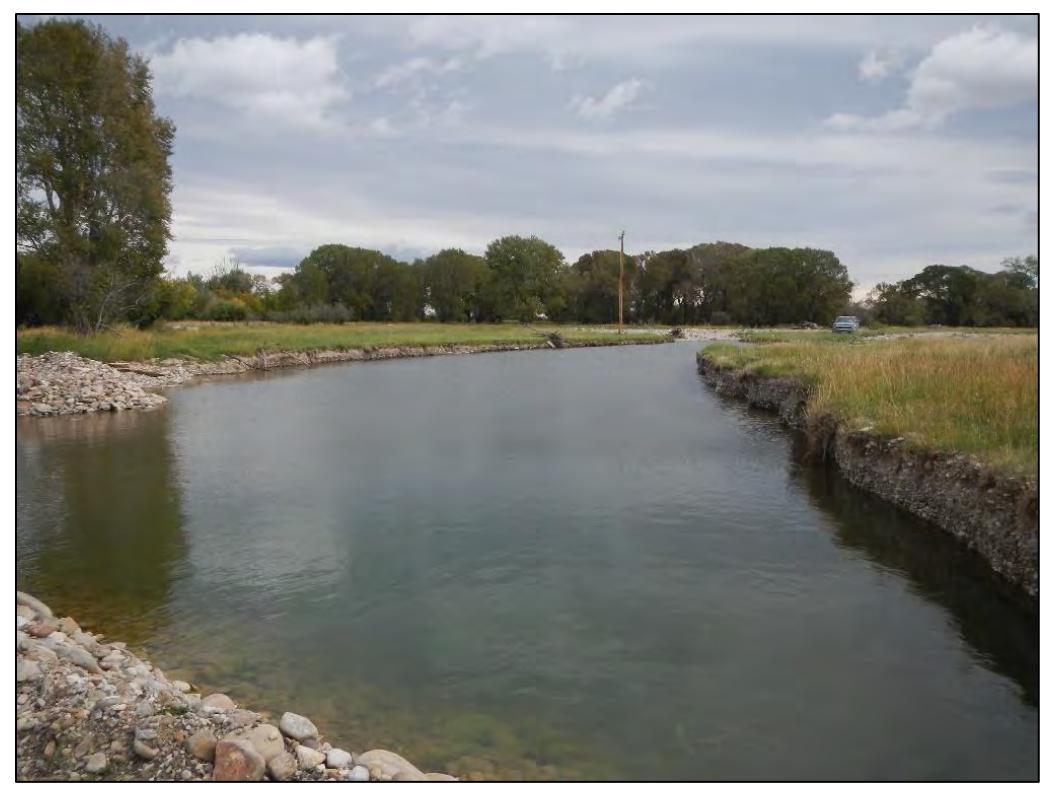
Three avulsions were mapped in this reach, two occurred between 1955 and 1978, and another occurred in 2019 at RM 13.1 on the Converse Ranch (Figure 116). Just below the Highway 435 Bridge an avulsion is underway on a small tight meander bend.

Figure 116. View downstream of 2019 eroded floodplain/erosion path on Converse Ranch at RM 13.1

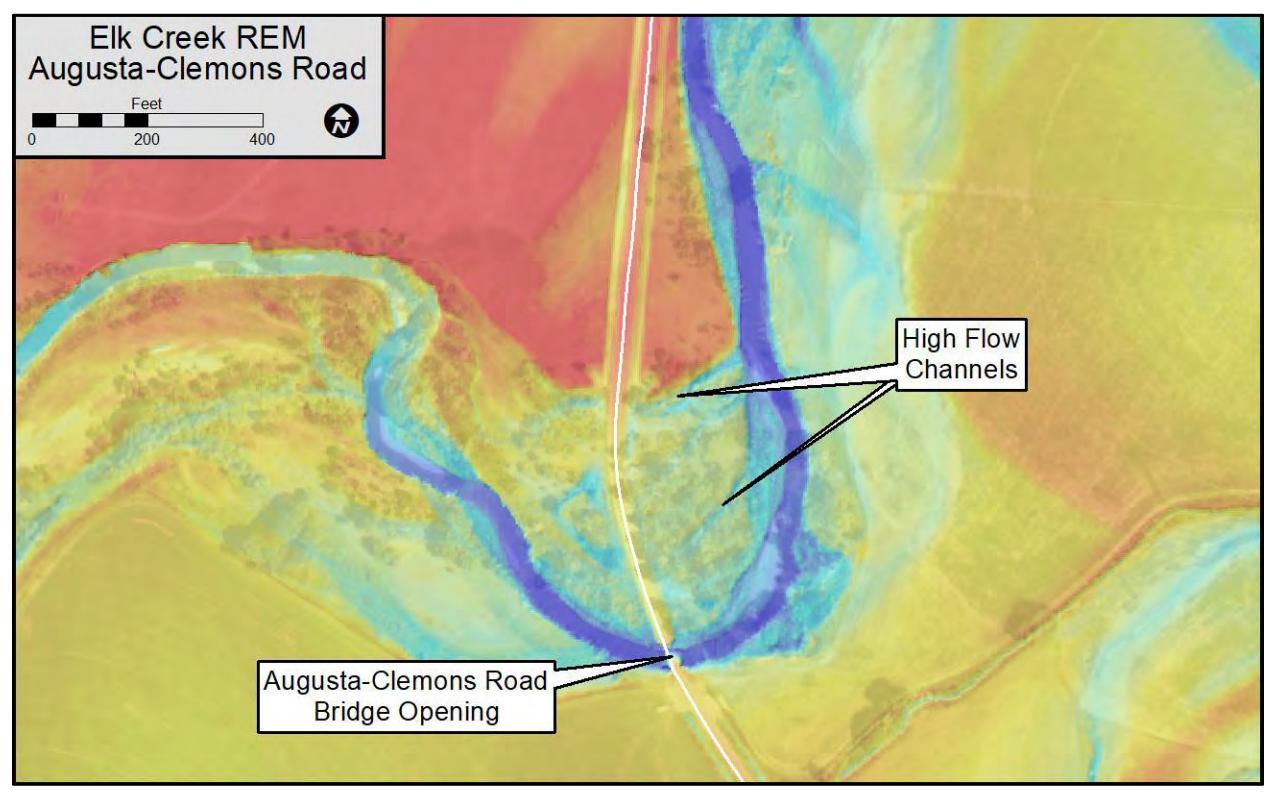
While at a stakeholder outreach meeting in Augusta on April 30, 2021, local landowners in this reach described issues at the Augusta-Clemons Road, which marks the downstream reach boundary. The road crosses the river corridor essentially perpendicularly, and near the creek it blocks several overflow channels that evidently used to have some culvert connectivity (Figure 117). Local landowners feel strongly that the lack of culverts at this

location dramatically worsens flooding in the area. They also felt that additional culverts should be added both north and south of the CMZ boundary on the Augusta Clemons Road to alleviate flooding in Augusta and road washouts.

Figure 117. Relative Elevation Model (REM) map the Augusta Clemons Road Bridge crossing, showing floodplain confinement and blocking of high flow channels in meander core.

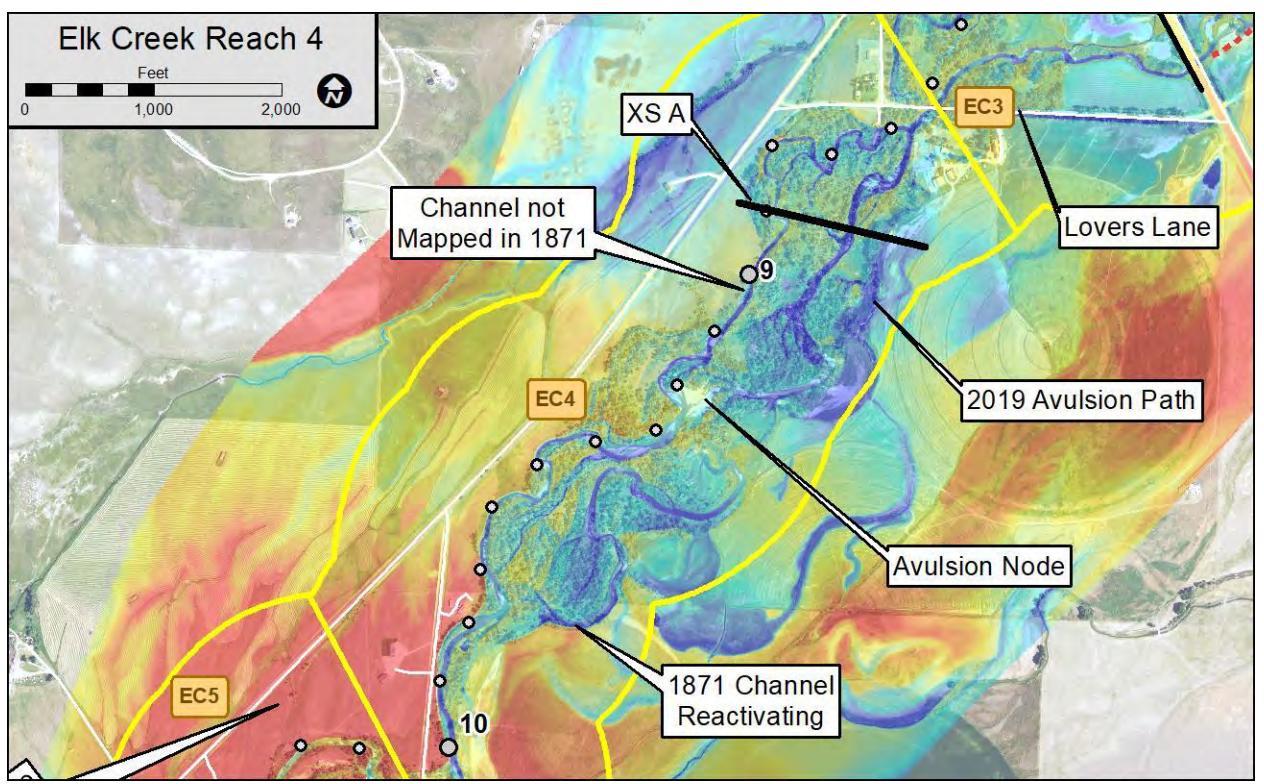
A major flow split at RM 9.3 marks a significant avulsion node in Reach EC4 (labeled "avulsion node" in Figure 118). This is a complex area where avulsions appear to be a dominant geomorphic process, and this condition carries on downstream past Augusta. The node marks a split between two major channels; the left channel ultimately feeds a diversion, and the right channel flows through a narrow thread that has some old riprap and levees on its banks (Figure 119).

Figure 118. Relative Elevation Model (REM) map for Reach EC4; blue shows areas of relatively low ground whereas red depicts higher surfaces. Cross Section A plot is shown in Figure 121.

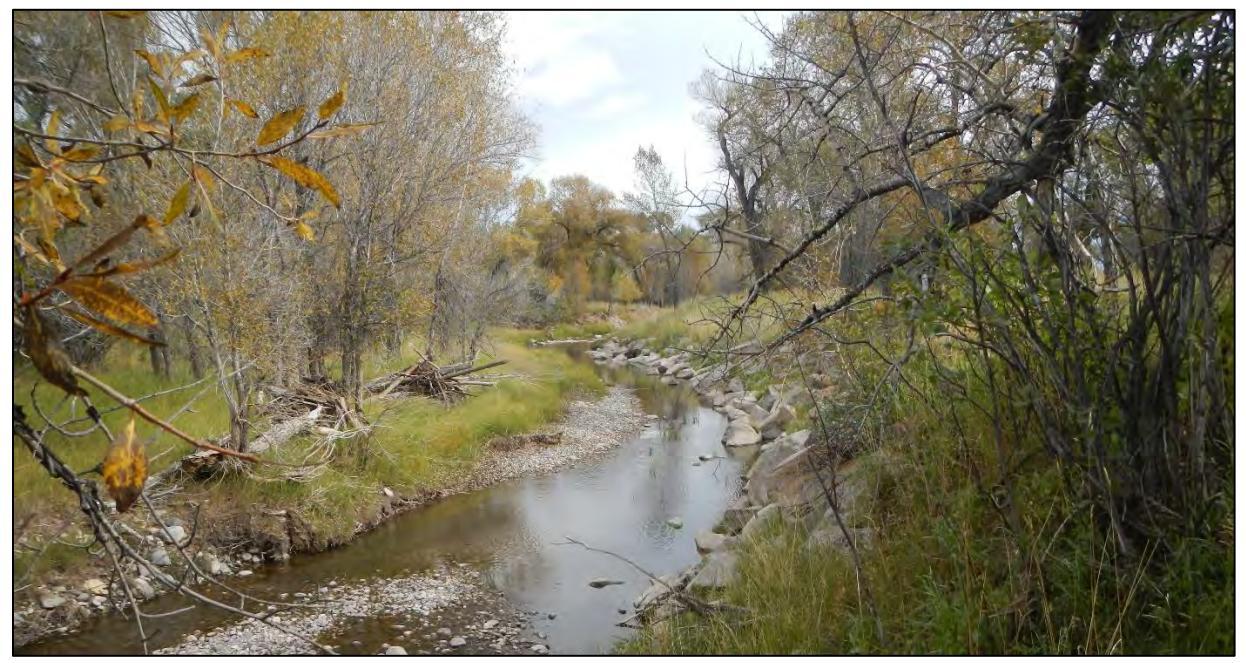
Figure 119. View downstream showing riprapped banks in Reach EC4 avulsion channel (right channel).

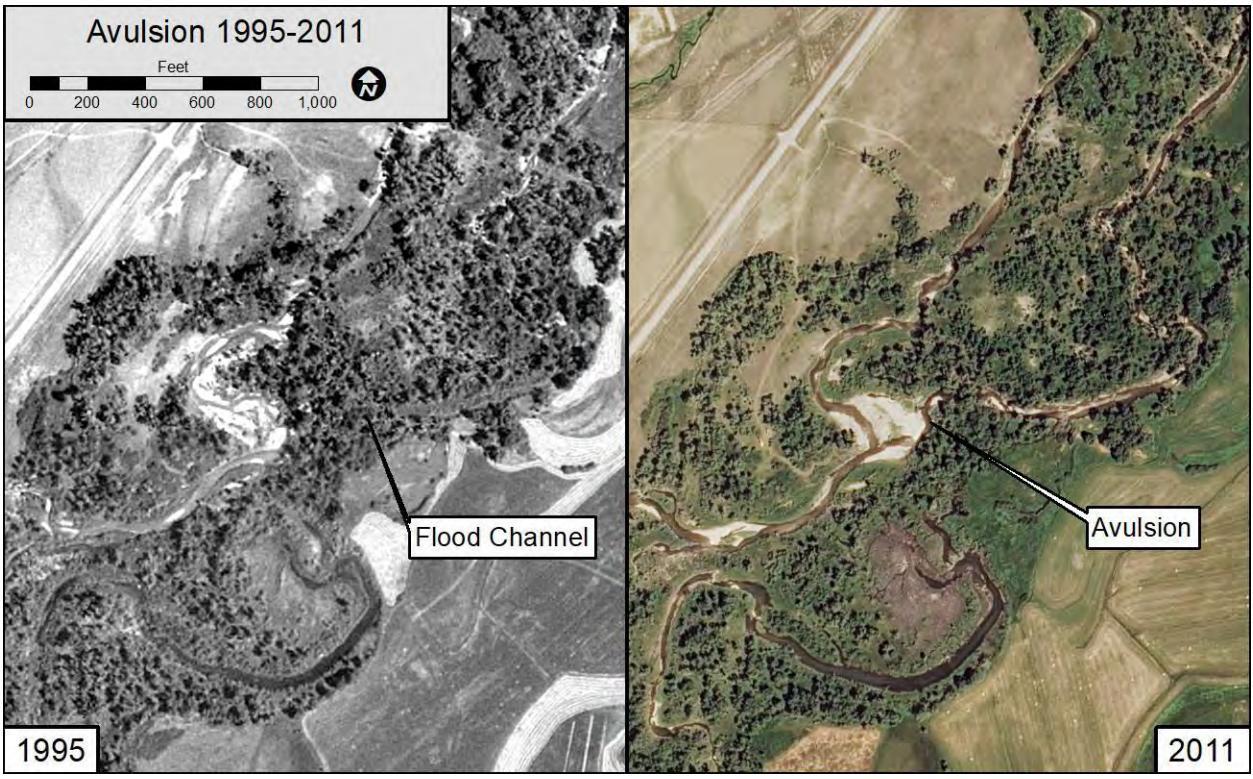
Figure 120. Photos from 1995 (left) and 2011 (right) showing avulsion into high flow channel remnant.

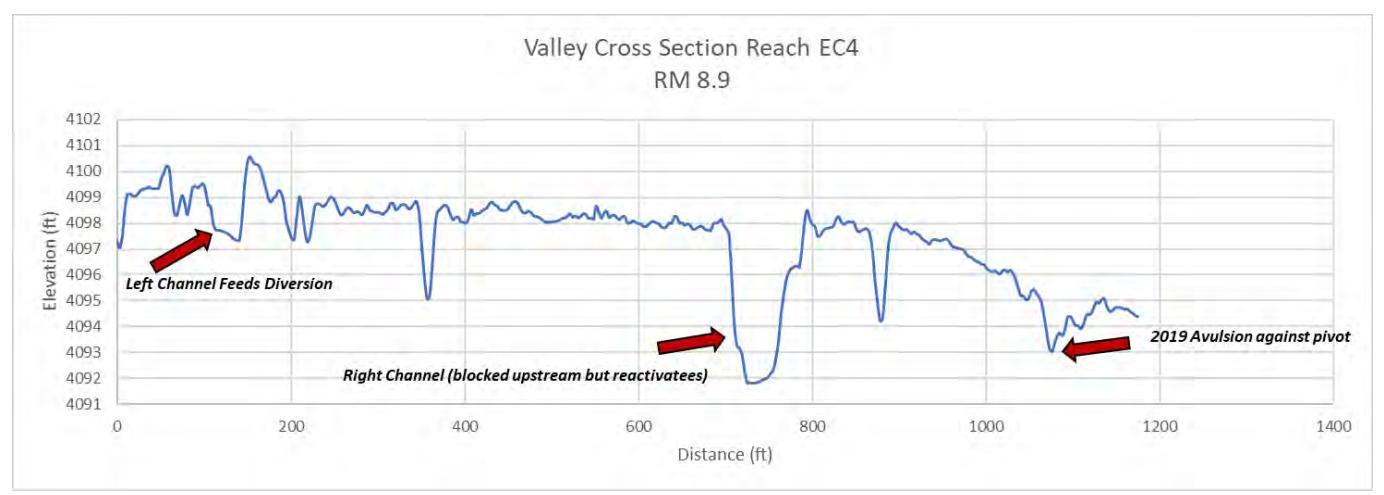
This history suggests that the left channel, which was not even there in 1871, may have been a ditch that was captured by the creek sometime prior to 1955. Since then, the flow split has been a problem as the creek appears to find preferential flow paths in the right channel. LiDAR data indicate that the left channel is perched about five feet above the right channel, which would support the tendency for flow to preferentially occupy the lower right channel.

Figure 121. View downstream of Cross Section A labeled in Figure 118 showing perching of left channel over right channel and 2019 avulsion path.

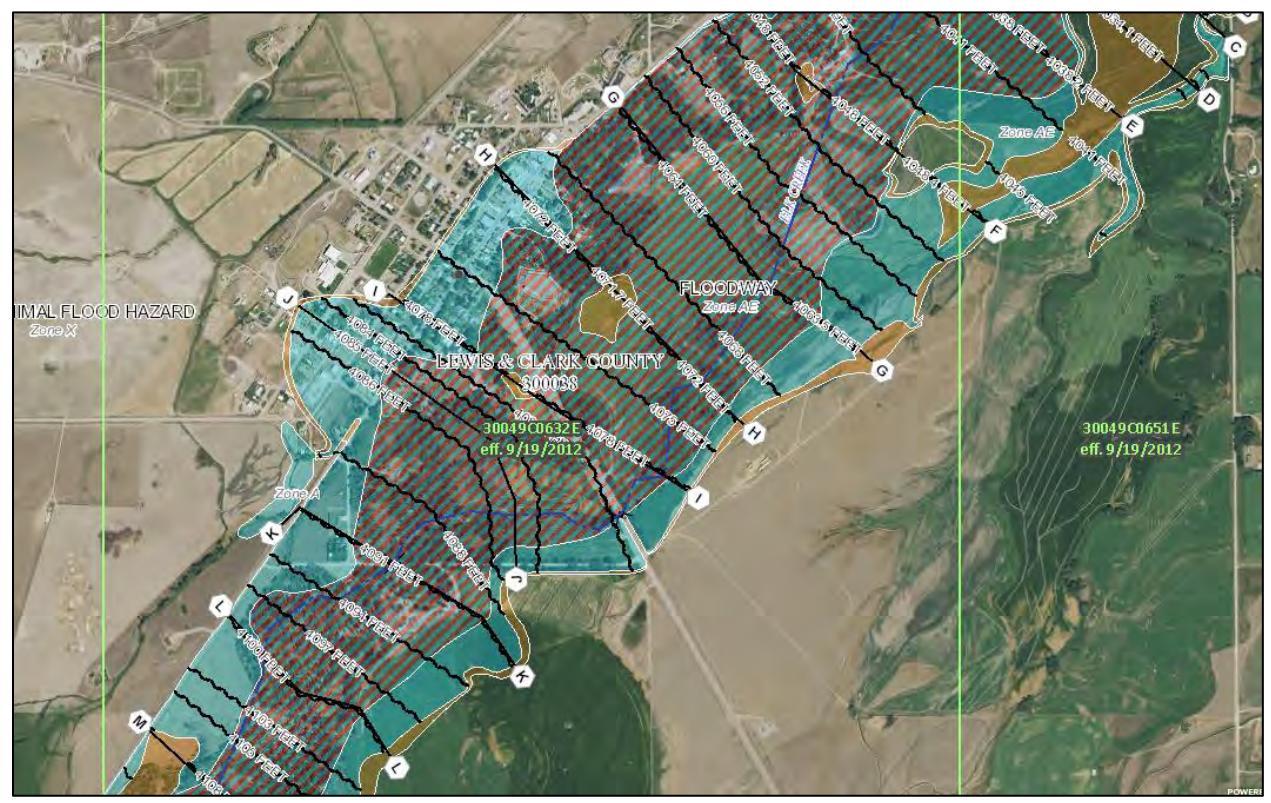
This reach is complicated by split flow, perched channels, avulsions, and a history of manipulation. Recent flood mapping of the area shows that much of the stream corridor is located within the mapped floodway (Figure 123).

Figure 123. FEMA flood map showing much of Reach E3 as floodway (cross-hatched).

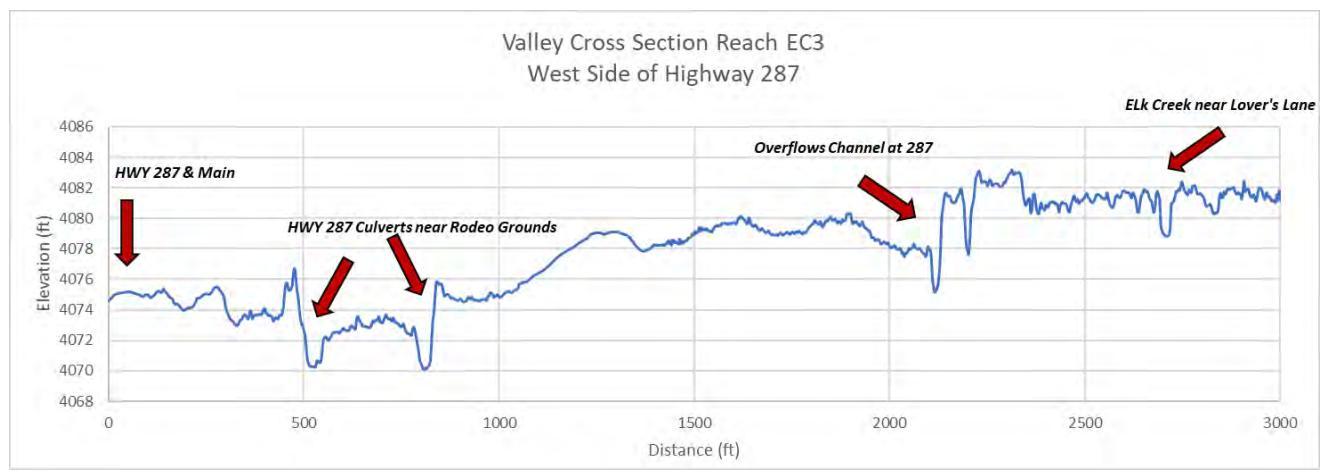
The tendency for water to flow northward across the Elk Creek floodplain towards Augusta reflects the fact that the floodplain slopes in that direction. At the 287 bridge, for example, a cross section extracted from the LiDAR data shows that the channels that flow through two culverts just west of the rodeo grounds are about 10 feet lower than Elk Creek where it crosses 287 about a half-mile south (Figure 124). The General Land Office Survey map shows that, at that time, the channel close to town was the main thread (Figure 125).

Figure 124. View downstream showing cross section pulled from just upstream of Highway 287; note lowest channels near rodeo grounds and perched modern Elk Creek near Lover's Lane.

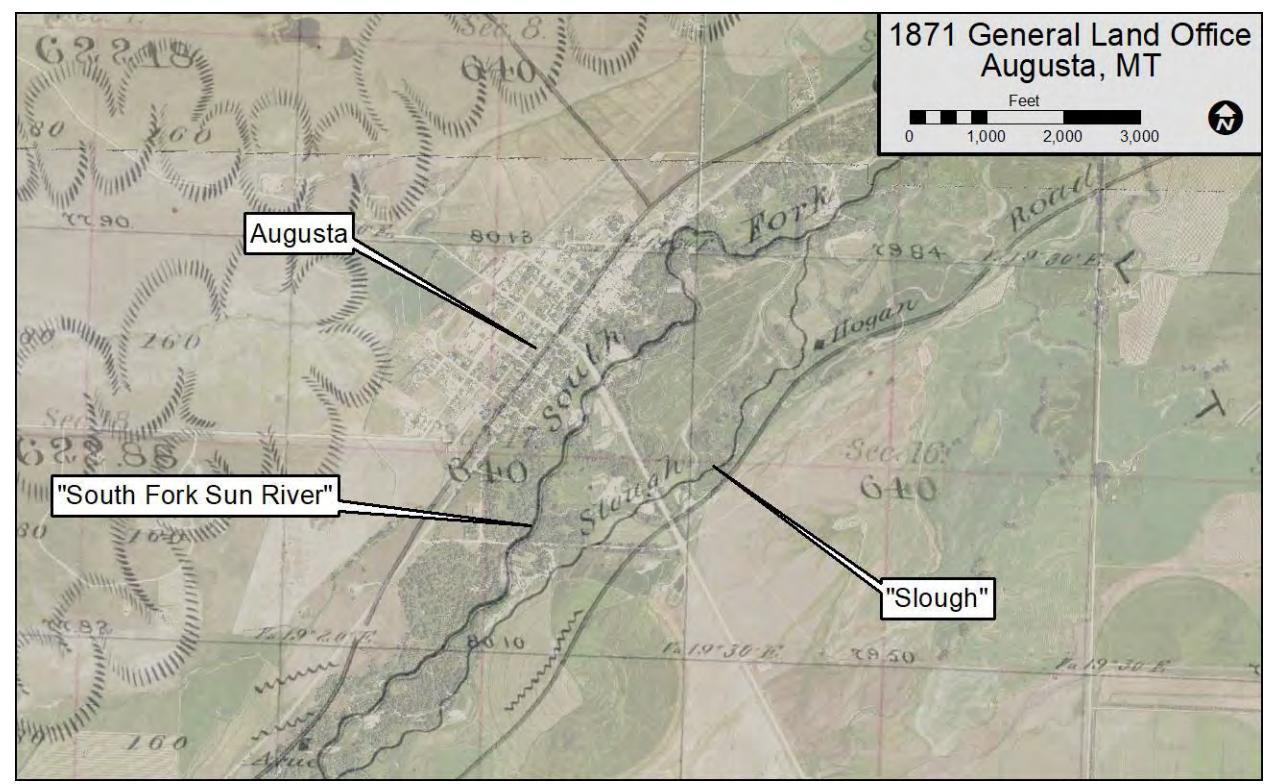
Figure 125. 1871 General Land Office Survey map showing main thread of Elk Creek ("South Fork of Sun River") flowing through what is now referred to as the Overflow Channel near Augusta, and modern Elk Creek following what was described as a slough in 1871.

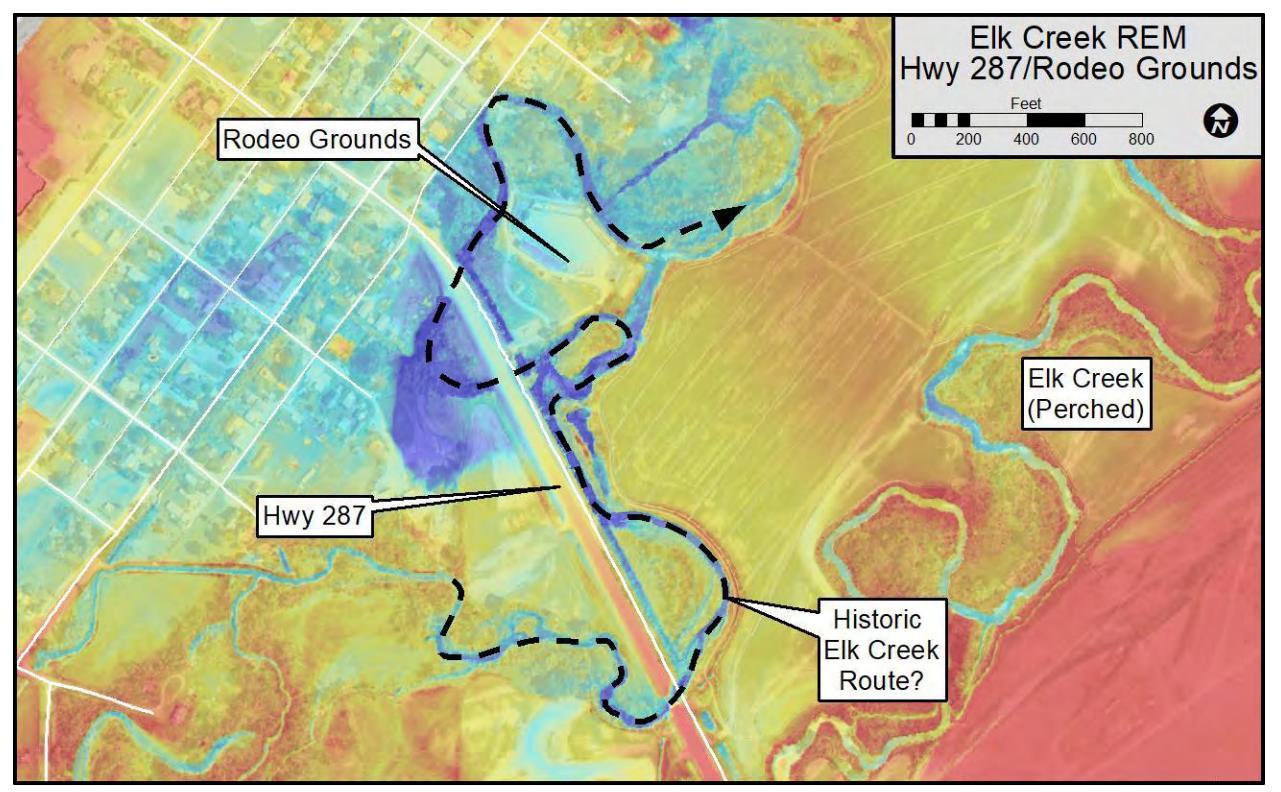
The Relative Elevation Model clearly shows historic channel routes in this area. It appears that when Highway 287 was built, it crossed Elk Creek channels several times (Figure 126), including three crossings over what is now referred to as the "overflow channel". In several locations the creek was channelized to re-route flows. Just southwest of the Rodeo Grounds, the two culverts appear to follow the path of an older channel that are the lowest in elevation along 287. The route shown in Figure 126 shows how those channels may be the lowest, as

Figure 126. Potential historic route of Elk Creek that would explain why the lowest channels at Highway 287 are located at the blue arrows near rodeo grounds.

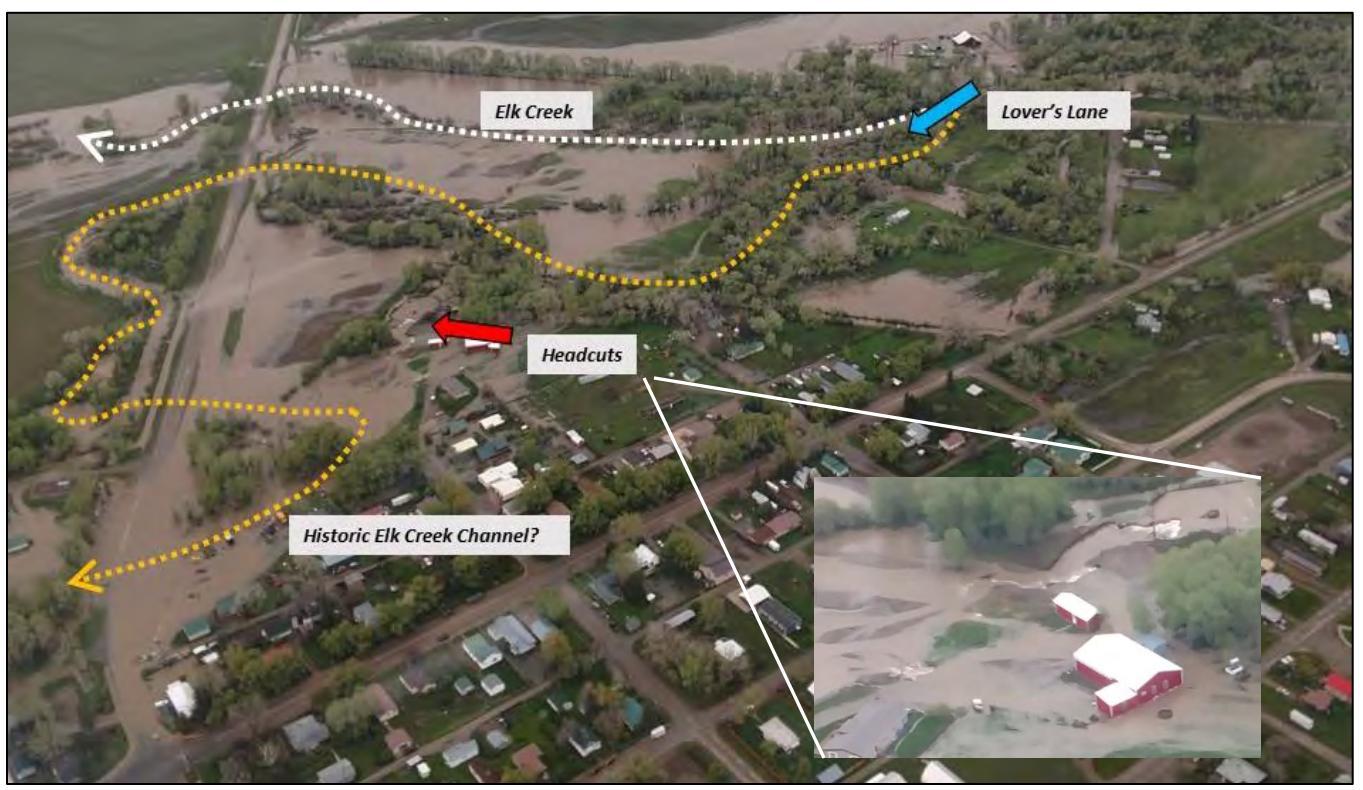
Figure 127. 2019 flood photo taken by Scott Gasvoda showing potential historic flow path of Elk Creek.

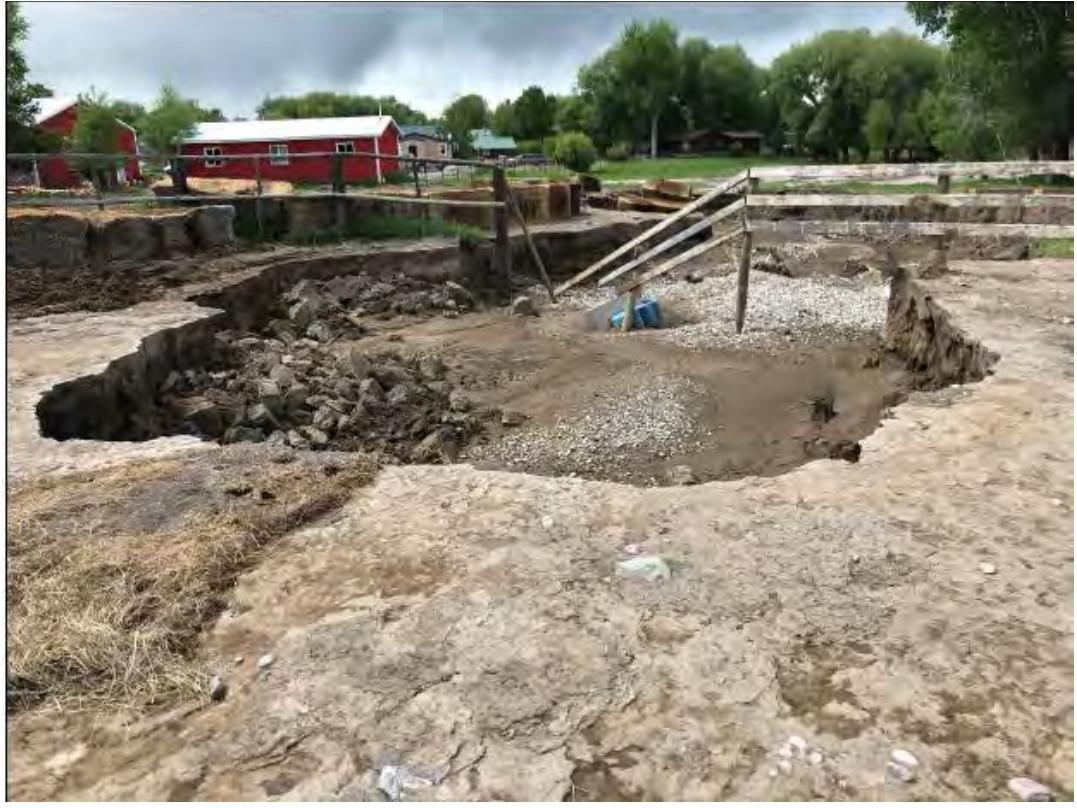
they were the furthest downstream when the road was built, hence they are lower. Currently overflows tend to be drawn towards these two culverts near the Rodeo Grounds; in 2019 major headcuts developed due south (upstream) of the two culverts (Figure 127 and Figure 128).

Figure 128. Headcut formed during the 2019 property upstream of Highway 287 (Confluence, 2019).

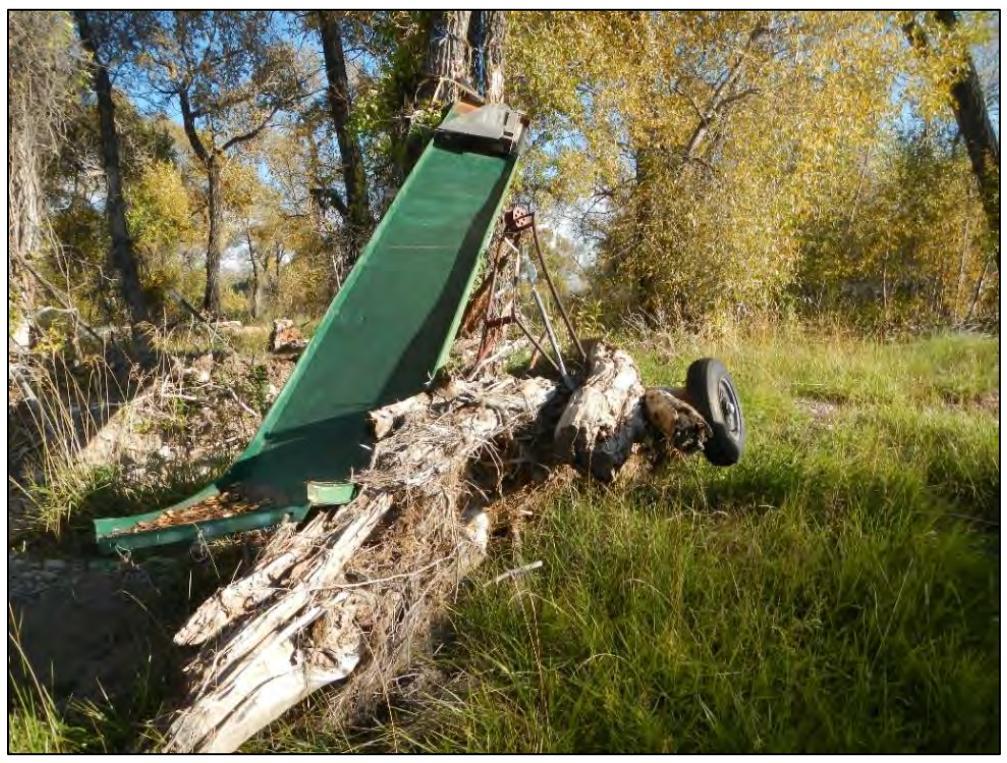
This reach fared well during recent flooding, although high water marks record several feet of floodplain inundation (Figure 130) and some erosion against hayfields (Figure 131). Overall, however, the flood rejuvenated riparian and aquatic habitats without causing extensive damage (Figure 132 and Figure 133). The presence of a robust riparian corridor in this reach may be contributing to its flood resilience.

Figure 130. Racked flood debris on Elk Creek floodplain, Reach EC2.

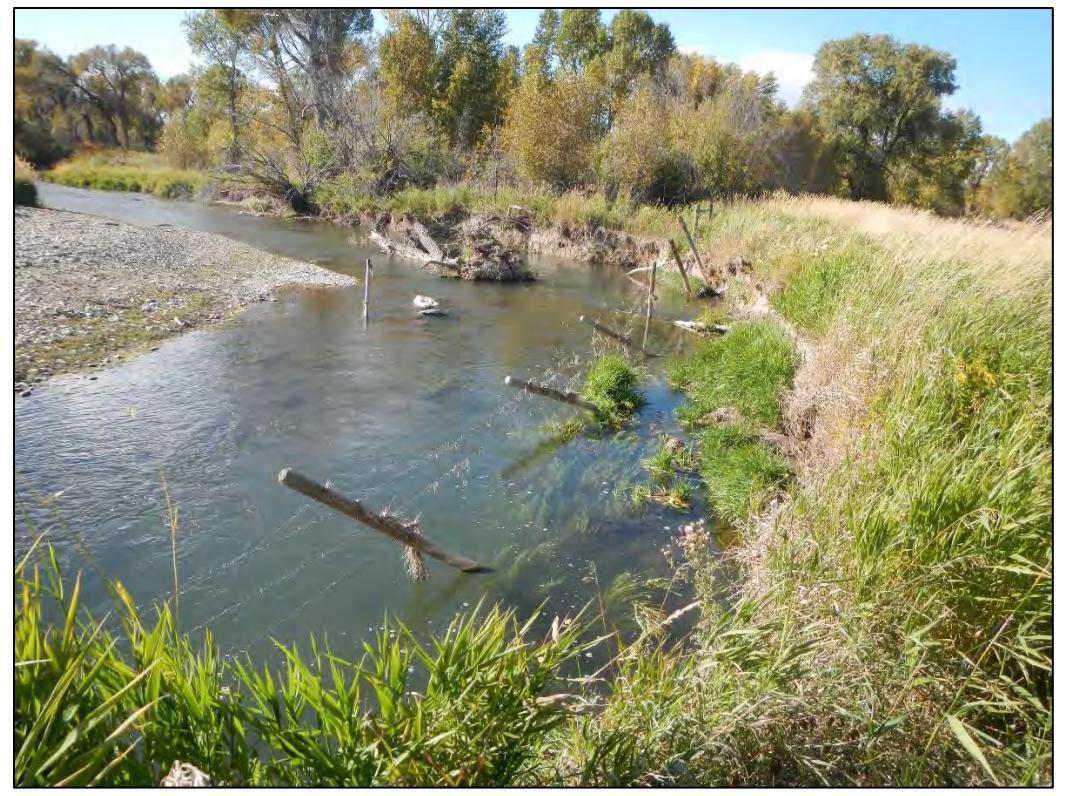
Figure 131. View downstream of right bank erosion against hayfield, Reach EC2.

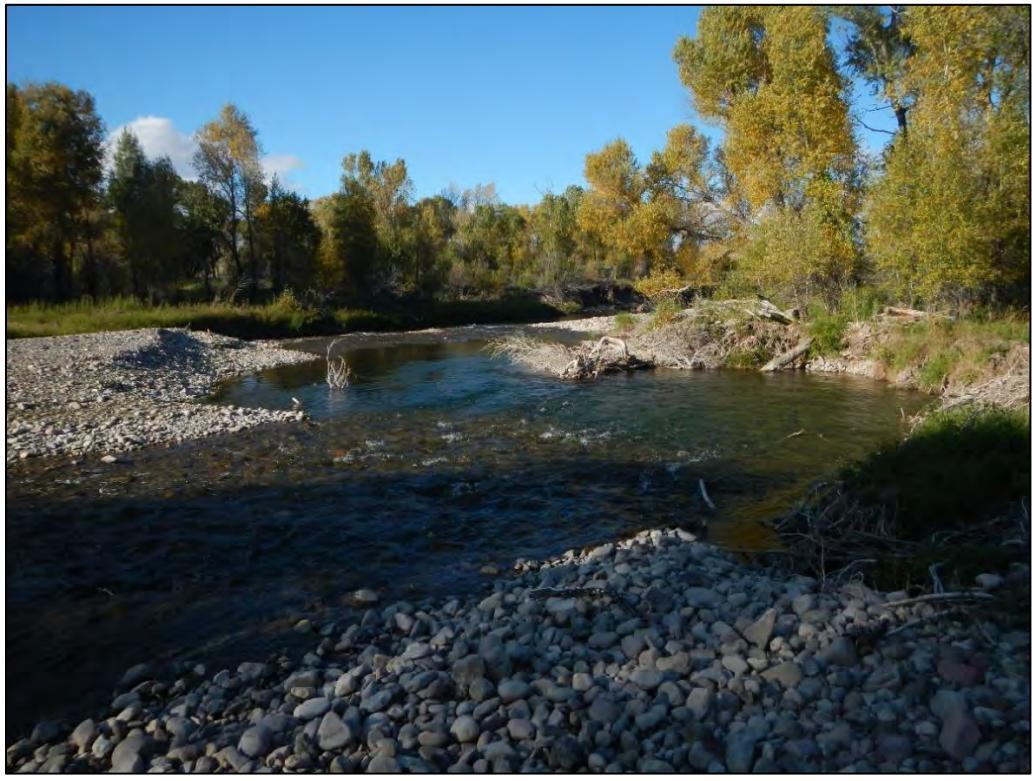
Figure 132. View downstream showing coarse bedload and post-flood habitat complexity common in Reach EC2, 2020.

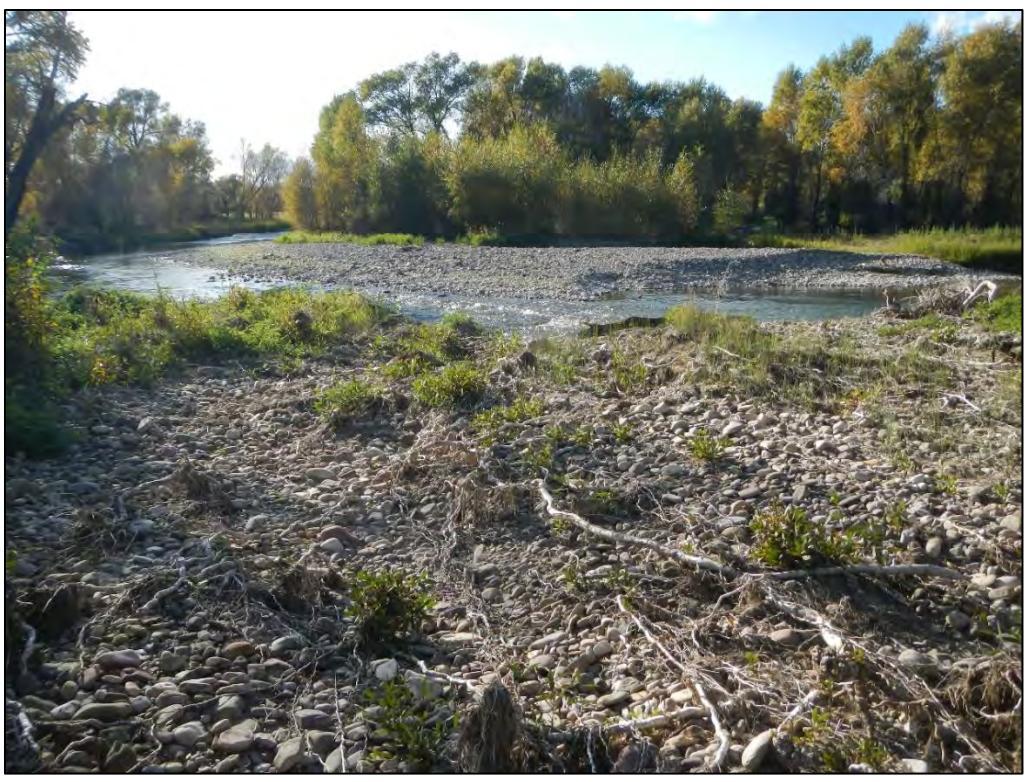
Figure 133. Exposed cottonwood roots currently sprouting in failed avulsion path, Reach EC2. Note young cottonwood establishment on point bar in center background.

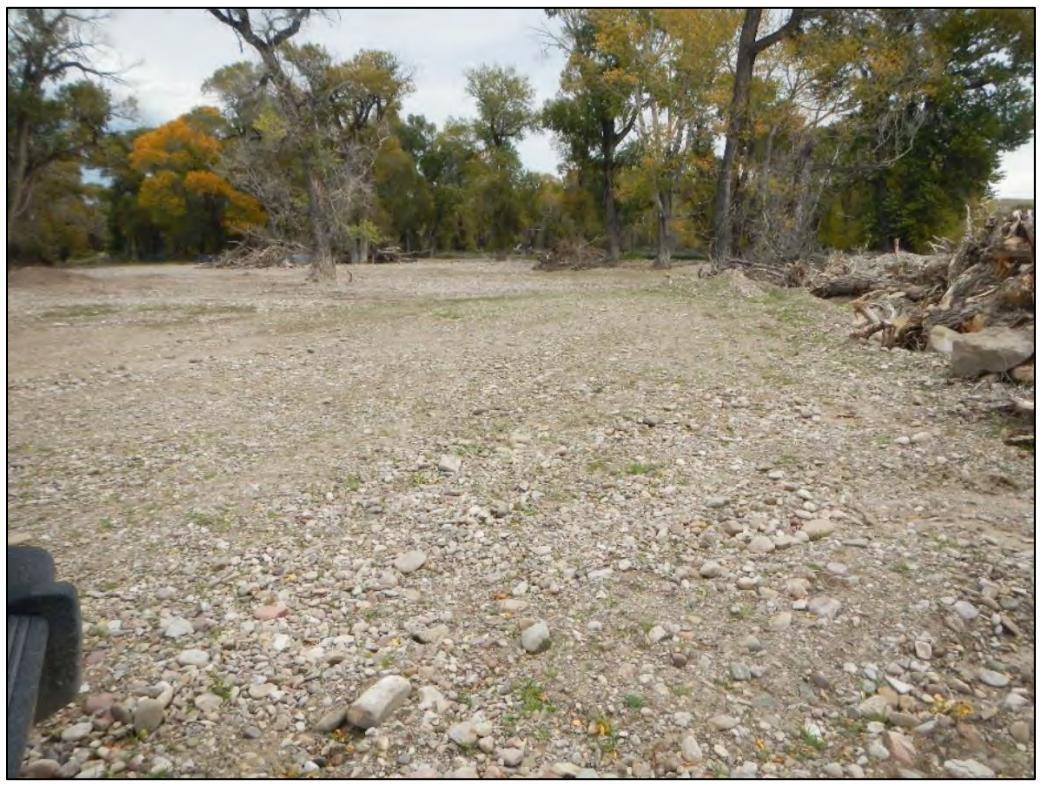
Figure 136. View downstream of flood channel reactivation route.

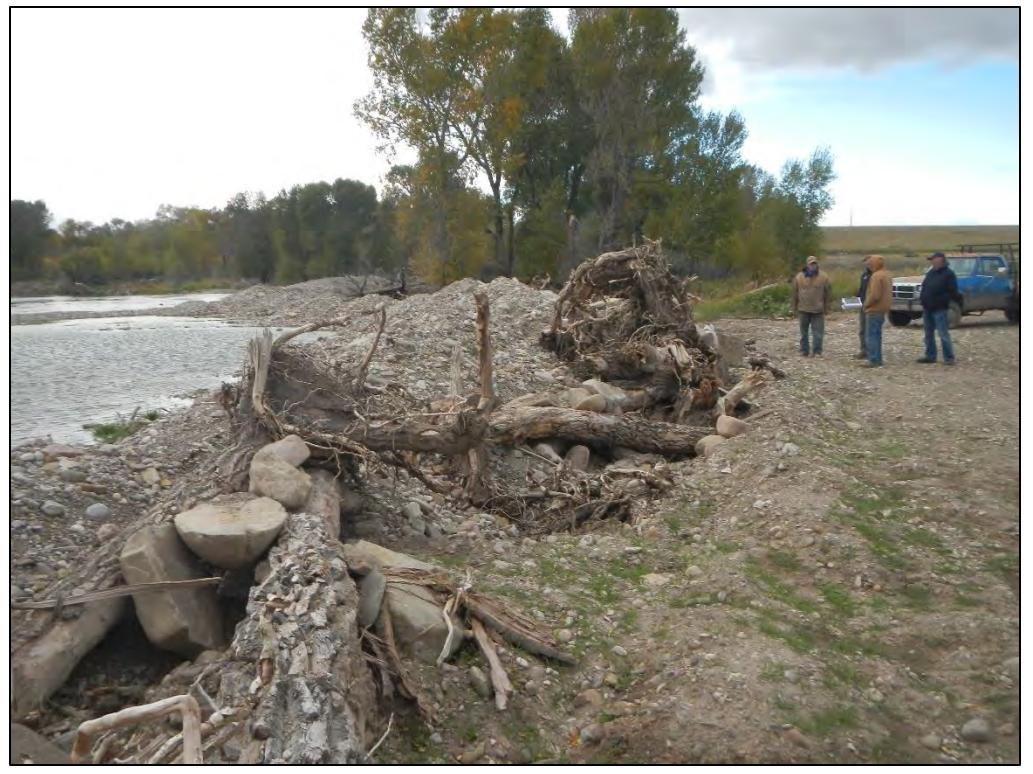
Figure 137. View upstream of berm constructed to block reactivation route.
