August 24, 2021

# Channel Migration Mapping Sun River (Phase 1) Elk Creek (Phase 2)

### **Executive Summary**

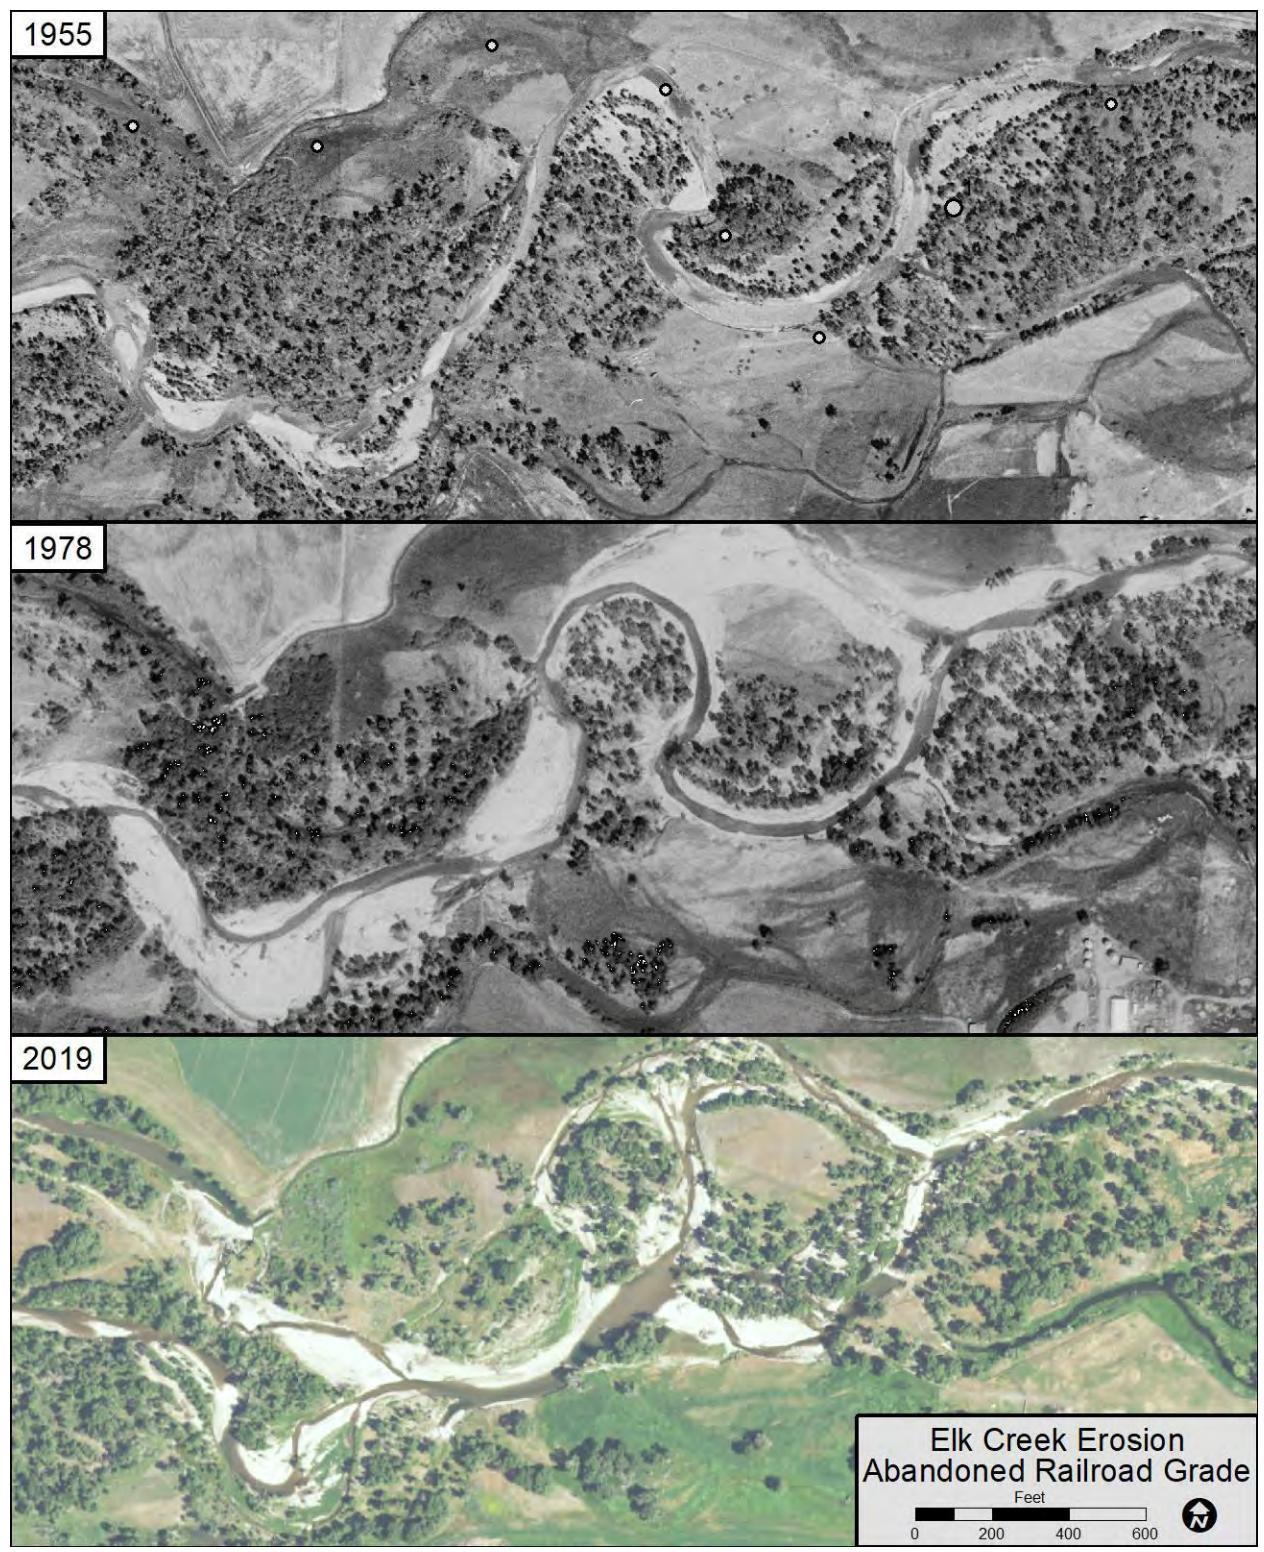
Figure 138. Time series from RM 1.0 showing dramatic changes in Elk Creek since 1955.

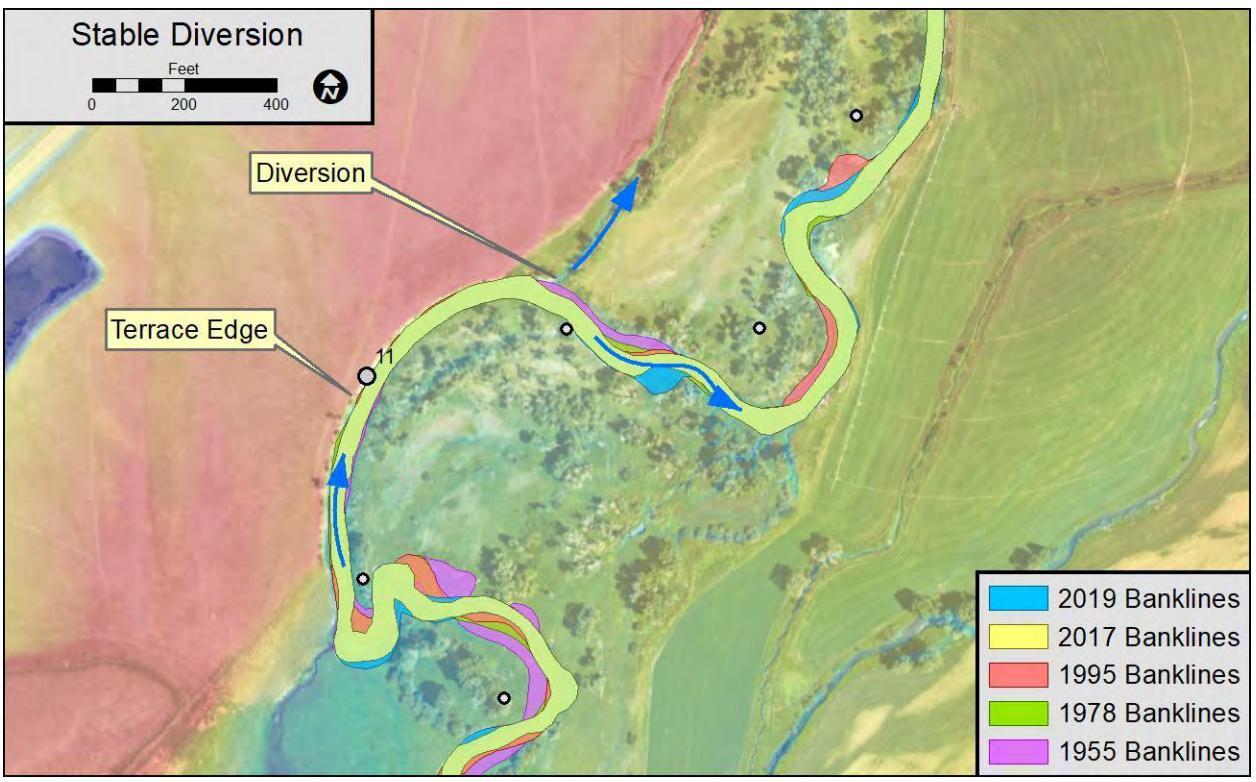
Irrigation infrastructure can be challenging to maintain on dynamic channels where diversion dams, headgates, or pumping systems are in fixed locations. Avulsions can completely bypass diversions, and there is some concern that will happen with the active avulsion occurring on Adobe Creek on the Sun River. In general, however, many diversion structures on these streams are well-placed and well-functioning. Structures that are placed on the downstream limbs of bendways that show low rates of movement tend to perform best. Figure 141 and Figure 142 show an example of such a diversion on Elk Creek—it diverts water on downstream limb of a bendway that follows terrace margin that is relatively erosion-resistant. This diversion also has a rock drop structure that survived the 2018/2019 flooding intact, while effectively diverting flows.

Figure 141. Stable diversion location on Elk Creek, RM 11.

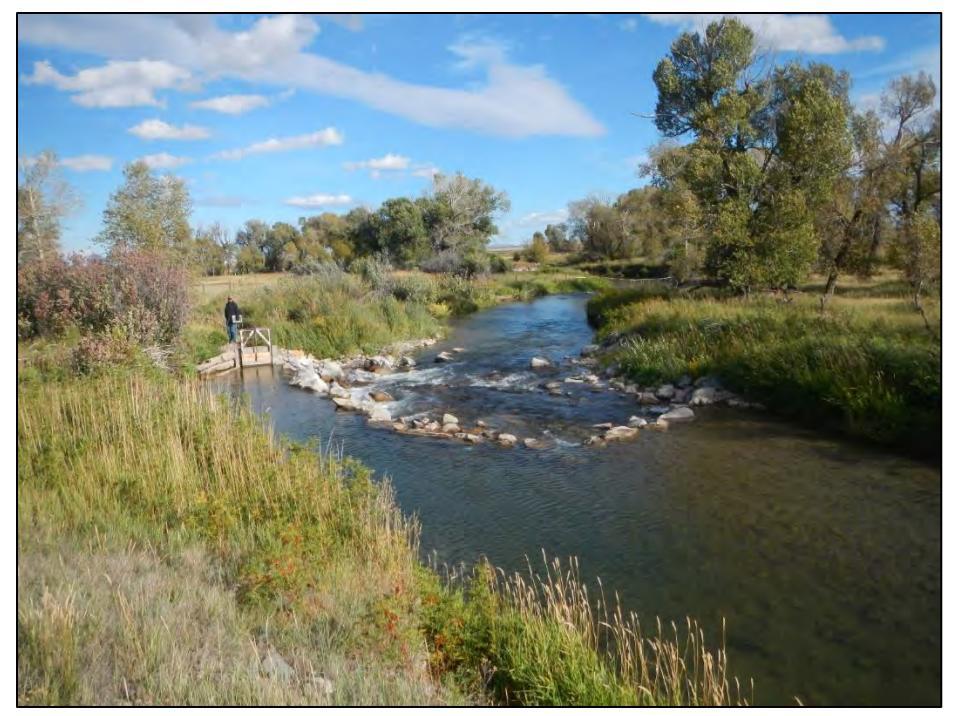
Figure 142. View downstream from left bank terrace of stable diversion structure, Elk Creek RM 11.
## 8.5 Development Pressures

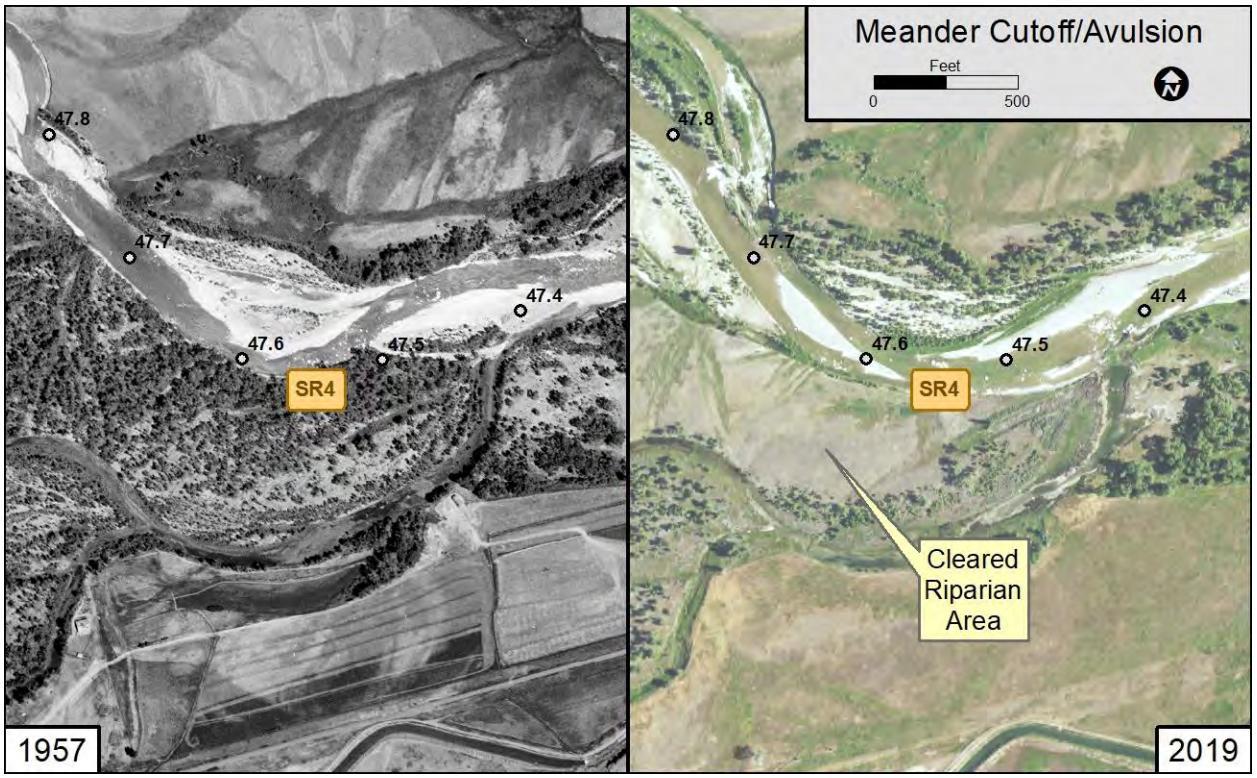
The CMZ mapping has revealed some riparian degradation on the Sun River. The cause of this degradation is probably active clearing to improve agricultural lands (Figure 143). However, the continued persistence of a robust riparian corridor on segments of the Sun River indicates that riparian restoration could be an effective means of improving floodplain/bankline resilience, and possibly reducing bank migration rates.

Figure 143. Riparian clearing on Sun River floodplain between 1957 (left) and 2019) right, Reach SR4.
