## PRELIMINARY DESIGN MEMORANDUM

**TO:** Tracy Wendt, Sun River Watershed Group  
**FROM:** Tom Coleman, P.E., Karin Boyd, Tony Thatcher, Robert Sain  
**DATE:** December 10, 2021  
**SUBJECT:** Muddy Creek – **Preliminary** Design Documentation

SUN RIVER WATERSHED GROUP  
MUDDY CREEK RESTORATION DEMONSTRATION PROJECT

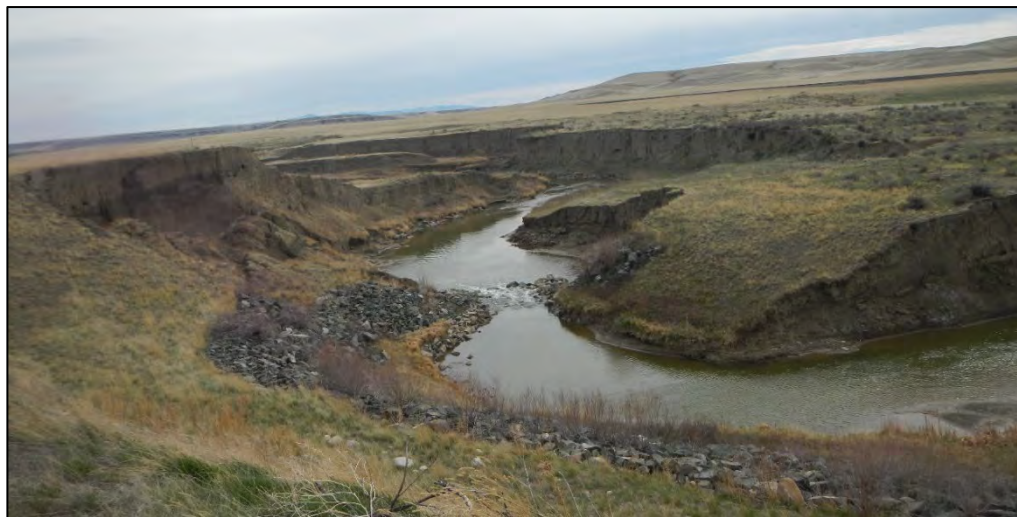
Photo 1, April 29, 2021. View downstream showing Muddy Creek drop structure within incised channel.

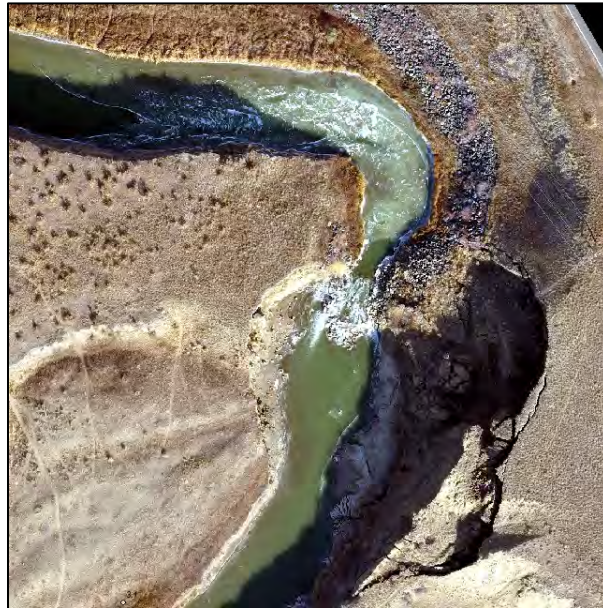
*Photo 2, November 2, 2021. Drone image of hillslope destabilization below grade control, Muddy Creek (flow direction is top to bottom).*

The conclusion that the grade controls remain functional largely remains the case, although they have become increasingly associated with excessive lateral scour and some hillslope failure, increasing their risk of failure in coming years (Photo 2).

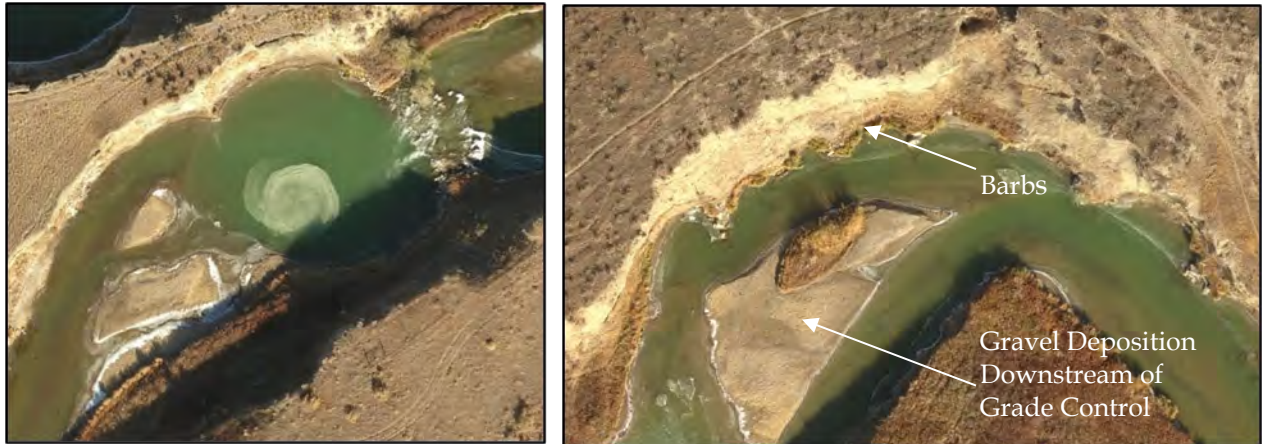
Photo 3, November 2, 2021. Existing Grade Control Structure (left) and Photo 4, November 2, 2021. Barb Series (right)

but the structure crests generally conform to the average channel gradient. The infrequent structure spacing has created a stepped longitudinal profile where the channel is most closely connected to an inset floodplain surface immediately upstream of each structure and most disconnected immediately downstream of the structures. Barbs that were installed concurrently to the grade controls are mostly still in place and functioning although they are generally associated with a scalloped bank pattern due to eddy erosion between the structures (Photo 4). Herbaceous vegetation has become established on some of the barbs adding additional stability.

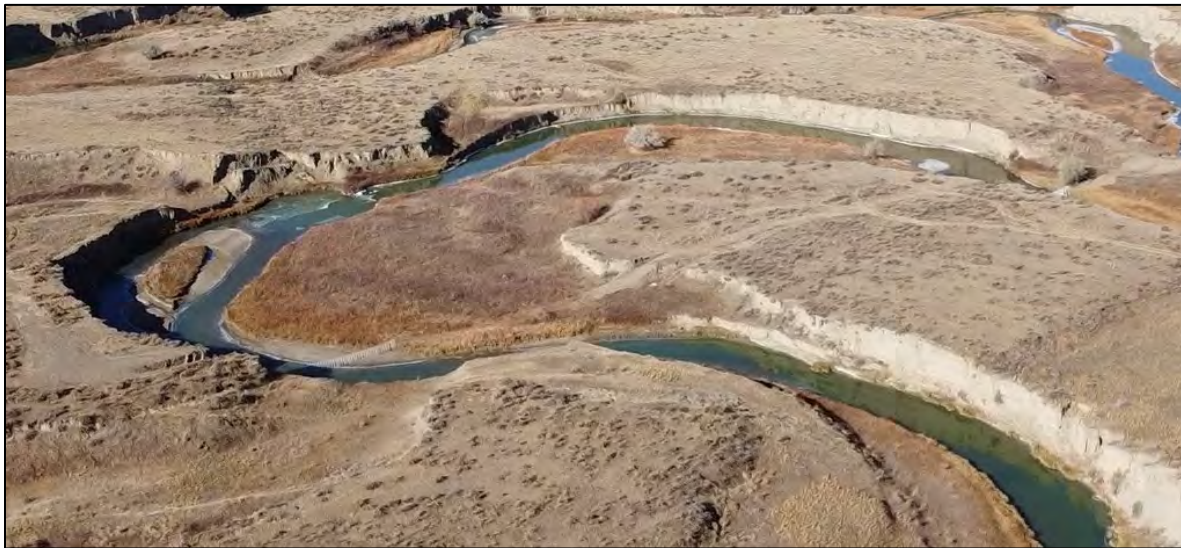
Photo 5, November 2, 2021. View upstream at RM 3.5 showing inset floodplain surfaces adjacent to channel.

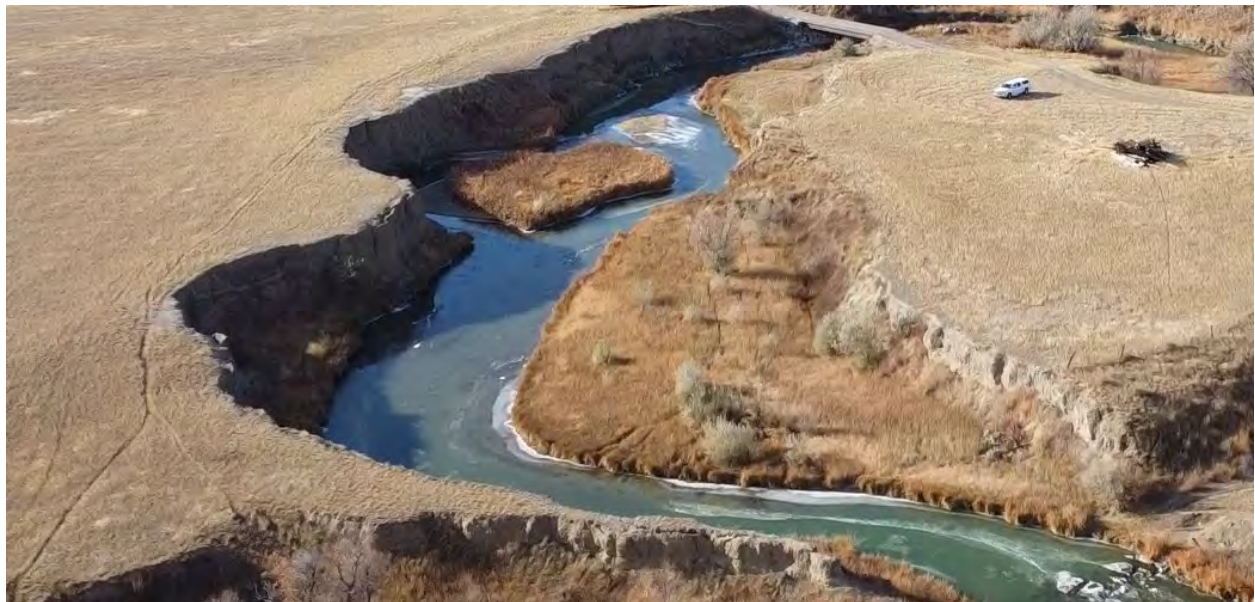
Photo 6, November 2, 2021. View upstream showing steep channel margins on passive edge and island; preliminary hydraulic modeling shows little hydrologic connectivity between these surfaces and the creek.

forming a discreet bankline. In this case, the meander core drops steeply to the channel, indicating that the entire meander tab is somewhat disconnected from the creek. This is the case throughout the system (Photo 6), it appears little of the grassed surface that appears as an inset floodplain is actually hydrologically connected to the river and thus capable of supporting riparian functions. Previous work has estimated the effective discharge on Muddy Creek to be about 300 cubic feet per second (CFS). A preliminary HEC RAS model was built with geometry taken from the 2020 Montana Department of Natural Resources and Conservation (MDNRC) LiDAR and a GPS survey conducted by this design team. The model indicates no inundation of inset floodplain surfaces at the effective discharge and the lowest elevation floodplain surfaces just begin to inundate at a flow somewhere between the 5-yr to 10-yr recurrence interval flood.

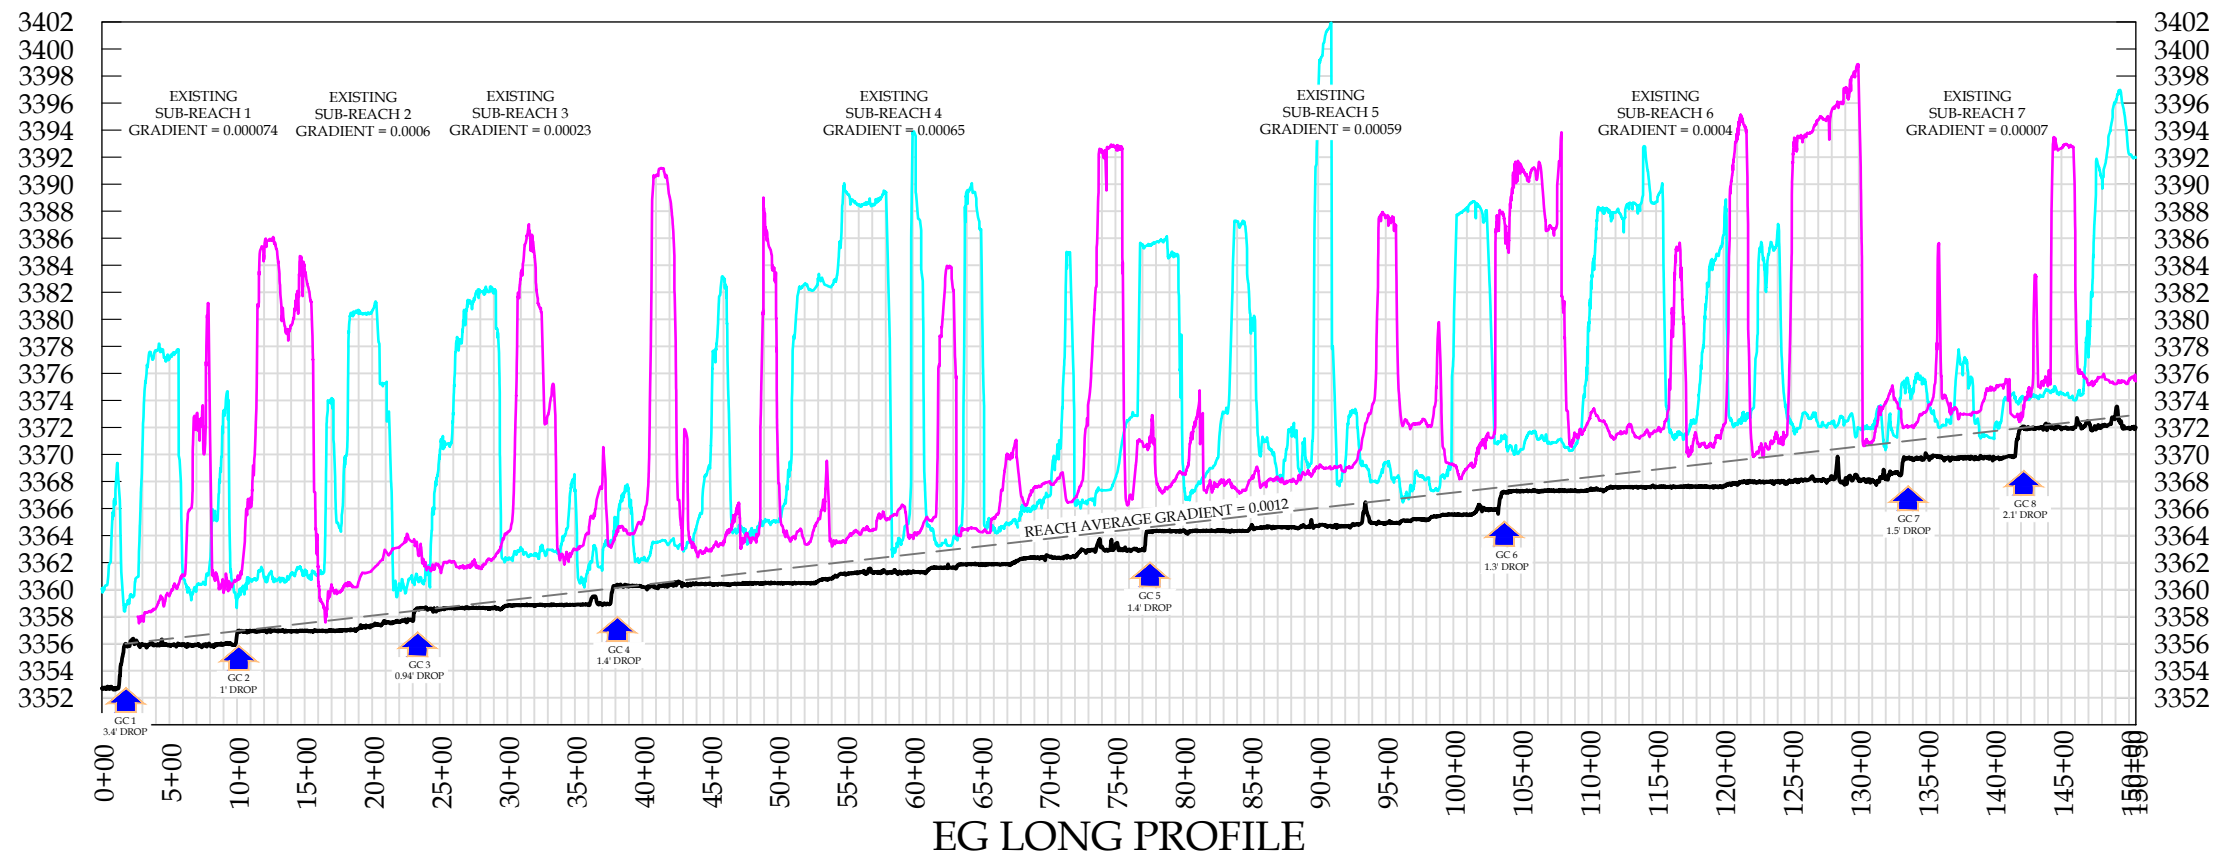
MUDDY CREEK RESTORATION  
EXISTING & PROPOSED LONGITUDINAL PROFILE

EG LONG PROFILE

PG ALIGNMENT

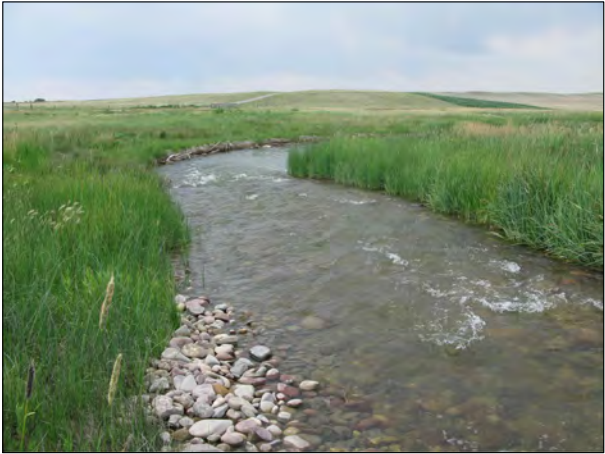
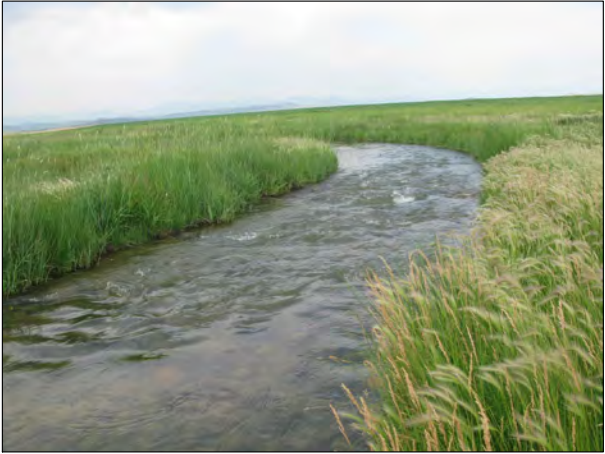
Riffle Grade Controls provide vertical stability and effectively increase (lift) the elevation of the existing streambed to provide connectivity to an existing abandoned floodplain. They also prevent channel incision because they are constructed with an immobile rock gradation. The shape, frequency, geomorphic position, and elevation drop across these structures allows them to behave like a natural riffles. The local water surface slope steepens across the structures at low flows but progressively flattens ("washes out") as water flows increase, eliminating the high energy loss conditions present at the existing grade controls and the associated scour and lateral erosion

1. Prepare subgrade to a firm and un-yielding condition
2. Excavate loose riffle sub-grade material from constructed riffle footprint and stockpile.
3. Place boulders on sub-grade in a random array throughout the riffle footprint avoiding a linear un-natural appearance.

4. Fill and compact imported riffle material in 0.5' lifts.
5. Fill interstitial spaces with native streambed material by washing or brushing the materials into the riffle matrix.

6. Repeat compacted lift sequence until design elevations are achieved.
7. The width of the riffle will be determined in final design.
8. Riffle gradation and boulders to be used to construct a stable shoulder at the margins of the constructed riffle.

9. Salvaged sod to be placed on shoulder to complete the bank to the bankfull elevation.
10. Typical structure length will vary form 75' to 100' depending on channel position and final design criteria.

11. Typical structure height at crest preliminarily ranges from 1.0' to 1.7'.
12. Material volume will range form 200 to 400 tons of rock depending on sub-grade quality and structure dimensions.

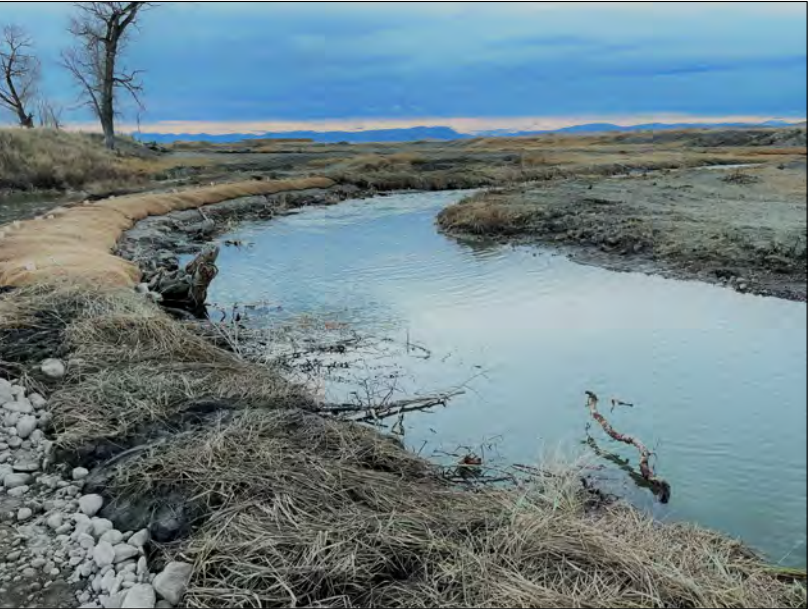
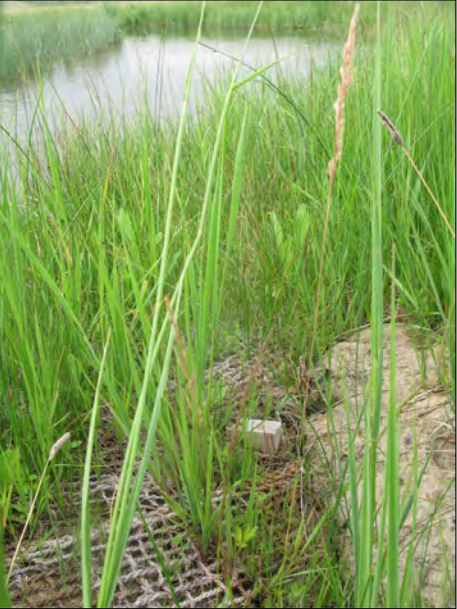
Creation of a bankfull bench at the toe of eroding terraces to prevent future erosion. The bankfull bench serves numerous purposes including; 1) Provides a platform to retain collapsed bank materials from terrace before they are entrained in creek flows, 2) Provides a platform for growing stabilizing riparian vegetation, 3) Increases system roughness, 4) Narrows over-widened cross sections and 4) Improves aquatic habitat. Use of a stabilizing composite wood toe allows for the use of more erodable (locally available) materials to create a bankfull bench. Large wood and willows are not readily available on site but may be available nearby opportunistically thorough maintenance operations on Greenfield Irrigation District (GID) lands, highway roadside ditch maintenance, Christmas tree collections, and selective harvest from health riparian areas in the region.

1. Sub-excavate streambed to create a platform for wood/brush placement that slopes down in the direction of the terrace.
2. Excavated materials to be placed at toe of terrace to be used as general fill.
3. Construction to occur at low water
4. Notch the downstream grade control to lower the base flow water elevation to make construction from the creek side feasible.
5. Place woody / brush in lifts and compact with alluvium.
6. Backfill bankfull bench with general fill up to top of wood/brush toe.
7. Place sod salvaged from the opposite floodplain to finish the bank up to the bankfull elevation.
8. Incorporate live will clumps and cuttings throughout the toe above the base flow elevation.
9. Create a rough surface on the bankfull bench per the floodplain roughness detail.

\*Inset Floodplain Width Varies Depending on Local Conditions

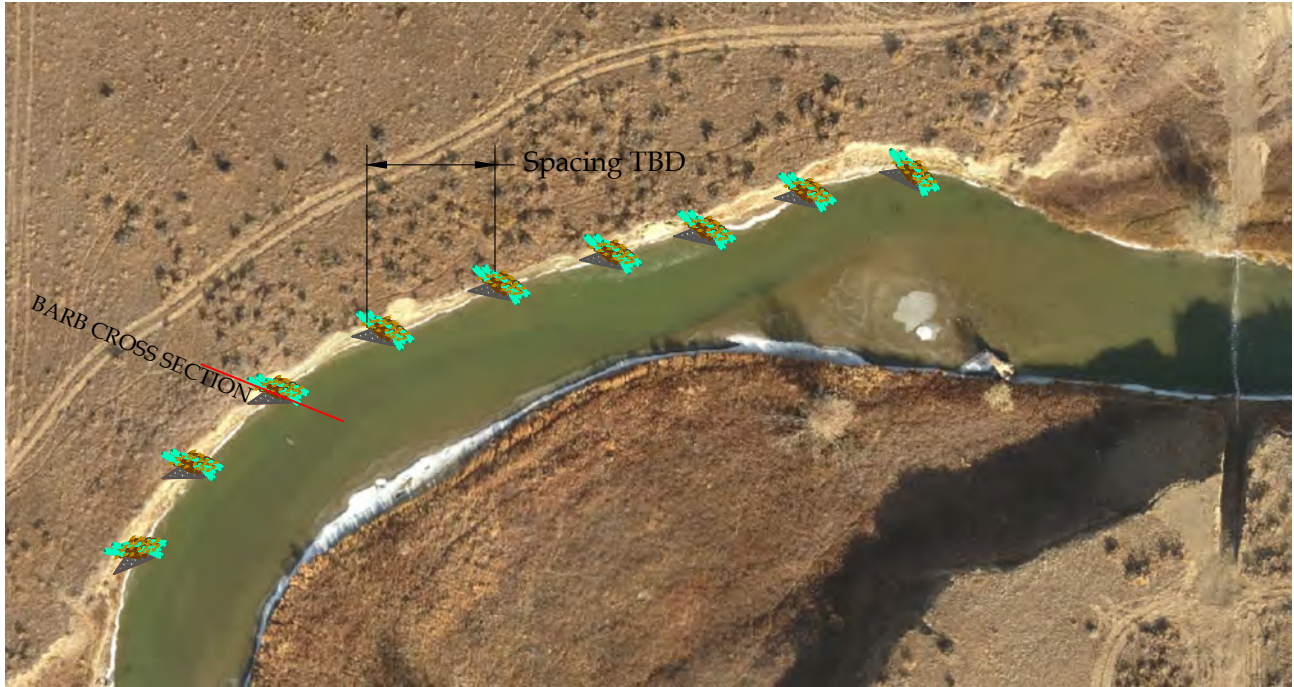
**Work Description:**  
Of the 160 barbs installed in the mid-90's, many are still functioning, which is testament to the effectiveness of the treatment. Barbs are also discontinuous treatments so material requirements are lower than other continuous treatments. Rock barbs move the channel thalweg away from the toe of a bank but they can increase velocities in the main channel. In keeping with the project objectives of reducing stream energy an alternative barb plan is proposed as shown on the attached concept drawings. Construction of the original barbs used large blasted quarry rock and were placed with a long-boom trackhoe from the top of 20 to 30 foot terraces. This practice limited the extent of the structures and precision in placement of materials. The proposed structure evision an alternative construction method, alternative materials and modified functionality.

- Notes:**
- 1. Construction to occur at low water
  - 2. Notch the downstream grade control to lower the base flow water elevation to make construction from the creek side feasible.
  - 3. Sub-excavate streambed to create a thickened end section
  - 3. End dump cobble/rock gradation from top of terrace at each structure location.
  - 4. Shape structure with trackhoe from the river level
  - 5. Place stacked brush mats upstream, on and downstream of the structures.
  - 6. Drive wood piles to secure brush mattresses.
  - 7. Top of elevations of select piles to exceed the 1% annual chance flood elevation.
  - 8. Incorporate live willow clumps and cuttings throughout the structures.

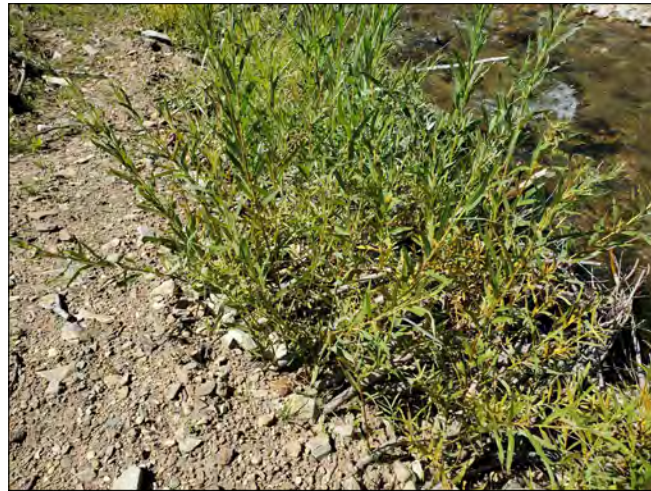
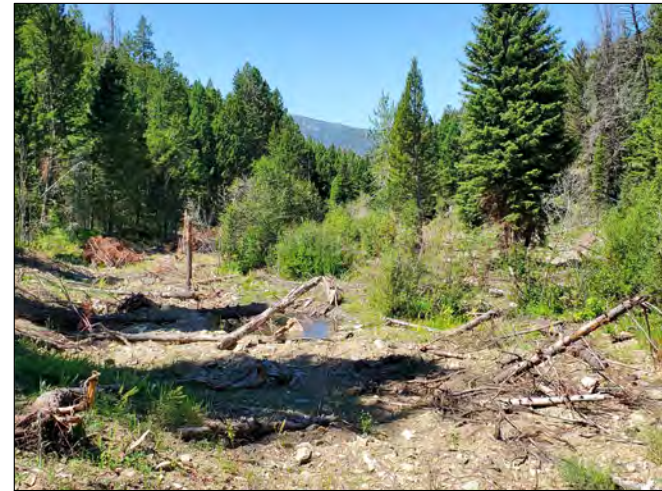
DRAWN:	TC/RS	NO.	DATE	REVISIONS	BY	CHK	PROJECT SPONSOR:	PROJECT:	DESIGN TEAM:	SHEET 10 OF 10
	ENGINEER:	TC								DATE: 12/8/2021
CHECKED:	KB						PROJECT SPONSOR:	PROJECT:	DESIGN TEAM:	SCALE: NA
APPROVED:										PROJECT NUMBER: 0221-01

#### Work Description:

At numerous locations within the project reach, a narrow bench is present along the toe of terraces banks. Benches vary in width and are generally colonized with grass and a few shrubs. These benches will be targeted with live willow cutting and containerized tree and shrub plantings. Stabilizing these existing surfaces with a riparian fringe is a comparatively low cost endeavor to increase system roughness and prevent future erosion of terrace surfaces.

1. For containerized plantings auger hole 3X the diameter of the container.
2. Install plant and backfill to the top of the root crown.
3. Mound surplus soil to create a water basin around plant.
4. Water-in plant with several gallons of water
5. Install weed mat.
6. Install browse control.
7. Create a pilot hole with a hand held dibble bar, hydraulic jet, or excavator mounted dibble bar.
8. Insert willow cutting leaving 2 to 3 buds above the ground surface elevation.
9. Water-in cuttings to ensure no air voids are present between the sides of the pilot hole and the cutting.
